# By Brook Project Phase 1 - 2013/14.

## Prepared for the Environment Agency by BART

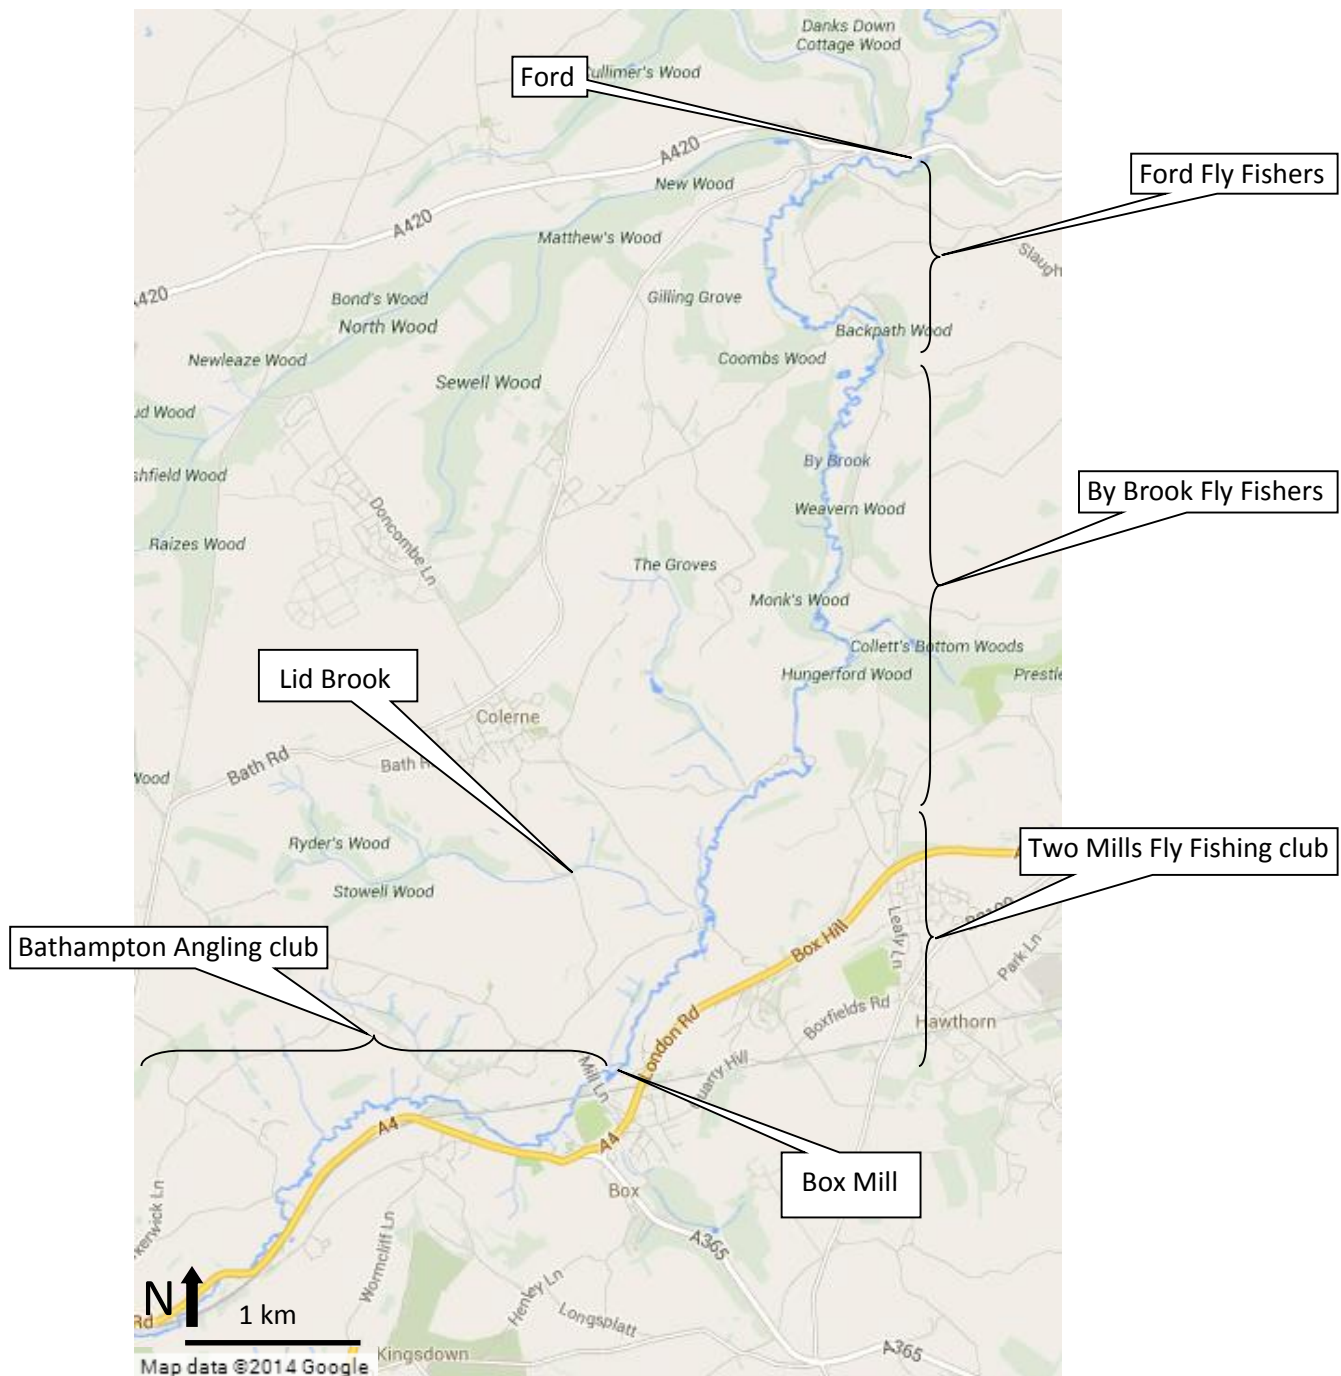
**Figure 1. By Brook Project area, showing the Lid Brook where most of the river protection works were undertaken and the approximate beats of the four fishing clubs that control the fishing in this section of the By Brook.**

The project area (Figure 1. By Brook Project area, showing the Lid Brook where most of the river protection works were undertaken and the approximate beats of the four fishing clubs that control the fishing in this section of the By Brook.) primarily covers these failing waterbodies, which include the By Brook between Ford (ST 83812 74507) in the north and its confluence with the Bristol Avon in the South (ST 78576 66993) and three tributaries, the Broadmead Brook, the Doncombe Brook and an un-named tributary.

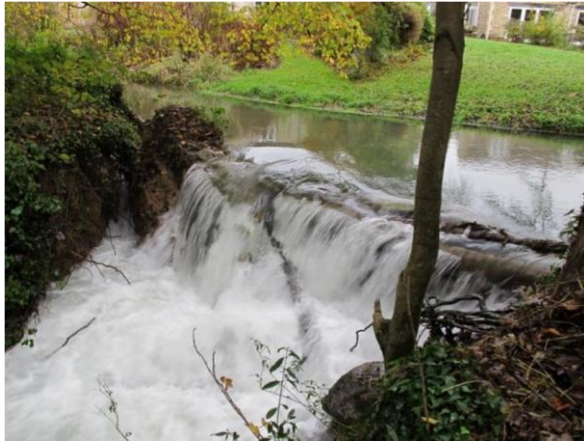
**Figure 4. Ford Mill Weir showing partial collapse on the far side**

Ford Mill (Figure 4 and Figure 5. Ford Mill watercourses showing position of Ford Mill weir) is owned by Mr Shaun Williams. The structure is the furthest upstream fish barrier in this study area and is in a very poor state of repair. Some make-shift attempts have been made to shore-up the structure using sandbags but this is a temporary solution and it seems likely that, unless significant, longer-term repairs are undertaken, the structure will partially collapse in the near future.

The proposed solution comprises a series of pre-weir structures, constructed from natural stone and a 7 metre Larinier style fish pass (Appendix 1: Fish pass feasibility designs from Mike and Matt Beach fish pass engineering consultants Site 1. Ford Mill Weir). A prerequisite to any works being carried out to facilitate fish passage would be for the weir to be fully repaired by the owner. This work could be carried out in conjunction with the fish passage works to reduce overall cost by having one set of machinery, one pre-lims cost and a single contractor. Given this situation, budget costs have not been prepared for this site. However, a budget cost of £9-10k has been given to carry out all necessary surveying, detailed design, engineering drawings and permissions preparation, to enable the scheme to go ahead.

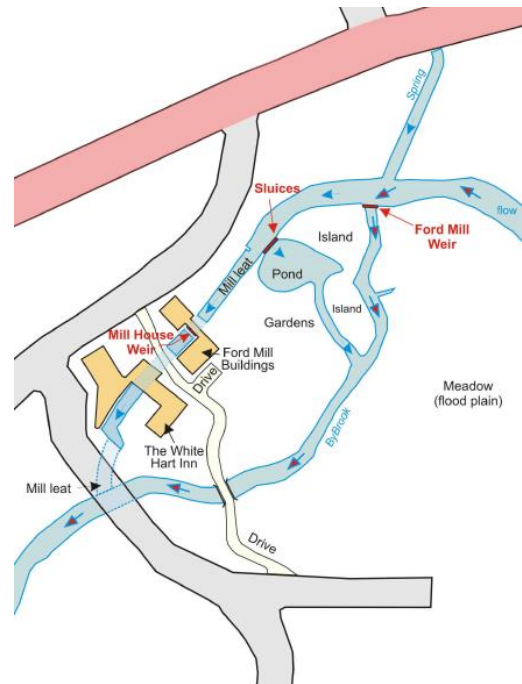
**Figure 5. Ford Mill watercourses showing position of Ford Mill weir**

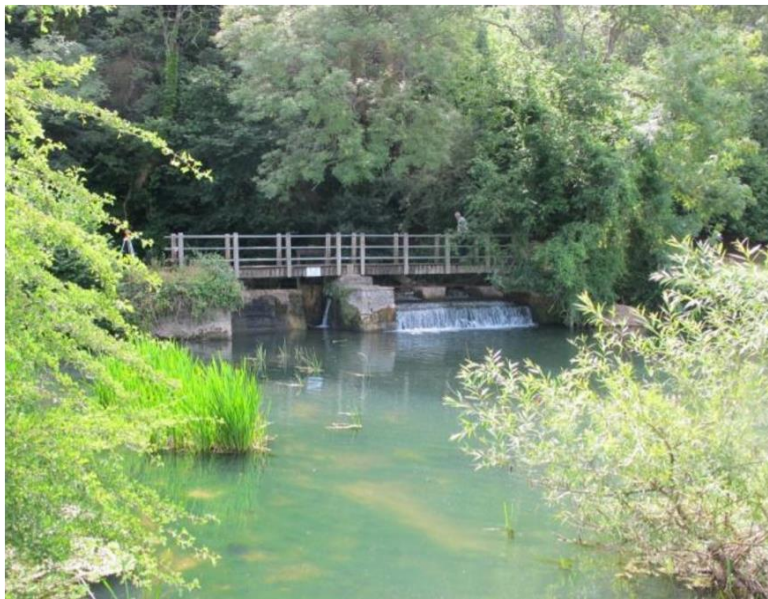
**Figure 6. Weir D/S Ford**

The weir downstream of Ford (Figure 6) is owned by Lord and Lady King but maintenance and repair is the responsibility of Ford Fly Fishers, who rent the fishing rights along this stretch of the By Brook. Feasibility design options for both pool and traverse and Larinier type fish passes have been prepared (Appendix 1: Fish pass feasibility designs Site 2. Weir D/S Ford). Budget costs for detailed preparation and installation are expected to be between £70 and £90k, depending on the choice of footbridge.

The weir and sluice infrastructure is in generally sound condition but there is considerable erosional force during spate conditions.

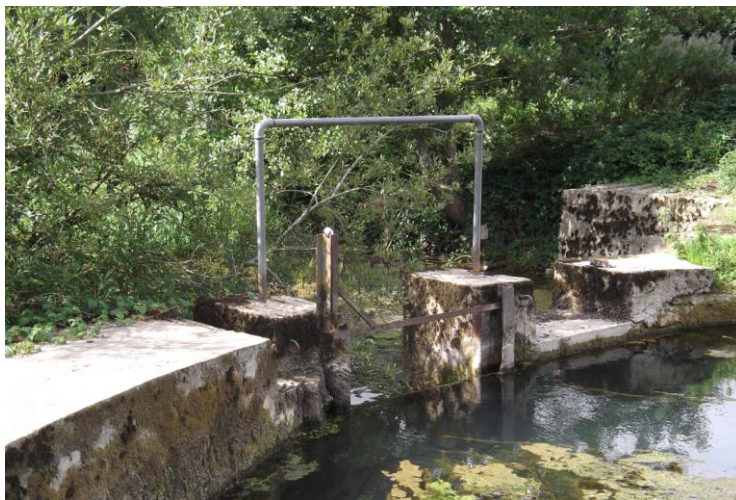
**Figure 7. Site 2, Weir downstream of Ford**

Site 3, Sluice D/S Ford, (Figure 7) is a substantial concrete structure with a steel sluice, situated approximately 150m downstream of Site 1. Site 3 was re-built using concrete during 2006/7, following previous collapse. The structure is thought to have been constructed originally to maintain a depth of water at the upstream structure (Site 2), to prevent under-cutting of the weir. The structure is of no historic or aesthetic interest and does not form a public access river crossing. However, the structure does provide fishable water for the Ford Fly Fishers, who control sluice level and have responsibility for the structure's upkeep, for approximately 100 metres upstream of the sluice and the club is keen to maintain this if possible.

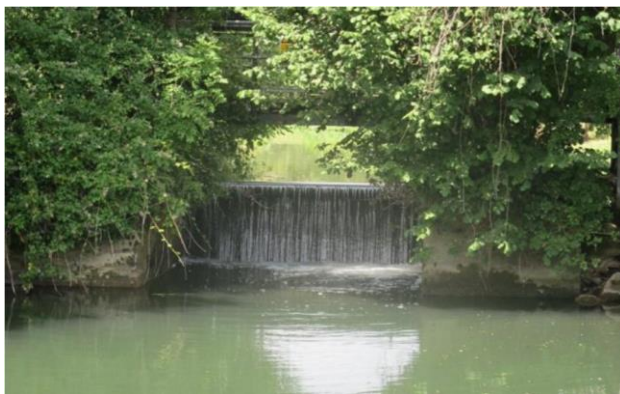
**Figure 9a. Slaughterford Gate from downstream showing steel sluice with approximate 1.8 metre drop**

Slaughterford Gate is the subject of on-going negotiations between the EA, By Brook Ltd (the current owners of the river bed at this point) and Lord King, the adjacent landowner. Responsibility for maintenance currently lies with the EA and this is also the subject of these negotiations. The currently preferred option amongst those proposed by the EA to the owner, is the removal of the steel sluice, to be replaced by boards, which it is understood would be the responsibility of the FFF to maintain and adjust. This solution would not, in itself, enable fish passage and it is unlikely that these works could not be undertaken under current regulations and EA guidance, without additional measures to enable fish passage also being included.

Two potential fish pass solutions, both comprising hard-engineered, pool and traverse structures, have been proposed as feasible options (Appendix 1: Fish pass feasibility designs Site 4. Slaughterford Gate Steel Sluice). However, due to the large drop in level to be overcome, both options require substantial infrastructure, which would cause the loss of a small area of grazing and this, combined with the visual impact make these options unlikely to be acceptable to either landowner. It is expected that either of these options would cost in the region of £80 - £100k to complete.

During winter flooding episodes, floodwater bypasses the sluice on both sides. On the right hand bank, floodwater escapes the current channel approximately 100 metres upstream of Site 4 and follows a natural landscape depression, assumed to be the original stream course, re-entering the channel downstream of Site 5, the Rag Mill. On the left hand side, floodwaters breach the channel some distance upstream of Site 4 but re-enter the main channel immediately to the left of the sluice. This is currently causing substantial erosion at this point, which may cause future structural damage to the sluice.

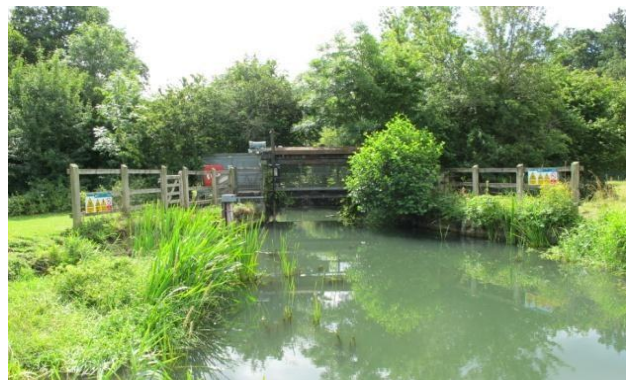
**Figure 9b. Slaughterford Gate from upstream showing non-functional electric level control mechanism, public footpath crossing and widened section of river above sluice.**

The structure also forms a river crossing with public access (Figure 9b). Hence, any engineered fish pass on either side of the structure would also require the construction of a footbridge and public access would have to be maintained during construction.

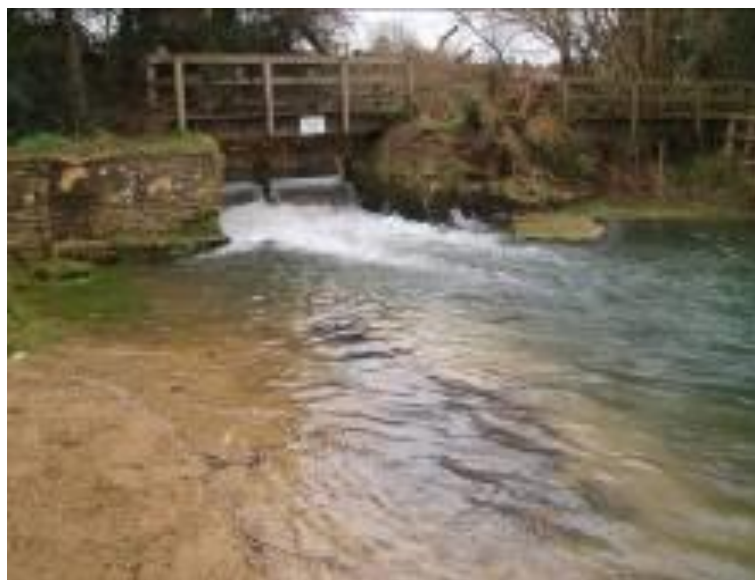
**Figure 10. Rag Mill Weir**

The Rag Mill weir, which includes a public footbridge across the By Brook (Figure 10), is owned by By Brook Ltd and maintenance is the responsibility of FFF, as part of their lease agreement. The structure comprises a stepped concrete weir with removable boards and is currently in a poor condition. A significant proportion (an estimated 60% on the day of survey) of the flow actually flows through the structure, instead of over the weir. Ford Fly Fishers have received verbal estimates for the required repair works, which are in the order of £10,000. The weir currently receives 100% of the river flow, except in extreme high flow conditions when, as described above, a proportion of floodwater bypasses both this and the upstream Slaughterford Gate sluice. This puts a great deal of pressure on the weir structure, which will result in a continual maintenance burden for the fishing club, or collapse of the structure in the coming years.

Two possible hard-engineered solutions are presented in Appendix 1: Fish pass feasibility designsSite 5. Rag Mill, one each side of the weir, both comprising pool and traverse structures and a public footbridge. If either of these options were to be implemented, it would also be essential to carry out comprehensive repairs to the weir structure to ensure a lifespan commensurate with the expected life of the fish pass. However, neither of these options would address the continued erosional pressure on the structure during high flows, resulting from the existing modified river channel configuration. Following consultation with the Ford Fly Fishers in the light of these considerations, it is recommended that the natural-infrastructure proposal, given in section 5.13, be implemented to address both this site and the upstream Slaughterford Gate fish passage issues.

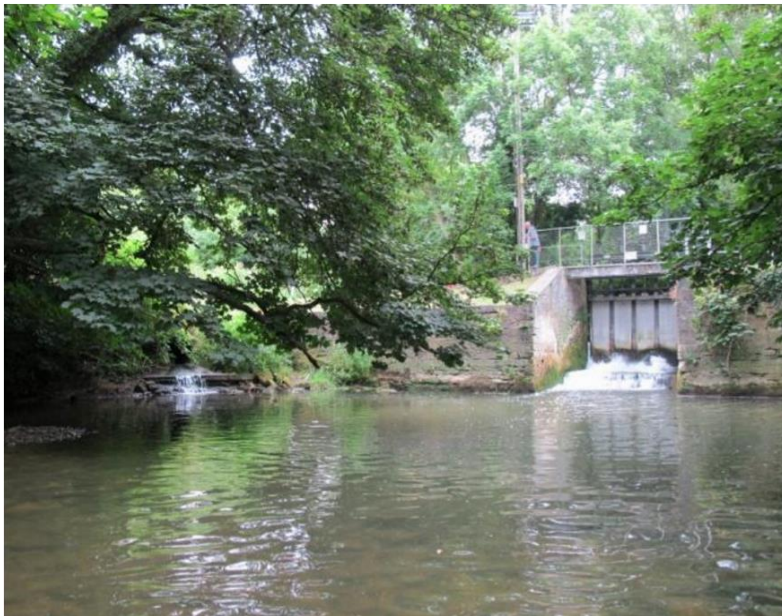
**Figure 11. Box Mill at Real World Studios**

Box mill is also owned by Peter Gabriel and lies within the curtilage of the Real World Studios (Figure 11). This structure comprises four steel sluices which maintain a hydrostatic head of over 2.8 metres, making this the largest fish migration barrier on the By Brook. Consultation with the owner's representative at the Real World Studios regarding works to enable fish passage has been favourable and engagement is on-going. As a result, and following discussions with EA colleagues, a second-phase of more detailed design work was undertaken, along with budget-level costing.

The recommended option that was taken forward for phase-2 design was a 2-stage Larinier Super-Active fish pass, with elver pipe, along the course of an existing back-channel (Appendix 1: Fish pass feasibility designs from Mike and Matt Beach fish pass engineering consultants Appendix 2: Stage 2 designs for Box Mill, Middlehill Gauging Station and Shockerwick weir

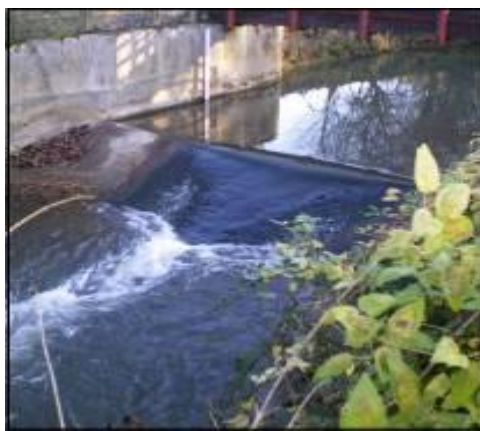
**Figure 12. EA-owned Middlehill Gauging Station**

Middlehill Gauging Station (Figure 12) is owned by the Environment Agency and was included in this work at their request. Survey and fish pass design work was carried out and a single Larinier super-active fish pass was proposed as these are registered as calibrated hydrometric structures. Following further consultation with EA colleagues, a second phase of detailed design was undertaken (Appendix 2: Stage 2 designs for Box Mill, Middlehill Gauging Station and Shockerwick weir Site 11: Middle Hill gauging station) and budget costs were prepared, which suggest a total estimated cost of around £120k. The EA are also considering an option comprising baffles within the weir structure, which would form a series of pools and riffles to enable fish passage.

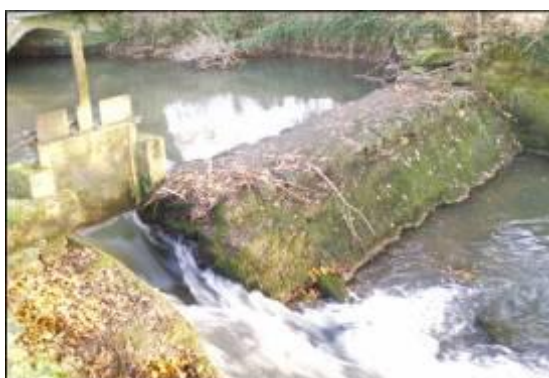
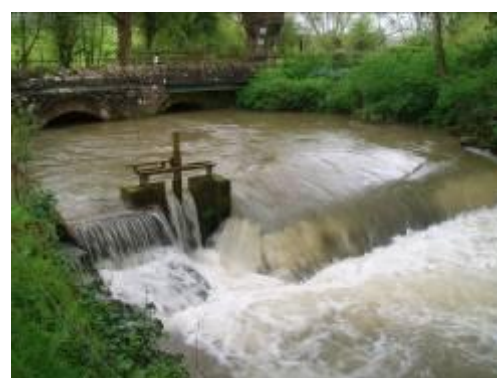
**Figure 13a. Shockerwick weir in normal winter flow conditions with open sluice and Figure 10b.**

Shockerwick Mill (Figure 13 a & b) is a concrete structure of unknown purpose, with a steel sluice. The operational purpose and regime for the sluice is unknown but it is clearly operated as can be seen by the changed position in Figure 13. To enable fish passage across the structure, a combination of lowering the weir crest and installing structures downstream of the weir to reduce the hydrostatic head, coupled with a short pool and traverse fish pass alongside the weir structure, is proposed (Appendix 2: Stage 2 designs for Box Mill, Middlehill Gauging Station and Shockerwick weir Site 12: Shockerwick weir). The expected cost of this work is in the region of £140k. If removal of the weir is considered preferable, care must be taken in surveying and understanding any potential risks to the upstream bridge supports, which can be seen in the background of Figure 13. The landowner has not yet been consulted over these proposals and Bathampton Angling Association have not yet given their support. If fish passage across this structure is to be realised, consultation early in Phase 2 is recommended.

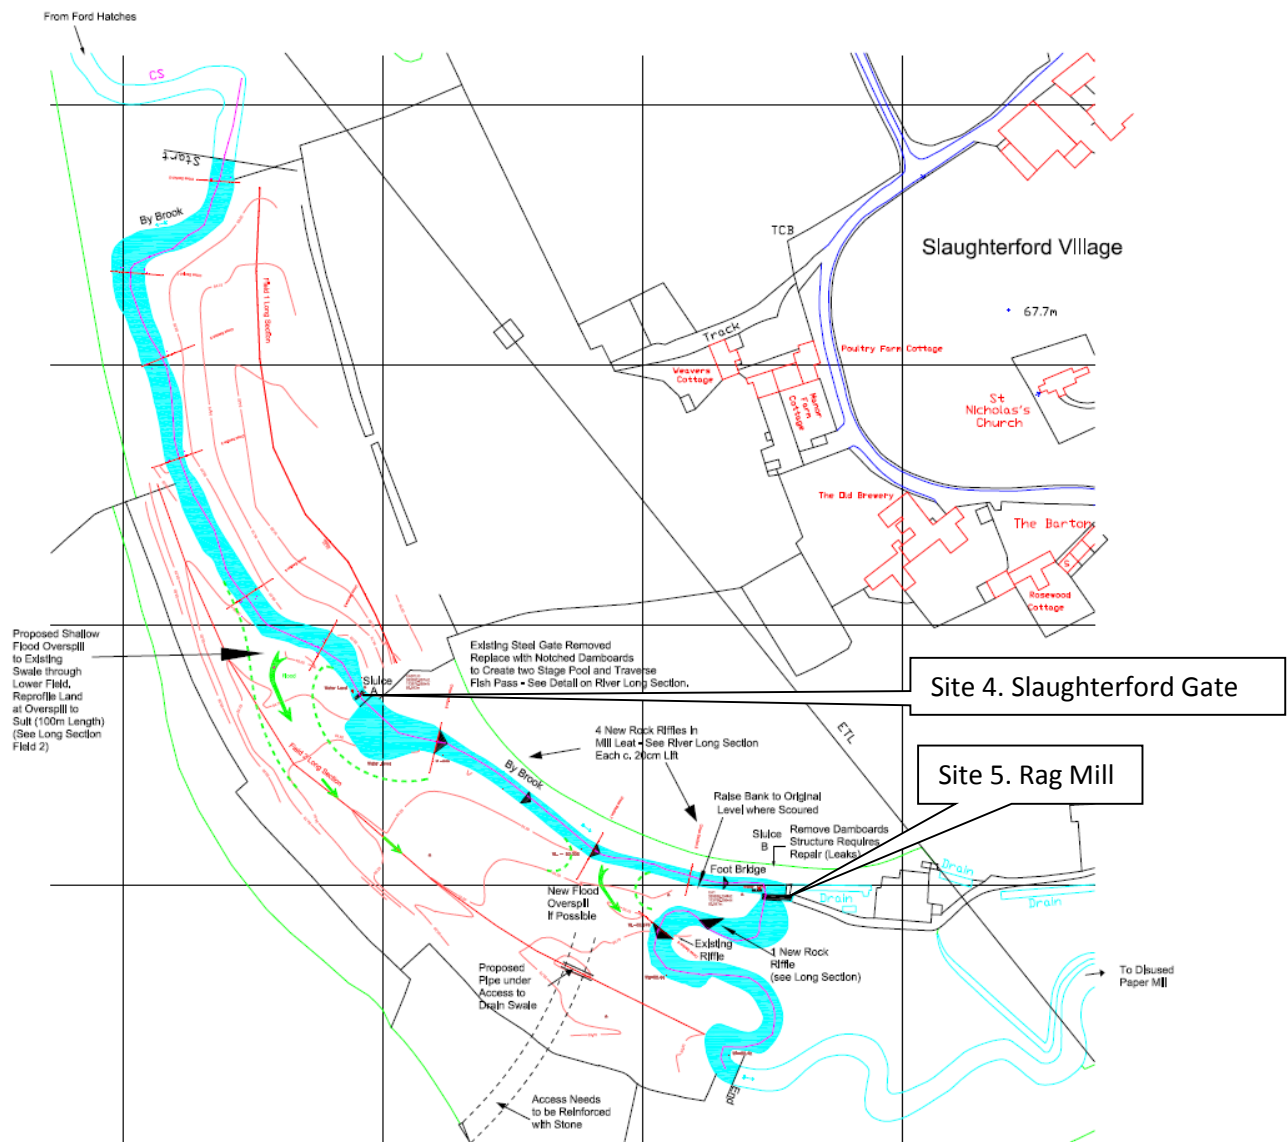
Figure 14. Plan view of riffles option for fish passage across Slaughterford Gate and Rag Mill weirs

The first of these comprises a series of naturalised riffles, using local Cornbrash stone, to raise the water level, in conjunction with the replacement of the Slaughterford Gate steel weir with a notched board and a reduction in the height of the Rag Mill weir (Figure 14 and Figure 15). This would enable fish passage, without the addition of hard-engineered fish passes. The second of these proposals involves the construction of a by-pass channel (Figure 16), which would follow the natural low-lying ground, thought to be the original river course, where flooding currently occurs during spate conditions.

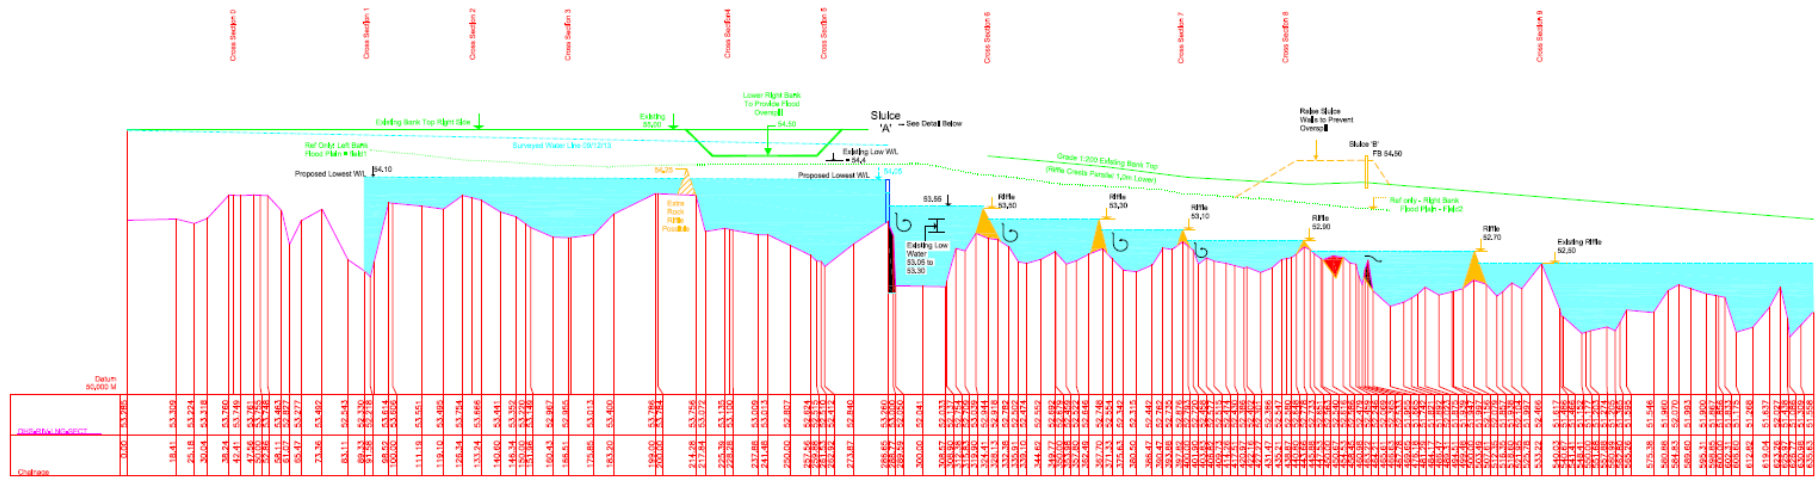
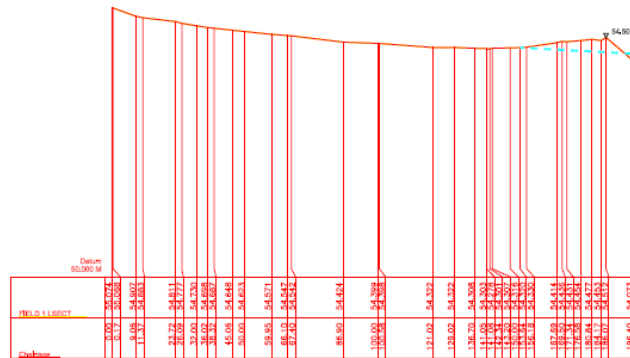
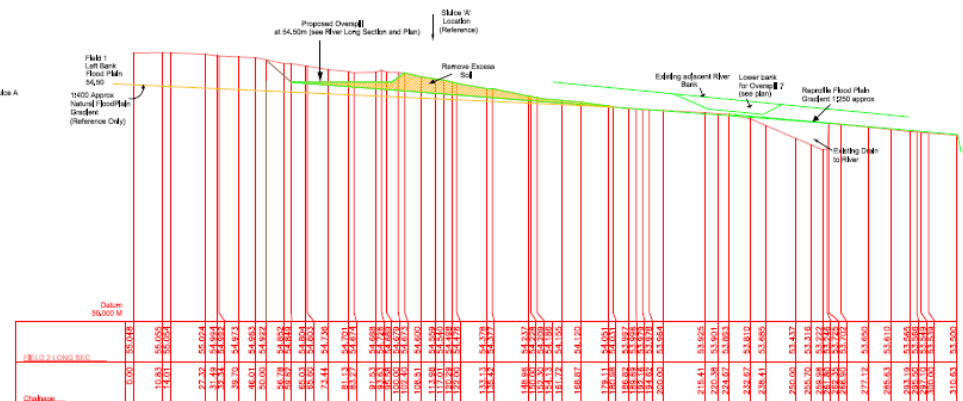
River Long Section

Field 1 Long Section Design

Field 2 Long Section Design

Figure 15. Long-section view of riffles option for fish passage across Rag Mill and Slaughterford Gate weirs

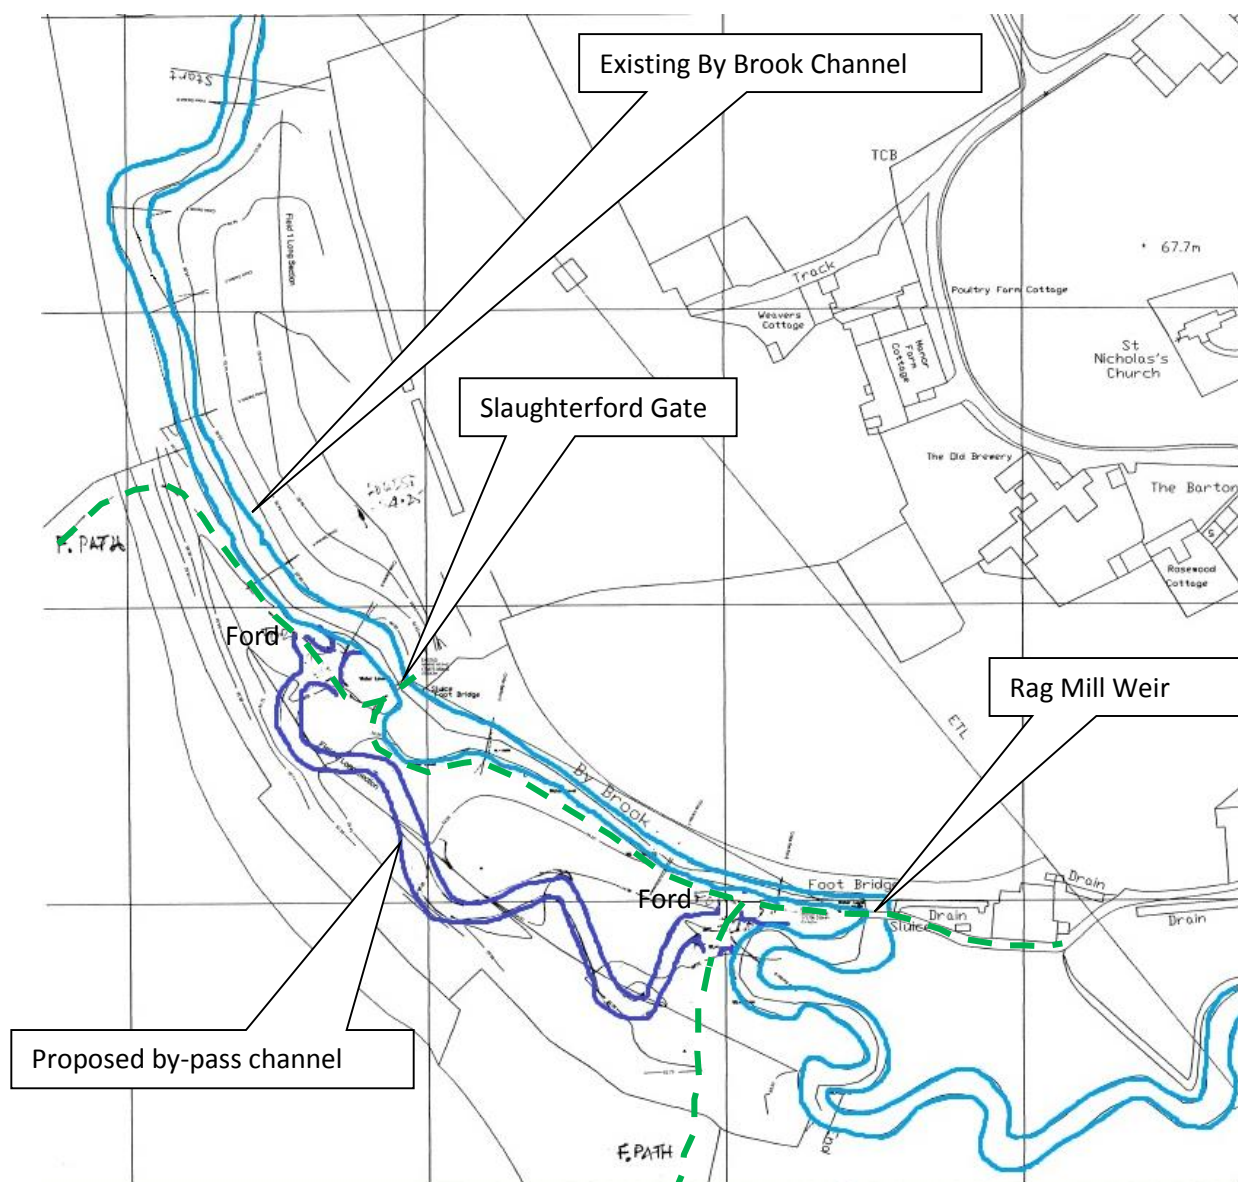
**Figure 16. Plan view of proposed by-pass channel for Slaughterford Gate and Rag Mill weirs**

- Naturalised solution that greatly enhances habitat diversity
- Increased flood capacity
- Retention of historic Rag Mill
- Reduction in erosional forces on Rag Mill
- Replacement of Slaughterford Gate steel weir with lower notched-board
- Eases possibility of transfer of ownership and responsibility of Slaughterford Gate from EA

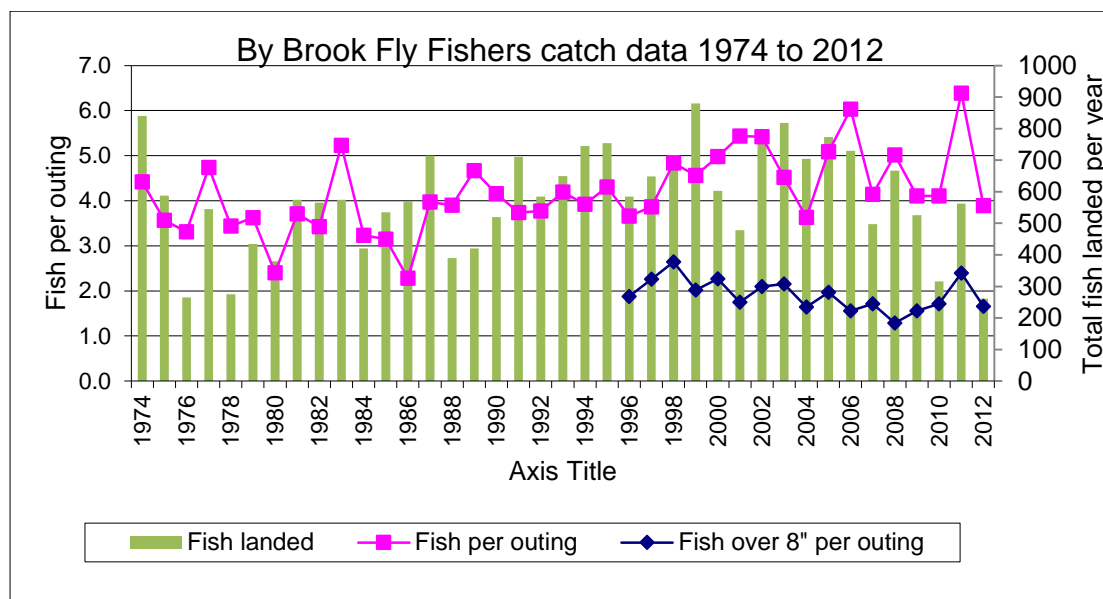
**Figure 17. Catch records from the By Brook Fly Fishers club 1974 - 2012, showing total number of fish taken each year, number of fish per outing and, since 1996, number of fish over 8" taken per outing.**

In contrast to this, the “over 8” data appears to paint a slightly different picture. Despite a particularly good year in 2011 when 211 fish over 8” were taken in 87 outings, there appears to have been a continual decline in the number of larger fish of over 8” landed per outing. This apparent decline was not found to be significant over the entire period and the increase seen in 2009 – 11 may indicate a recovery. Hence, caution must be taken in drawing any conclusions. However, when considered in the light of the “fish taken” data (Figure 18), the proportion of larger fish becomes much more interesting.

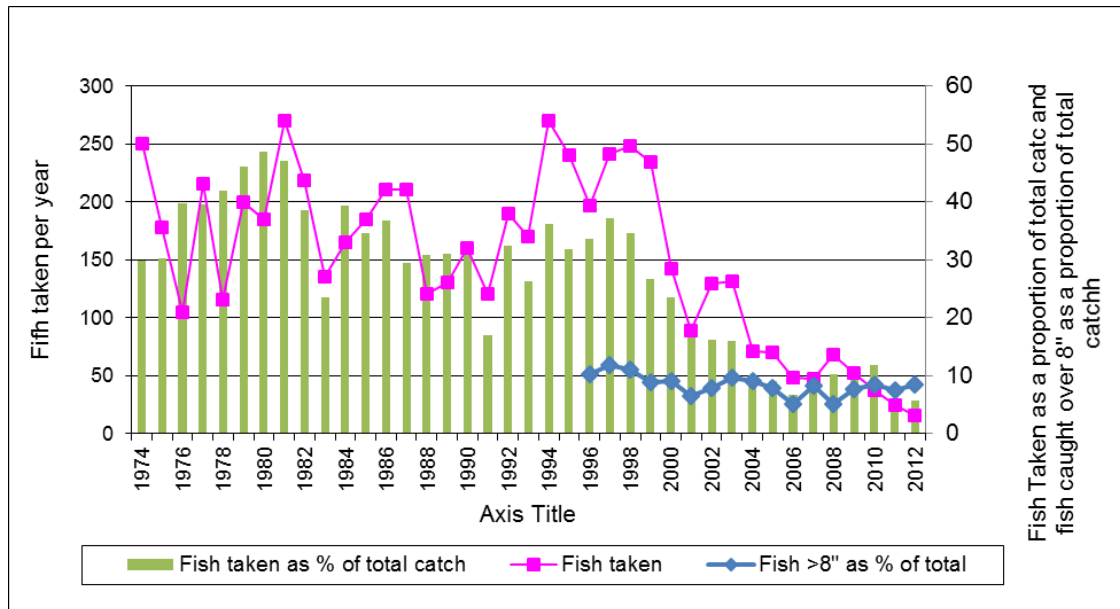
**Figure 18. Fish taken for consumption from By Brook Fly Fishers' beat, as total and as proportion of catch 1974 – 2012, and fish caught over 8" as proportion of total catch 1996 to 2012.**

the total catch shows no increase over this period, suggesting that other pressures are preventing fish from reaching the larger size classes previously encountered. We have no evidence to suggest what these pressures might be but food availability may be a contributing factor.

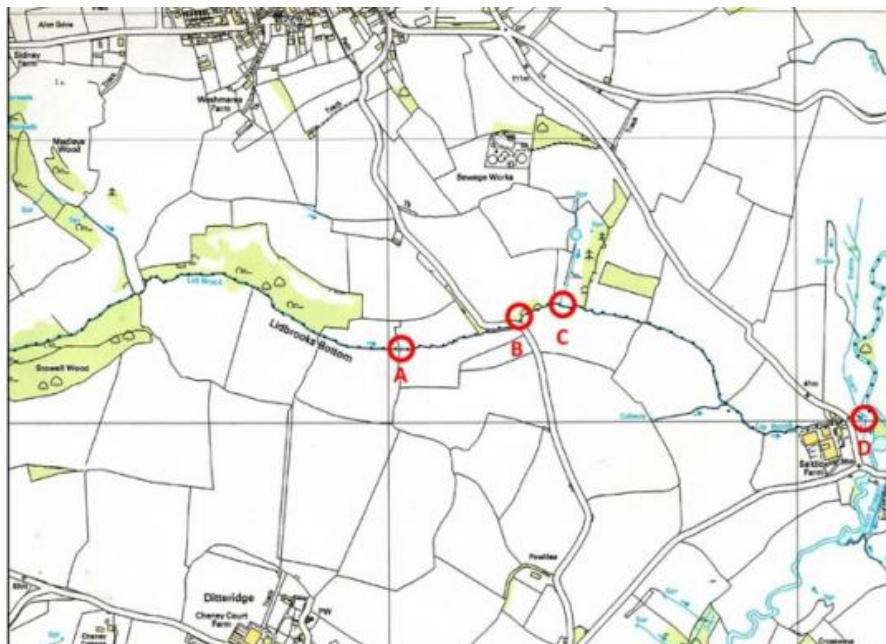
**Figure 19. Invertebrate sampling sites on the Lid Brook monitored by Bath Spa University students, reproduced from student coursework report.**

Invertebrate sampling was carried out by Bath Spa University students on the Lid Brook as part of the works discussed in section 7.2. Four sites were sampled (Figure 19). Sites A and B were upstream of Colerne STW where severe cattle poaching has been mitigated by fencing works carried out during December and January. Site C was just downstream of Colerne STW and Site D was downstream of Saltbox Farm. The BMWP scores for Sites A, B, C and D were 60, 36, 42 and 19 for respectively, indicating a heavily impacted and deteriorating ecological quality with distance downstream. The score of 19 recorded at Site D, downstream of Saltbox Farm indicates poor/polluted/impacted under the BMWP classification scale.

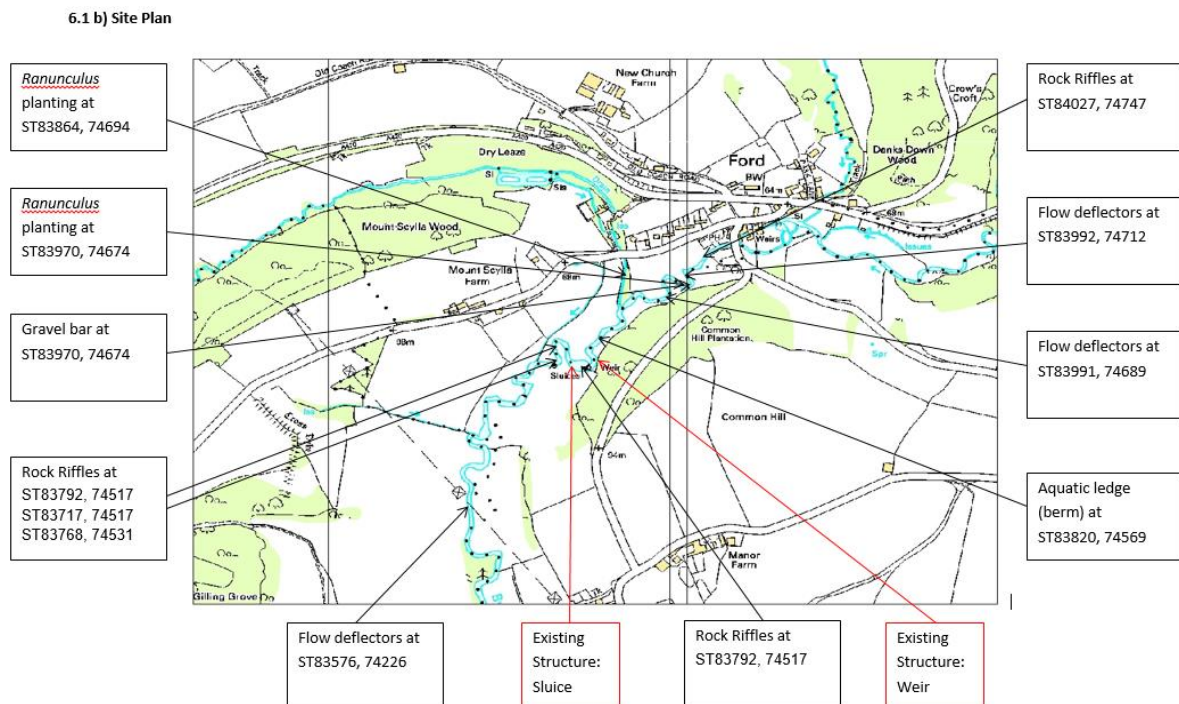
**Figure 20. Planned river habitat improvement works on FFF stretch, below Ford**

The FFF club are responsible for maintenance and repair on three of the four structures impacting on fish migration in their stretch (Sites 2, 3 and 5; Table 2). Responsibility for Site 4 (Slaughterford Gate)

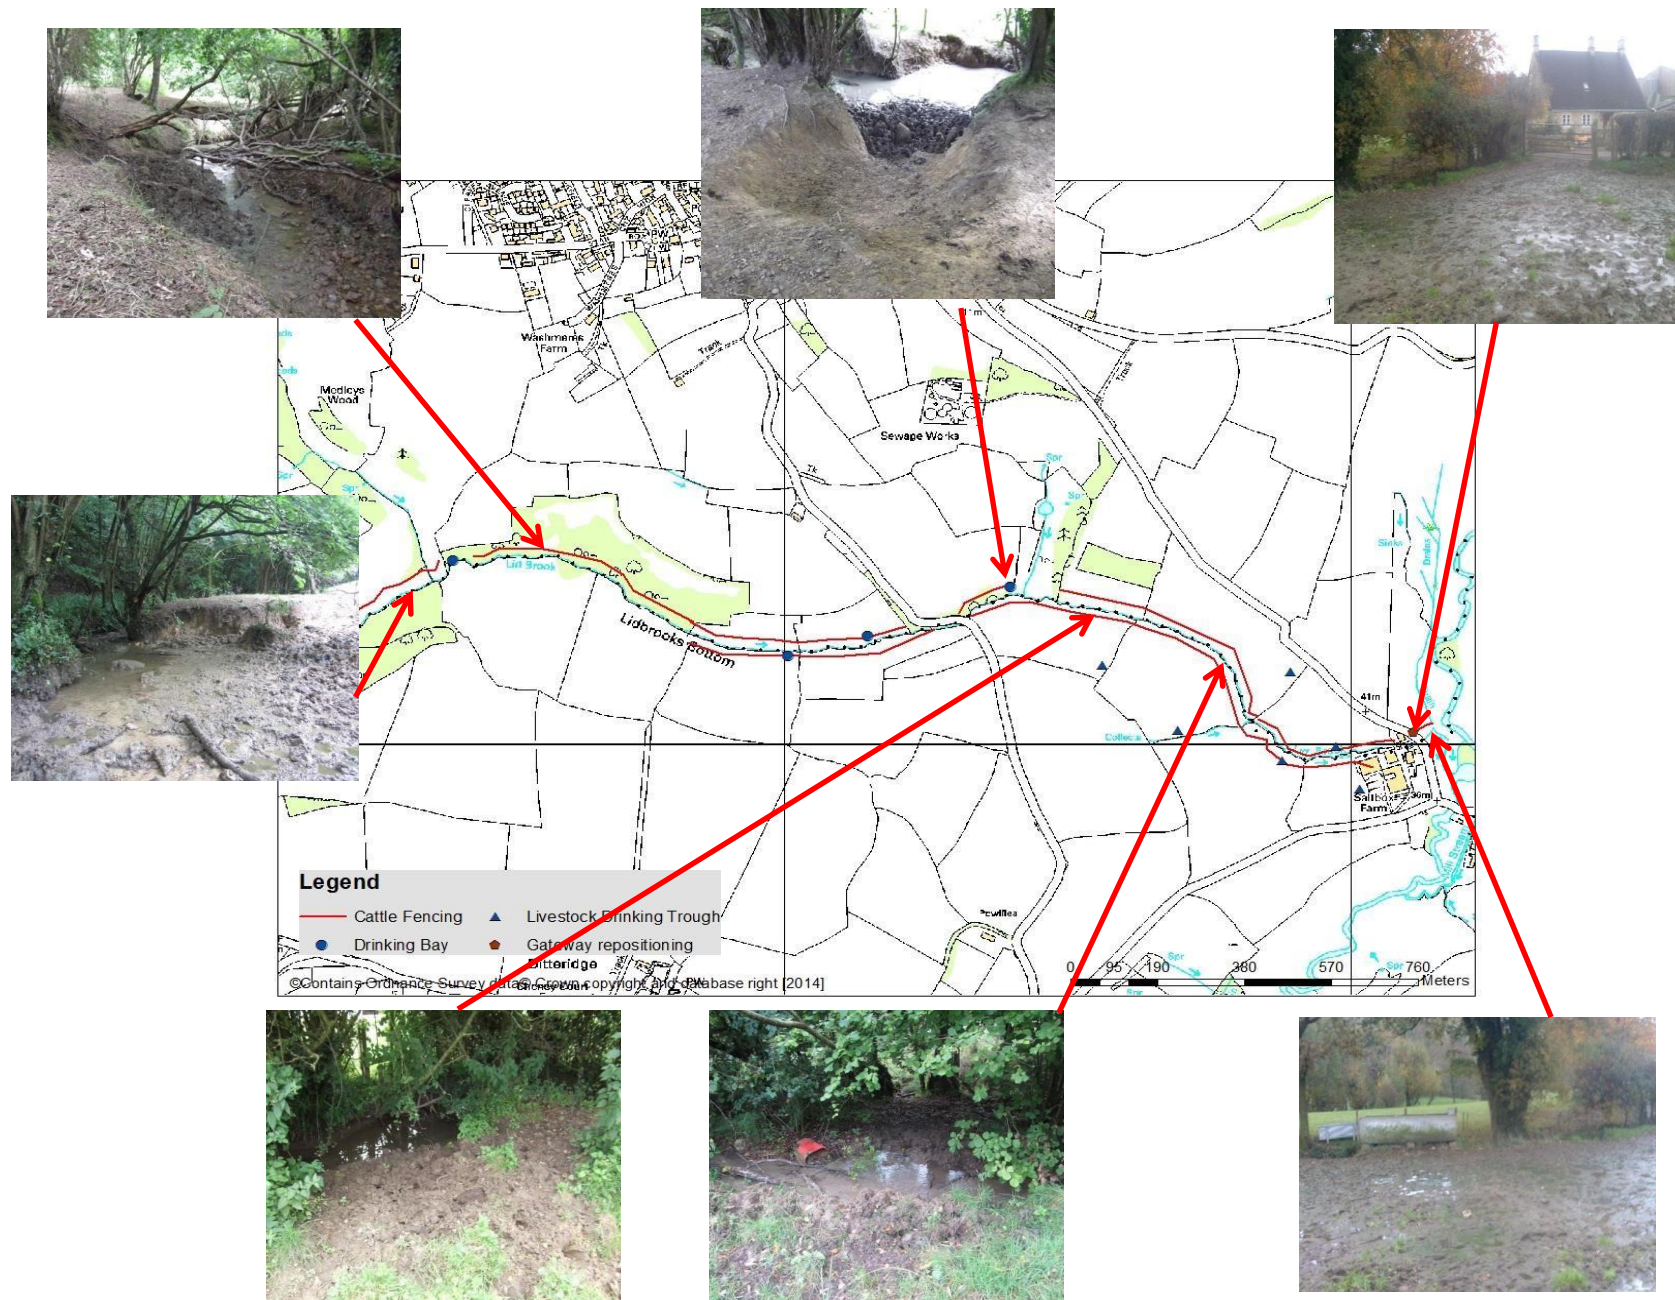
Figure 21. Lid Brook map showing images of habitat destruction identified during walkover surveys and mitigation measures undertaken

The Lid Brook was identified early on in the project as a key area for attention. The Brook receives treated effluent from Colerne STW (Owned by Wessex Water). The lower three quarters of the Lid Brook is intensively grazed by dairy stock, which are owned by Saltbox Farm, situated at the lower end of the Lid Brook, close to the confluence with the By Brook. This entire length of the brook was characterised by a lack of fencing and severe damage to the riparian strip and surrounding woodland Figure 21.

In addition, a combination of controlled in-stream cattle drinking access points and off-stream drinking was provided for stock watering. At the lower end of the brook, opposite the entrance to Saltbox farm, a gateway and watering trough that was situated immediately adjacent to the Lid Brook and had caused severe erosion was moved and re-constructed to enable recovery.

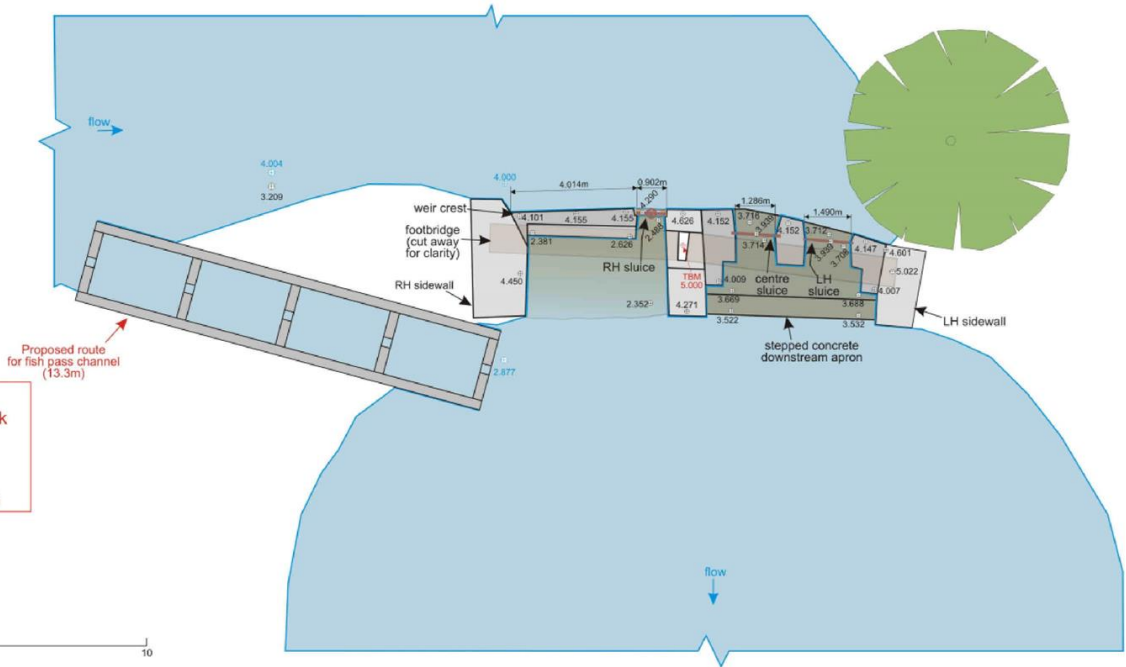
**OPTION 1:-**  
Pool & Traverse Fish Pass through RHS bank  
5 traverses 2m wide, each with a low flow notch 0.30m wide x 0.25m deep.  
3 pools 2.95m long x 2m wide x 2.5m deep  
Turbulence: 149W/m<sup>3</sup> at Q10 flow conditions.

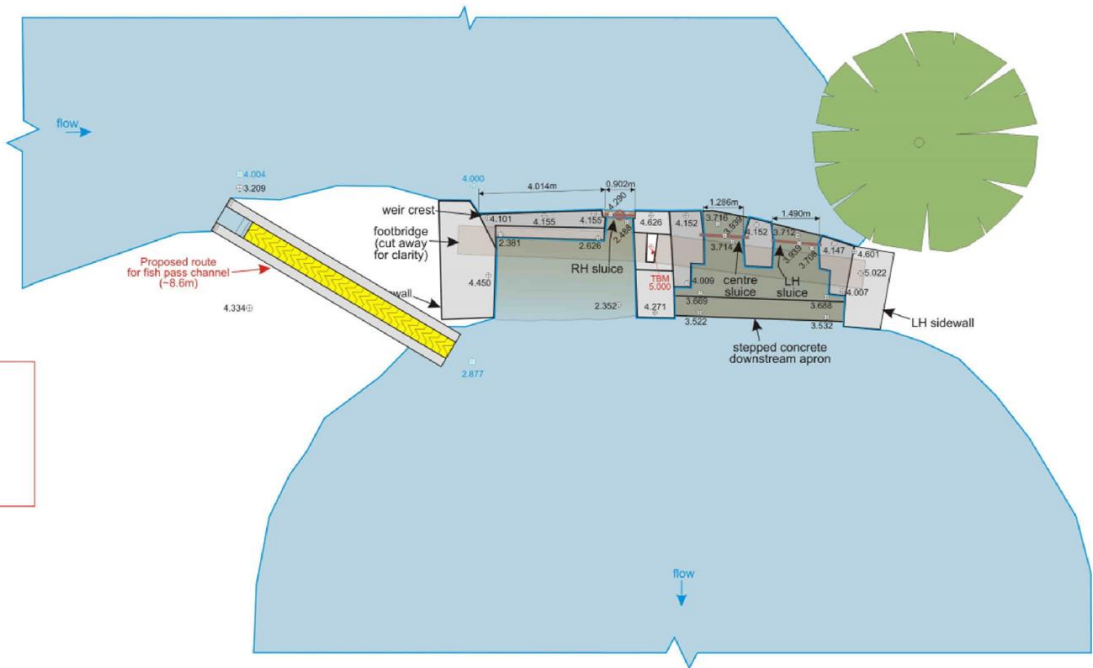
**OPTION 2:-**  
Larinier Super Active Fish Pass  
Single flight ~7.6m long, 0.6m wide,  
baffles 0.1m high, slope of 15%.  
ha at Q95 = 0.14m  
ha at Q10 = 0.50m

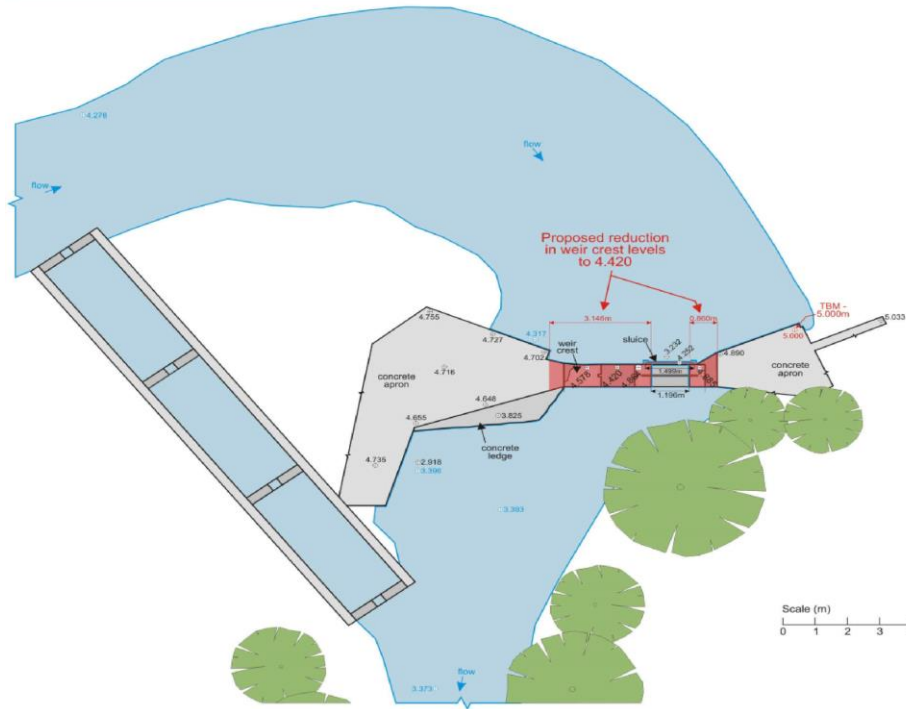
SITE 3 POOL & TRAVERSE  
FISH PASS - OPTION 1

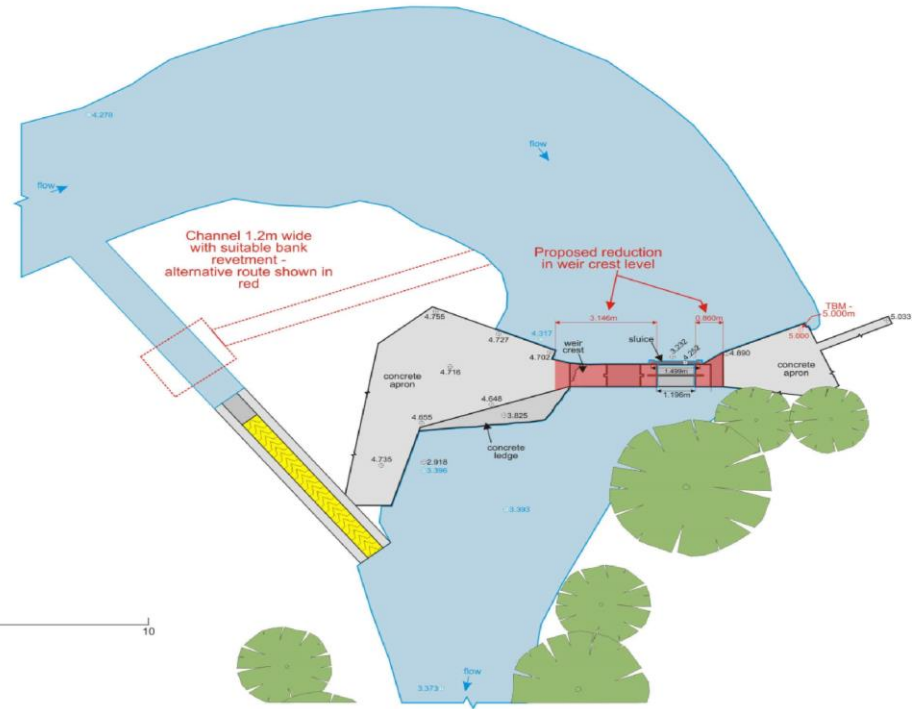
**SITE 3 LARINIER SUPER ACTIVE  
FISH PASS - OPTION 2**
