# By Brook Project Phase 1 - 2013/14.

## Prepared for the Environment Agency by BART

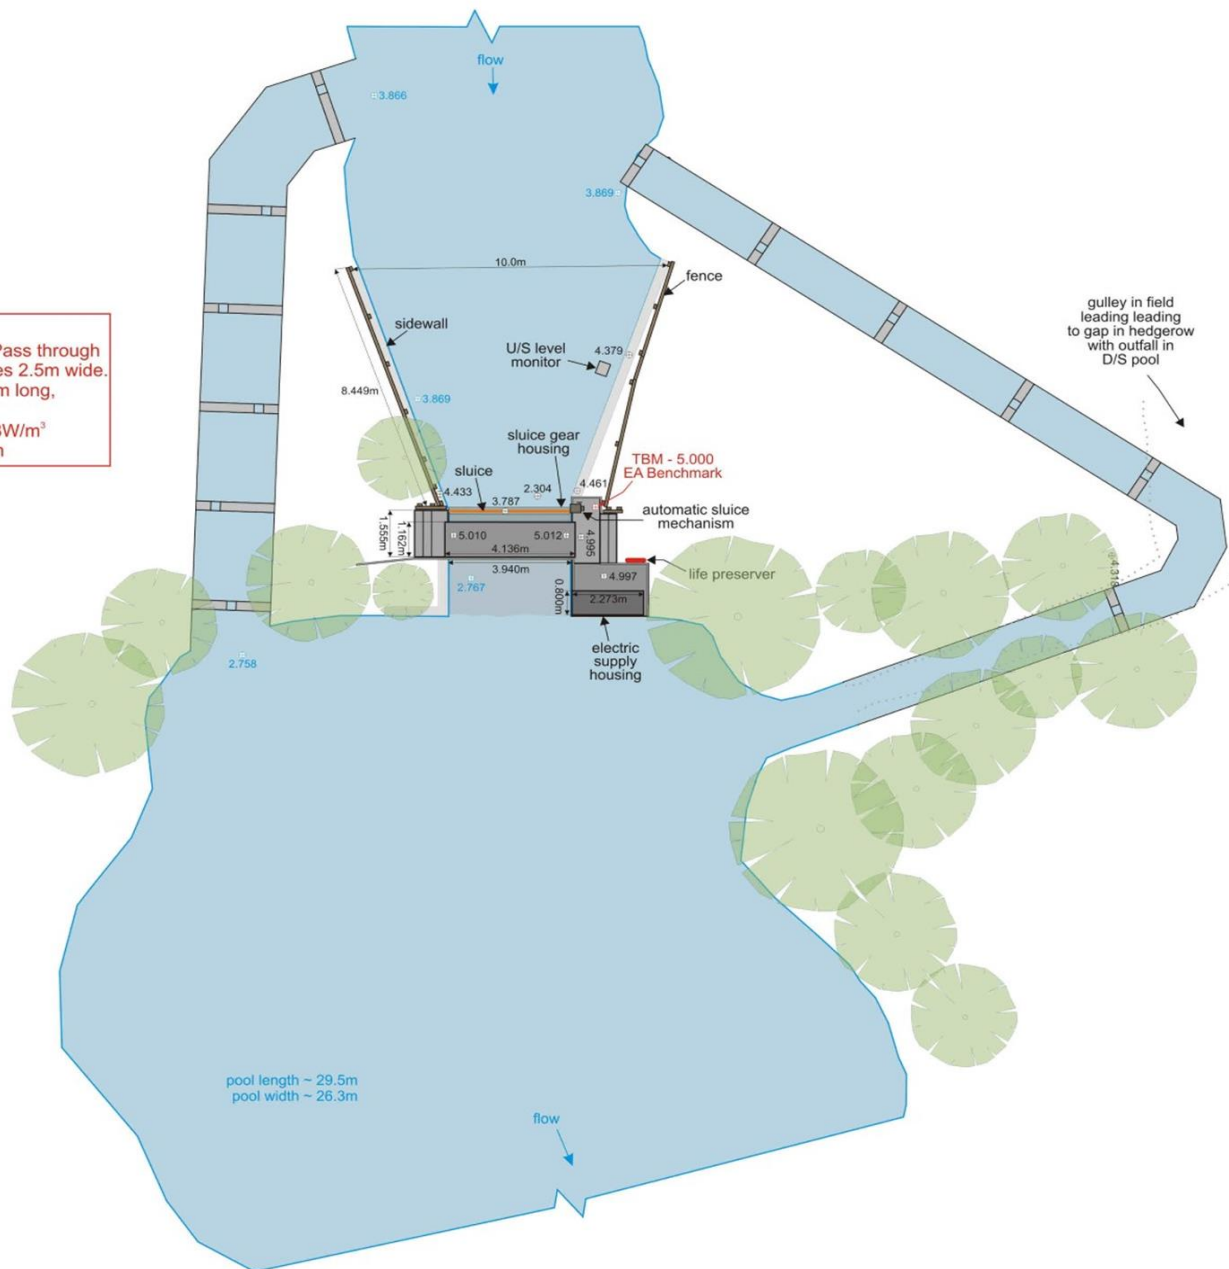
**OPTION 2:**  
Pool & Traverse Fish Pass through  
RHS Bank - 6 Traverses 2.5m wide.  
5 Pools 2.5m wide x 3m long,  
min depth 2m .  
Turbulence at Q10 148W/m<sup>3</sup>  
Total pass length ~17m

**OPTION 1:-**  
Pool & Traverse Fish Pass through  
LHS bank - 6 Traverses 1.5m wide,  
5 Pools 1.5m wide x 4.5m long,  
min. depth 1.5m.  
Sited to take advantage of natural  
gulley in field and route through  
field boundary into D/S pool.  
Total pass length ~33m

Two potential fish pass solutions, both comprising hard-engineered, pool and traverse structures, have been proposed as feasible options (Appendix 1: Fish pass feasibility designs Site 4. Slaughterford Gate Steel Sluice). However, due to the large drop in level to be overcome, both options require substantial infrastructure, which would cause the loss of a small area of grazing and this, combined with the visual impact make these options unlikely to be acceptable to either landowner. It is expected that either of these options would cost in the region of £80 - £100k to complete.

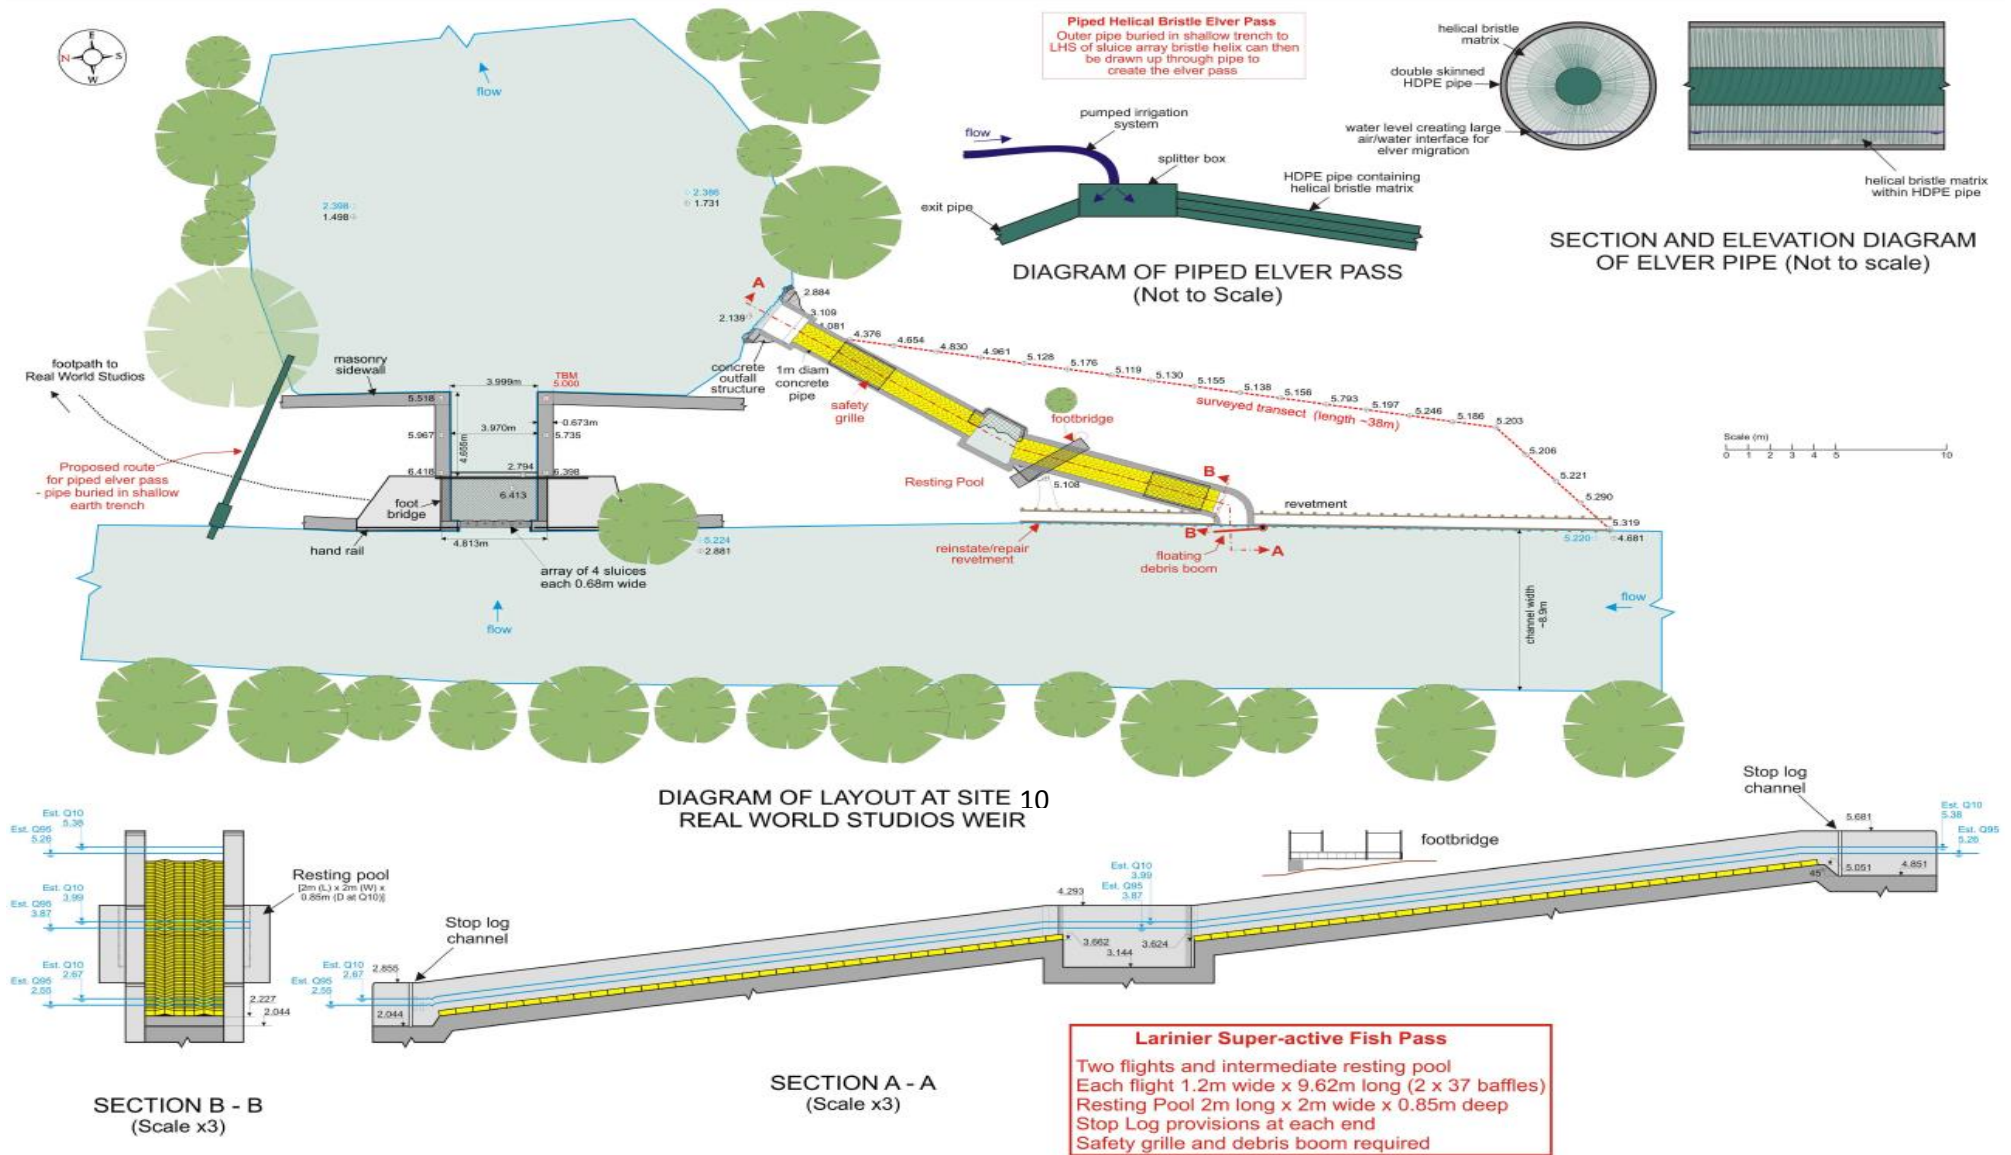
Site 10 Box Mill Real World Studios back-channel option concept sketch

The recommended option that was taken forward for phase-2 design was a 2-stage Larinier Super-Active fish pass, with elver pipe, along the course of an existing back-channel (Appendix 1: Fish pass feasibility designs from Mike and Matt Beach fish pass engineering consultants Appendix 2: Stage 2 designs for Box Mill, Middlehill Gauging Station and Shockerwick weir

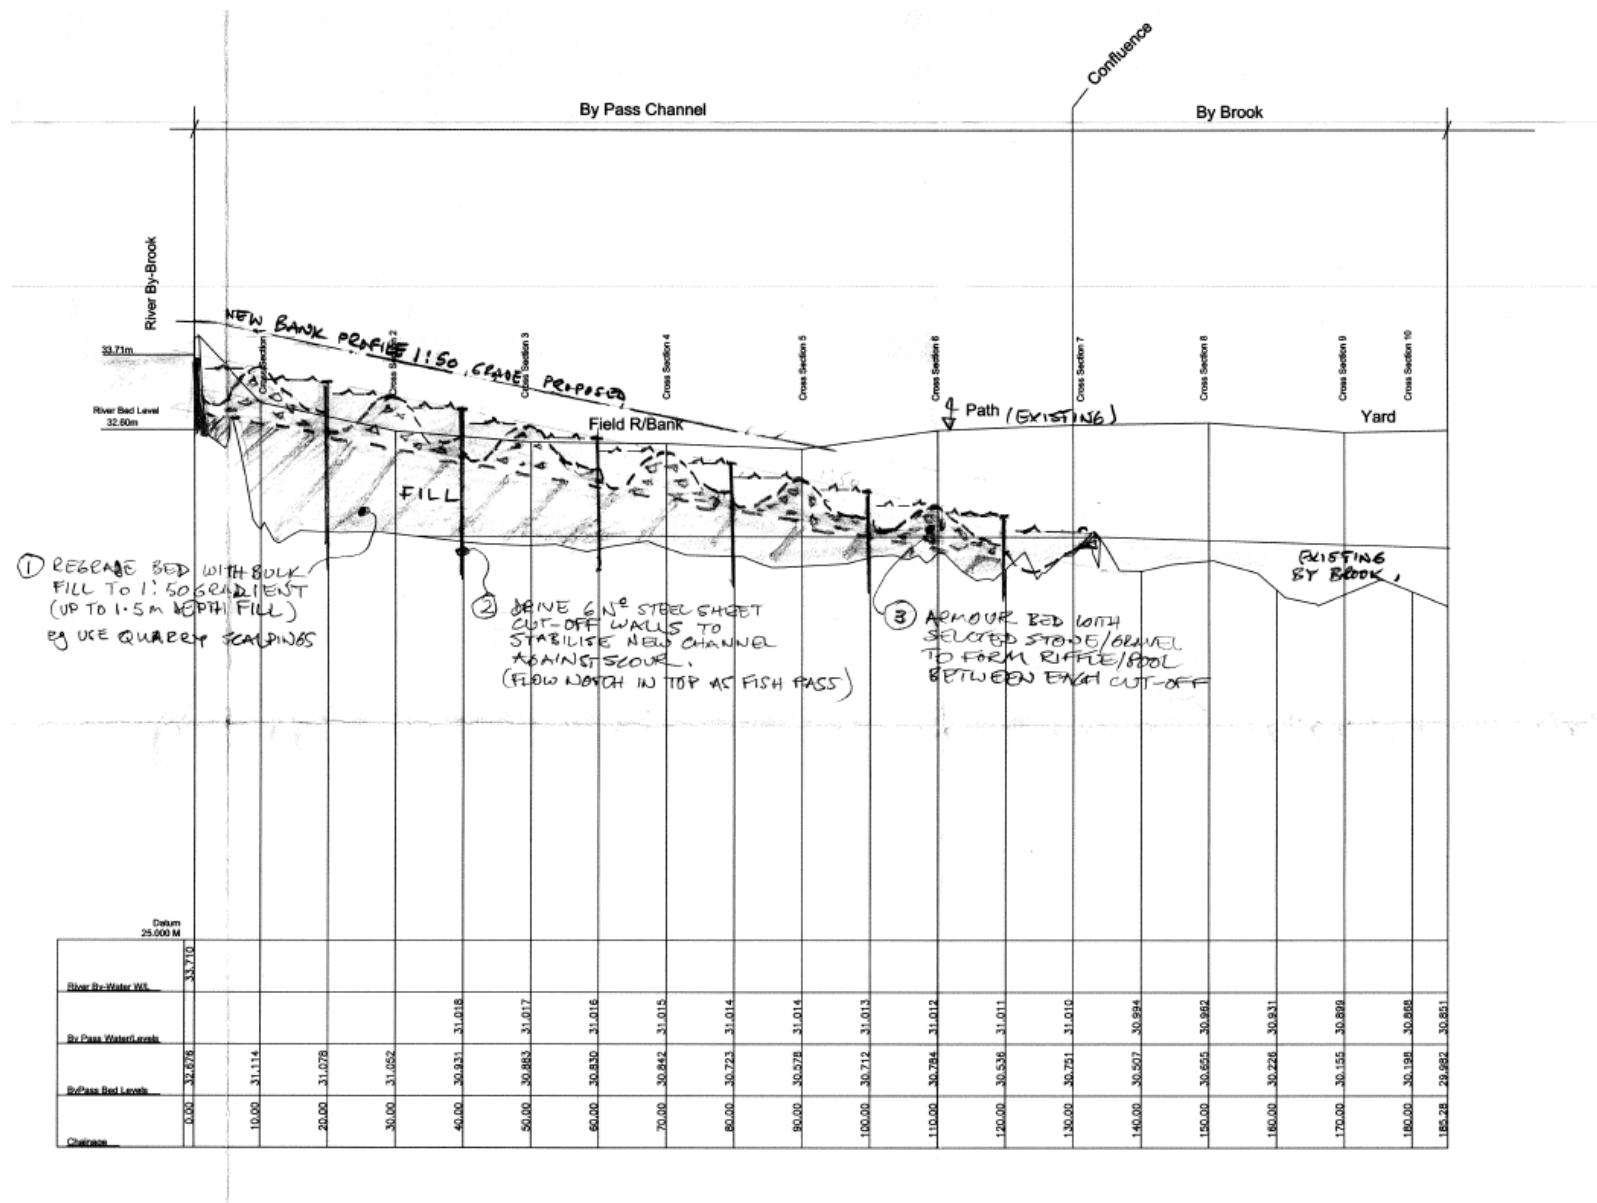
## Site 10 Box Mill Real World Studios back-channel option topographic plan

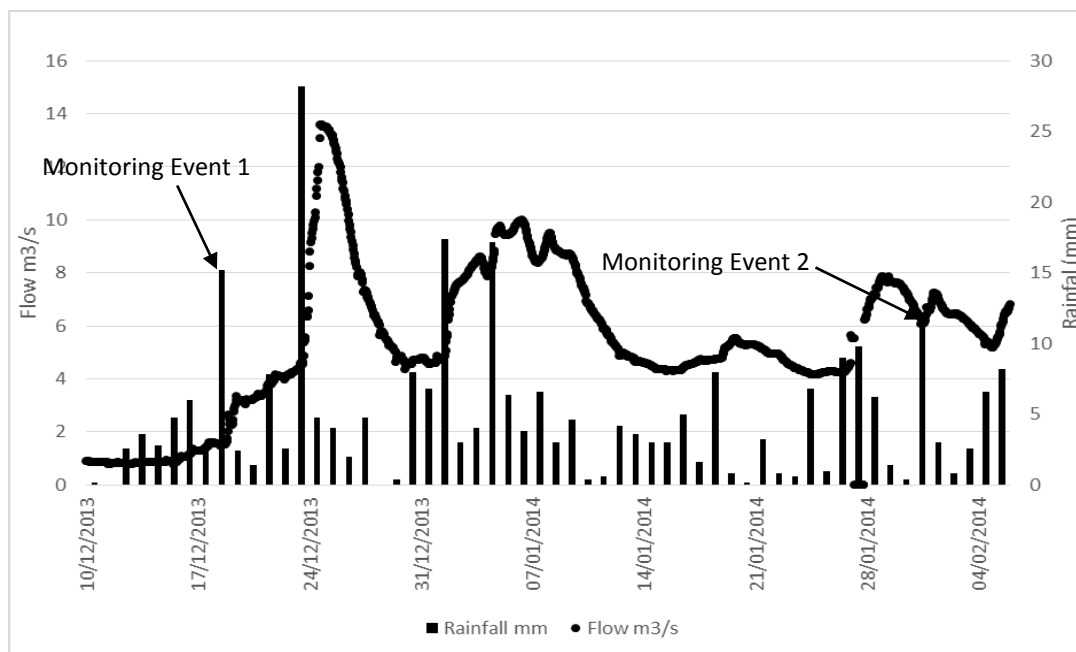
**Figure 22. By Brook Flow (m3/s) and daily rainfall (mm) from Middlehill gauging station 10/12/2013 - 05/02/2014**

The wet weather events can be seen in the context of daily rainfall records and By Brook flow, throughout the 2013/14 winter period (Figure 22). Event 1 was at the beginning of a prolonged period of wet weather, which lasted until a few days after Event 2. The three exceptional wet weather events over the Xmas/New Year break were not monitored.

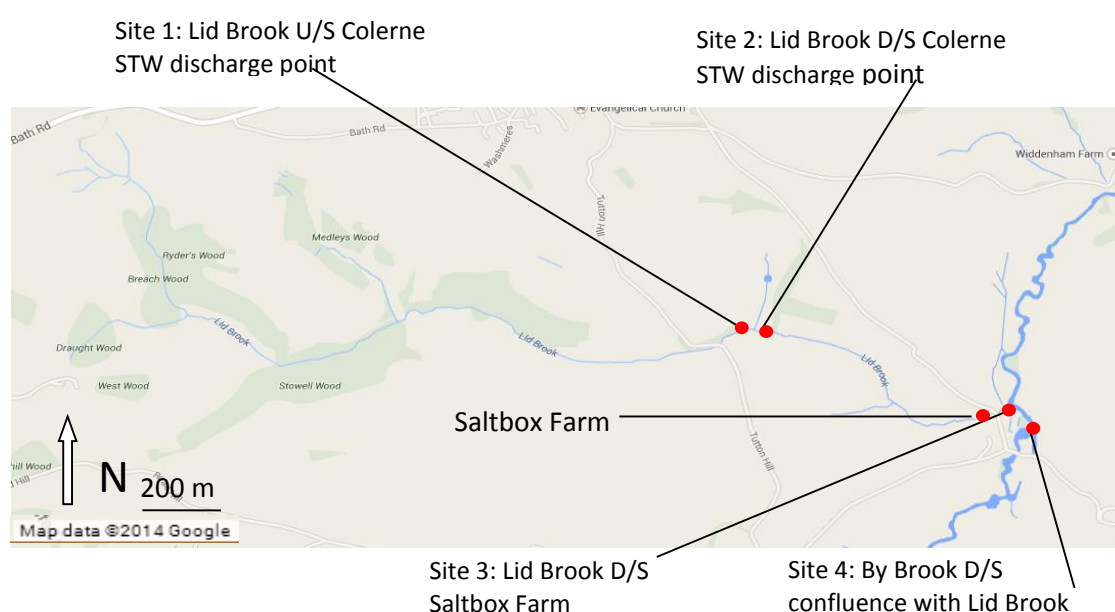
**Figure 23. Lid Brook sampling locations, also showing position of Saltbox Farm**

Water quality monitoring was carried out on the Lid Brook and on the By Brook, D/S of the Lid Brook confluence during two 24 h wet-weather events on December 18/19 2013 and Jan 31/Feb 01, 2014 (Figure 23). The Lid Brook was chosen for this work as it has been identified as one of the most heavily impacted watercourses in the catchment, in terms of riparian damage from livestock poaching (Figure 21) and so was a primary focus for fencing and remedial works during phase 1 of the By Brook project. The intention is that these data will form part of a simple bio-geo-chemical baseline understanding of the state of the Lid Brook, ahead of implementation of remedial works, against which, future improvements can be measured.

ISCO auto-samplers were deployed at four locations (Figure 23) between Dec 16<sup>th</sup> 2013 and Feb 3<sup>rd</sup> 2014. Sites 1 and 2 were chosen to assess the impact of Colerne STW on dissolved orthophosphate (OP) and total phosphorus (TP) concentrations in the Lid Brook and to enable these to be eliminated from the impacts of diffuse agricultural sources. Site 2 was also used as a surrogate for U/S Saltbox Farm, for comparison with Site 3 (D/S Saltbox Farm) to assess the impact of the farmyard and surrounding land. Site 4, in the By Brook main channel, was used to assess water quality in the main By Brook, during the events monitored. Insufficient resource was available to include additional sites that would have enabled isolation of Saltbox Farmyard or a quantitative assessment of the impact of contaminants from the Lid Brook on the main By Brook.

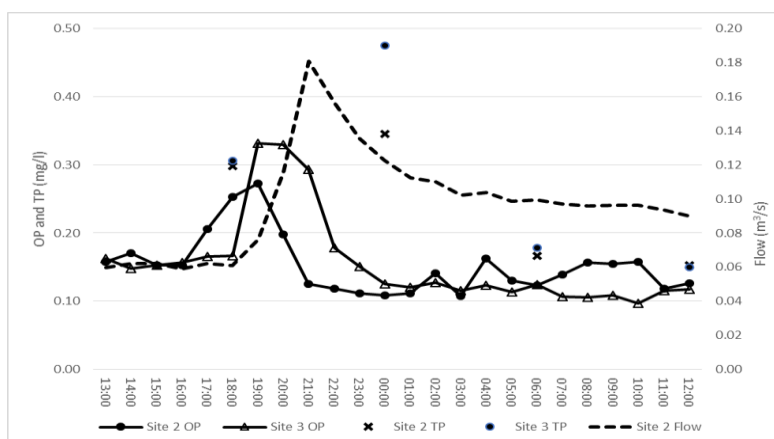
**Figure 24. Dissolved phosphate (OP) and total phosphorus (TP) concentration (mg/l) and flow (m<sup>3</sup>/s) U/S and D/S of Saltbox Farm during wet weather monitoring event 1: 18-19 Dec 2013**

OP and TP behaviour during this event was relatively unremarkable. There was no difference in OP or TP concentrations U/S and D/S of Saltbox Farm prior to the rainfall event and concentrations returned to broadly similar levels quickly after the event (Figure 24). During the rainfall event, OP concentration reached a maximum concentration of 0.27 mg/l at Site 2 and 0.33 mg/l at Site 3. OP concentration following the peak flow was lower than prior to the event, due to additional dilution. TP was not measured at the peak of the flow curve but at 00:00 hrs, was three times greater than OP concentration at Site 2 and 4 times greater than OP concentration at Site 3. Flow increased rapidly from a baseline of *ca.* 60 l/s to 180 l/s in three hrs, before declining rapidly in the following three hrs to below 120 l/s, demonstrating the flashy nature of the catchment.

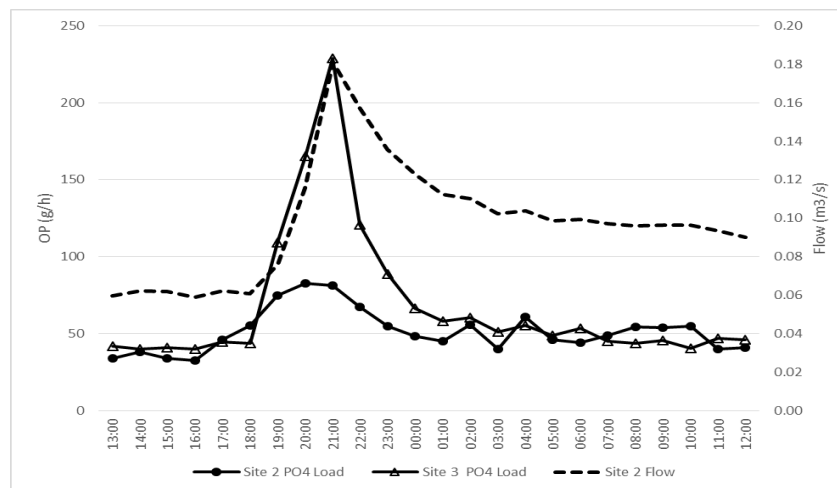
**Figure 25. Dissolved phosphate (OP) and total phosphorus (TP) load (g/h) and flow (m<sup>3</sup>/s) Lid Brook U/S and D/S saltbox farm 18-19/12/2013**

While OP loads were unremarkable, it would be expected that P mobilised during a wet weather event would be associated with particulate matter and therefore be captured as TP. Realistic estimations of TP loads were not possible during this event, due to too few samples being analysed for this parameter. This was addressed in the second monitoring event.

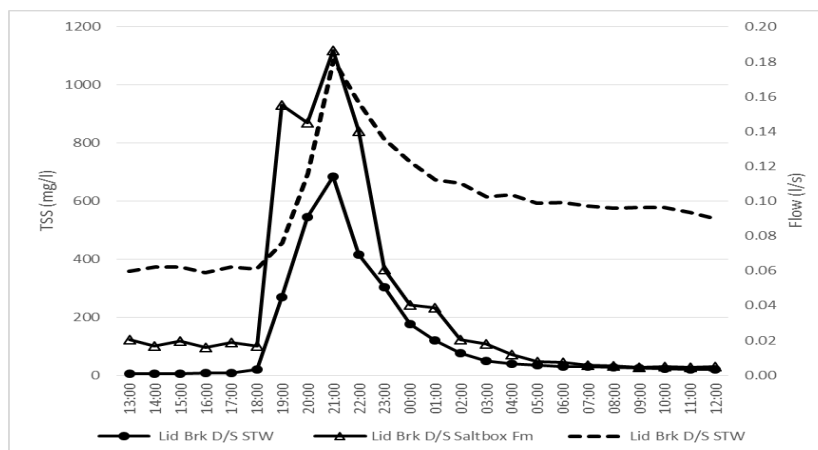
**Figure 26. Total suspended solids (mg/l) and flow (m<sup>3</sup>/s) Lid Brook U/S and D/S Saltbox Farm 18-10/12/2014**

In contrast to OP, total suspended solids provided some remarkable information on the rate of soil loss from this small sub-catchment (Figure 26). Prior to the rainfall event, TSS concentration was approximately 20 times greater at Site 3 than at Site 2, demonstrating a more continual sediment loss in the lower reaches of the Lid Brook. Sediment was mobilised rapidly following the onset of steady rainfall at approximately 18:00, increasing to 685 mg/l at Site 2 and over 1,000 mg/l at Site 3 during maximum discharge at 22:00.

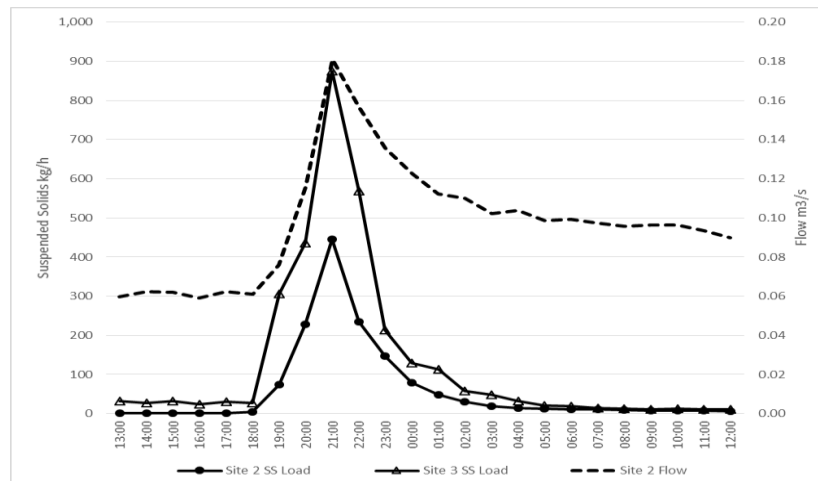
**Figure 27. Suspended solids load (kg/h) and flow (m³/s) U/S and D/S of Saltbox Farm**

TSS load, given in kg/h (Figure 27), demonstrates clearly the impact of land management practices in this small sub-catchment in terms of soil loss. During the 24 h sampling period, approximately 2 tonnes of soil were lost from the catchment U/S of Site 2 and a further tonne in the short ( $\leq 1$ km) distance to Site 3, the majority of which was lost in an 8 hr period from 18:00. In the 8 hrs following the onset of rainfall, approximately 3 tonnes of soil were lost from the catchment and washed into the By Brook.

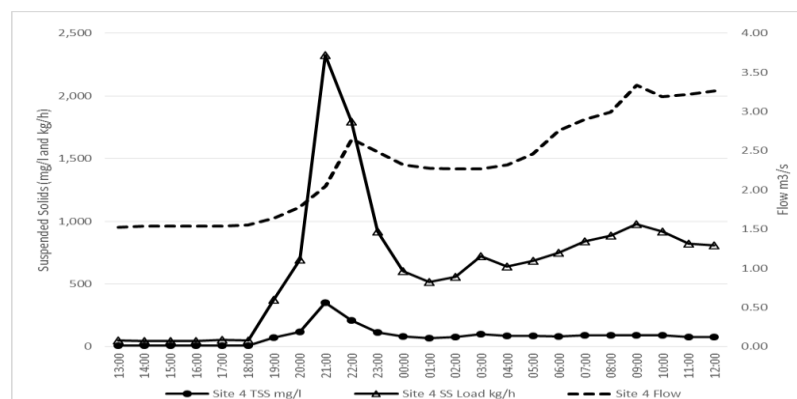
**Figure 28. Suspended solids concentration (mg/l) and load (kg/h) with flow (m³/h) in the main By Brook during wet weather event 1**

TSS measured in the By Brook at Site 4 (Figure 28) showed that approximately 16 tonnes of sediment was lost from the catchment during the 24 h sampling period. Given that the Lid Brook represents such a tiny proportion of the total By Brook catchment as a whole, it is remarkable that almost 20% of the sediment load measured during this event came from the Lid Brook. That said, impacts of sediment load from higher in the catchment would not have been measurable at this point until after this monitoring period and it can be seen in Figure 28 that sediment load continued at an elevated level after the lid brook event was over.

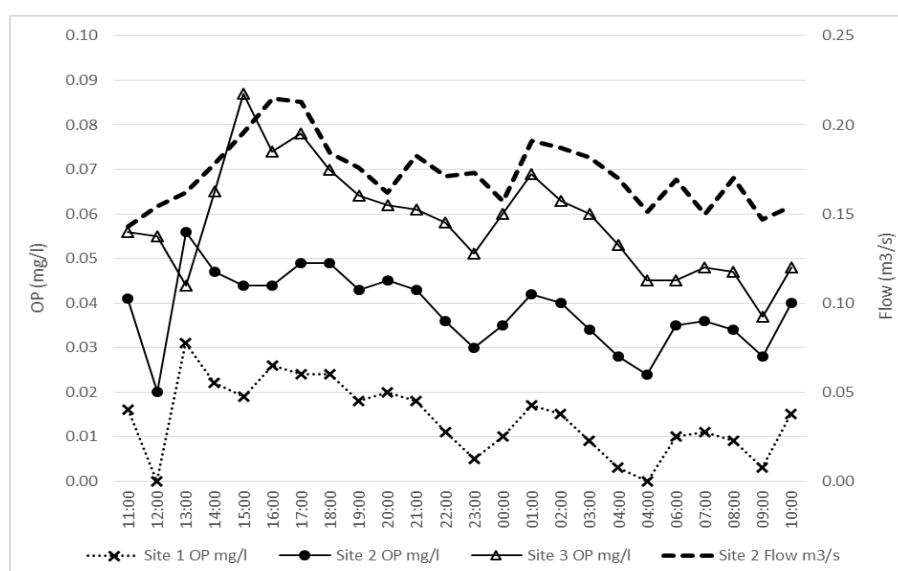
**Figure 29. OP concentration sites 1, 2 and 3 during wet weather event 31/01 - 01/02/2014, with flow at Site 2. OP concentration for Site 1, U/S Colerne STW, (dotted line with markers) is calculated (see text).**

OP concentration at Site 1, U/S of Colerne STW discharge point, was below the assay detection limit of 0.02 mg/l for all but two of the samples, taken at 16:00 and 17:00, during the peak of the event. Data given for Site 1 in Figure 29 were calculated using the difference between Site 1 and Site 2 in these samples as an indication of the contribution to OP concentration from Colerne STW, which has then been subtracted from the remainder of the Site 2 samples to estimate U/S, background OP concentration. This calculation was carried through to estimate loadings of OP to the Lid Brook during Event 2 (Figure 30). OP concentration resulting from the Colerne STW input was above 0.02 mg/l throughout the sampling period. The average increase in OP concentration at the D/S Saltbox Farm site was 0.2 mg/l, approximately the same as the contribution from Colerne STW. However, inputs from Colerne STW would continue during dry, low-flow periods, which would result in OP concentrations being further elevated, while inputs from Saltbox Farm would be expected to reduce.

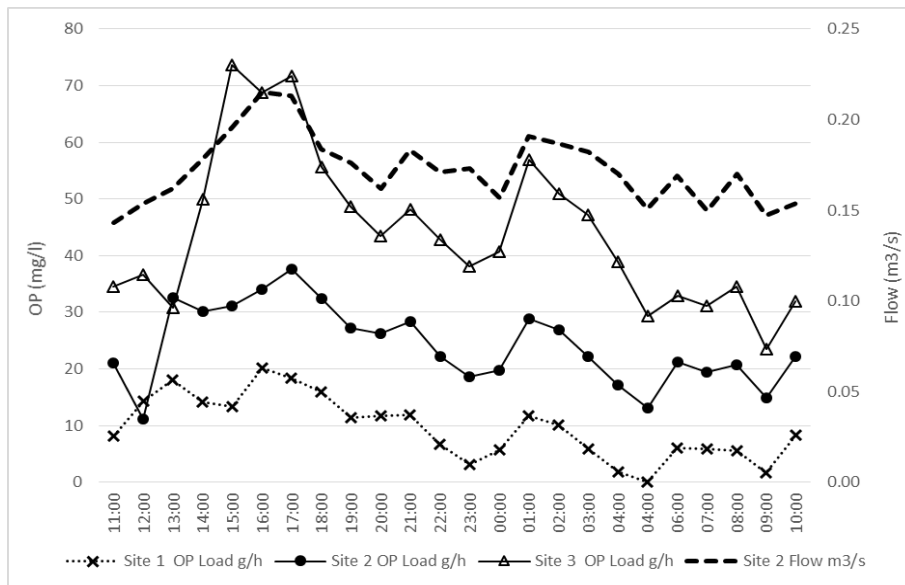
Figure 30. OP loadings to Lid Brook during wet weather event 2, 31/01-01/02/2014.

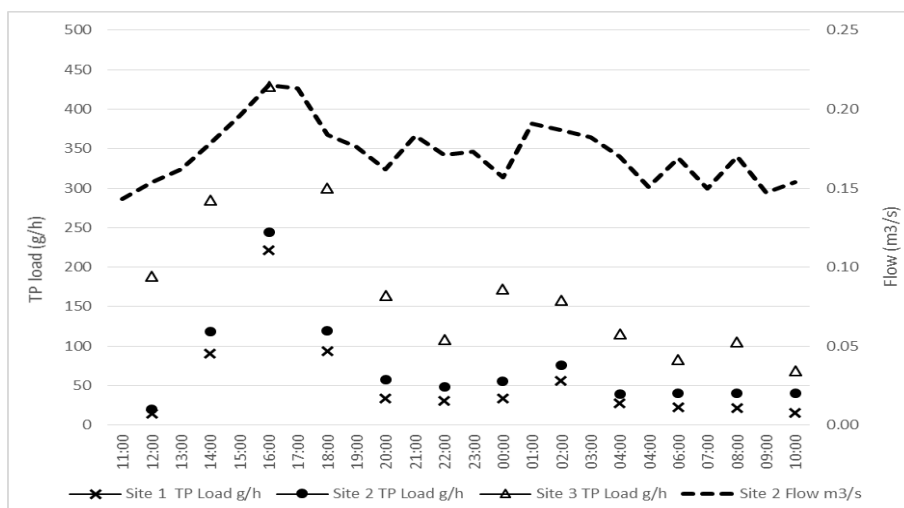
Figure 31. TP load at Sites 1, 2 and 3 during wet weather event 2, 31/01-01/02/2014

Maximum TP concentration, which coincided with maximum flow at 16:00, was 0.286, 0.316 and 0.462 mg/l at Sites 1, 2 and 3 respectively (data not shown). Total P load was 1,324, 1,803 and 4,353 g at Sites 1, 2 and 3 respectively, over the 24 h event. During the first hour of rainfall (sample 1, 12:00, Figure 31), TP load at site 3 was over 900% greater than at Site 2, probably indicating run-off directly from Saltbox Farmyard. The difference in TP load at Sites 2 and 3 reduced during the course of the event but averaged approximately 300% during the monitoring period. During peak flow, TP load was approximately 420 g/h, approximately 184 g of which entered the Lid Brook, downstream of Site 2. Mean TP load was approximately 60% higher D/S of Colerne STW (Site 3), than at the U/S site, indicating the scale of particulate-associated P inputs from Colerne STW that would not be picked up in statutory OP-based, consent-related monitoring.

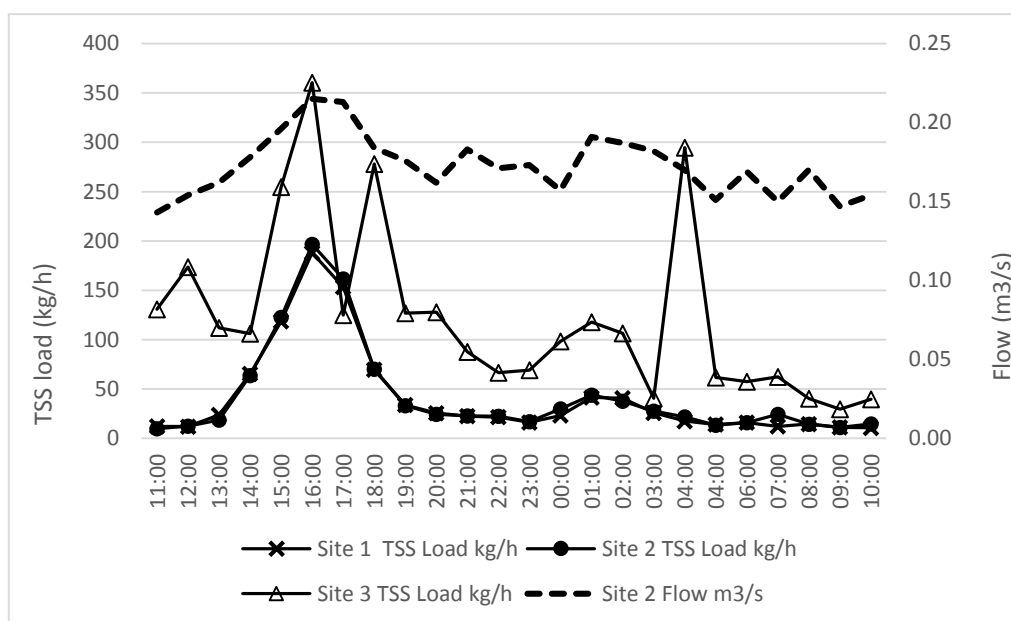
**Figure 32. Total suspended solid load, Sites 1, 2 and 3 Lid Brook**

A flush of solids were quickly mobilised in the Lid Brook, U/S of Colerne STW during the first few hours of rainfall (Figure 32), before equally quickly receding. In total, approximately one tonne of solids were transported past Site 2 during the 24 h monitoring period, approximately 65% of which occurred during the 6 h period between 13:00 and 19:00. TSS were much more variable and considerably higher at Site 3, reflecting inputs from the farmyard, roadway and heavily poached banks between Sites 2 and 3. Total solids load discharged at Site 3 during the 24 h monitoring period was approximately 3 tonnes, indicating a loss of 2 tonnes of soil in the <1 km distance between Sites 2 and 3, during the 24 period.

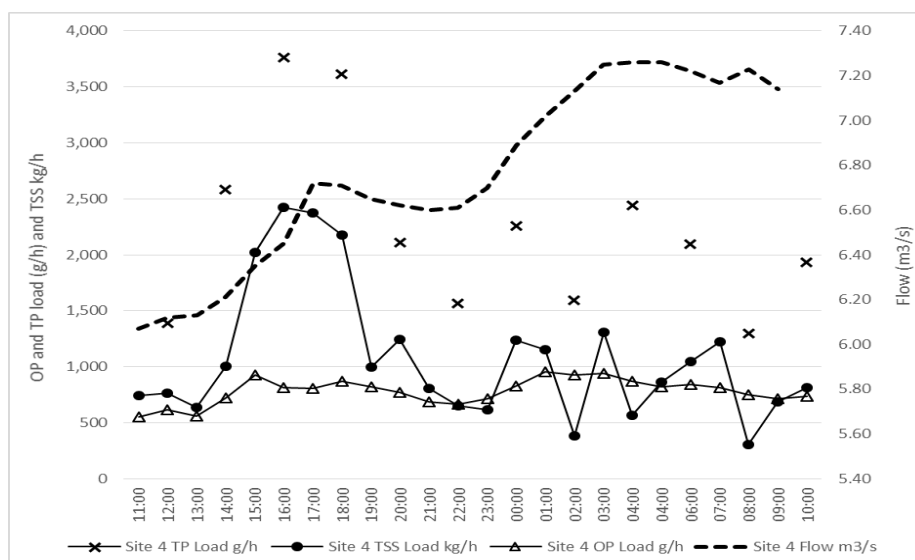
**Figure 33. Ortho-P, TP and TSS load, Site 4, By Brook D/S Lid Brook confluence. Flow estimated from Middlehill gauging station (less 10%).**
