Feasibility Restoration Report for By Brook, North East Bath

Status: Final

Date: May 2015

Project name: By Brook Restoration Project

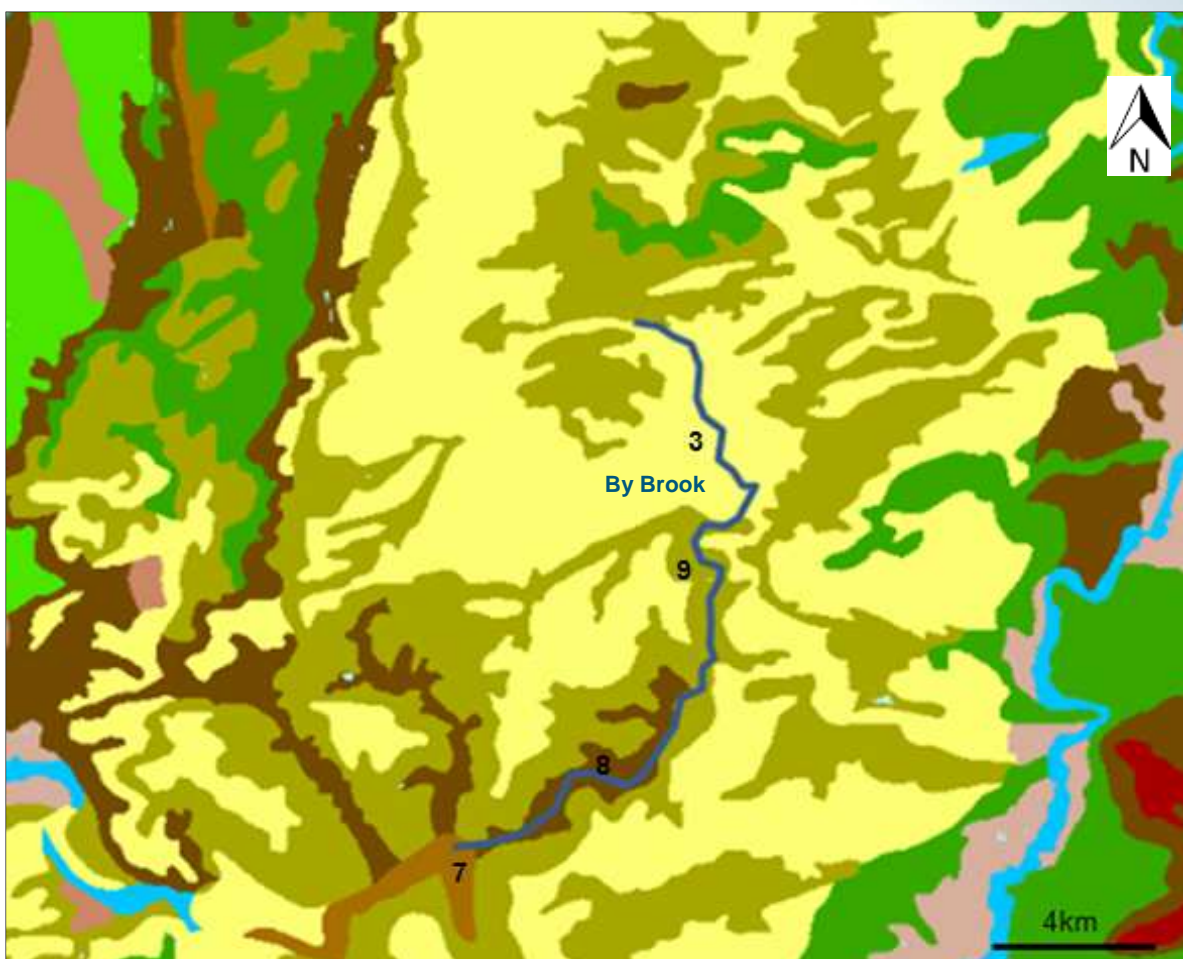
Figure 2.2 Soilscape Characteristics of By Brook Catchment⁴

Soilscape 3 – Shallow lime-rich soils over chalk or limestone

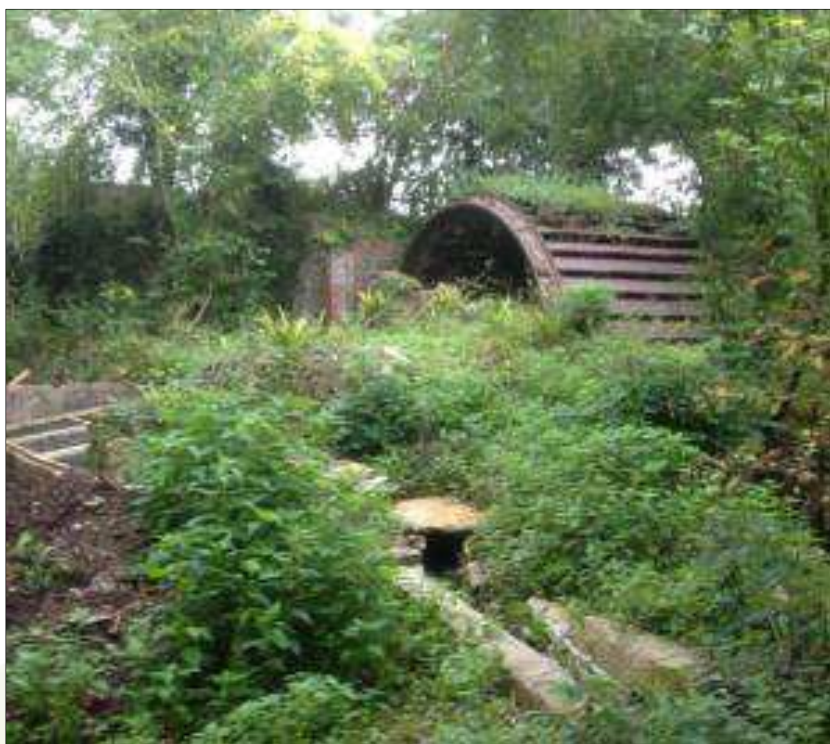
Figure 2.4 Paper Making at Slaughterford

- 2.4.4 A review of historic maps¹¹ indicates that the main activities to influence channel form and processes are mill structures and bridges for road and rail. There is evidence of at least 20 mill sites along the By Brook, a number of which were listed in the Domesday Book (see **Figure 2.4**). Many of these structures and bridges are still in place along the By Brook today; for example, at Chapps Mill the By Brook upstream is artificially widened to provide a reservoir of water. In the tributary of Doncombe Brook, river flow was less reliable and an artificial reservoir was created to regulate supply which is still in place today in the form of a pond behind the mill house¹².

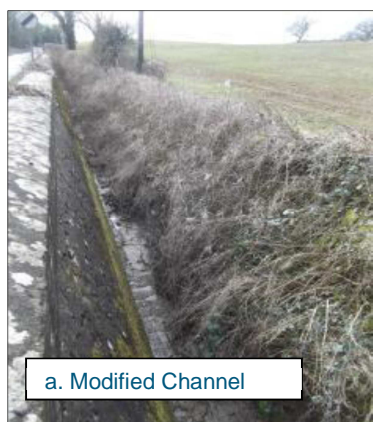
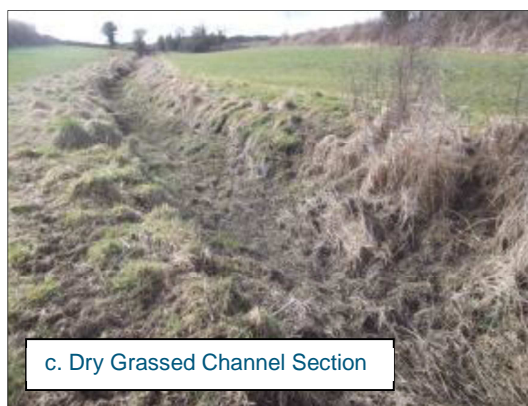
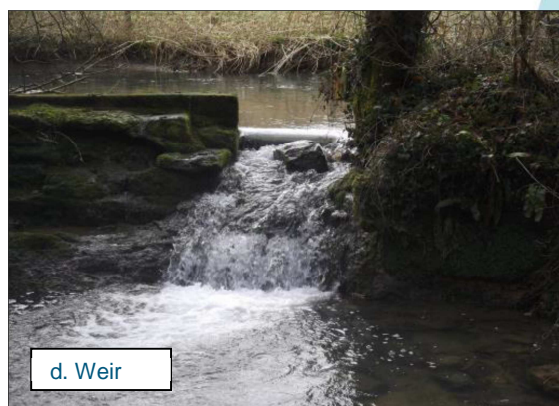
Figure 2.7 Key Environmental Features - Burton and Ford

2.4.15 Overall this section of the By Brook (Burton brook) between Burton and Castle Combe is characterised by large sections of straightened channel some of which have been modified as a result of road transport, residential housing or old historic milling (see **Figure 2.7a**). The banks are typically steep sided where they have been over deepened and predominantly supports glide flows (see **Figure 2.7b**). There is limited riparian zone and bank vegetation is generally restricted due to grazing of livestock along the upper sections of Reach 1, however downstream sections support a variety of plant species.

2.4.16 There is lack of substrate between Phydomic and Westfield along the middle section of Reach 1 where the river runs through a grass channel (see **Figure 2.7c**), with evidence of general siltation of the channel bed along most of this reach with no evidence of clean gravels. A combination of limited geomorphological diversity and sedimentation has led to localised sections of the reach also becoming choked with vegetation and slowing down flows. Reach 1 contains one in-channel structure (fixed concrete weir approximately 0.8m in height and 0.8m wide) which is only likely to be passed by migratory fish during medium to high flows (see **Figure 2.7d**).

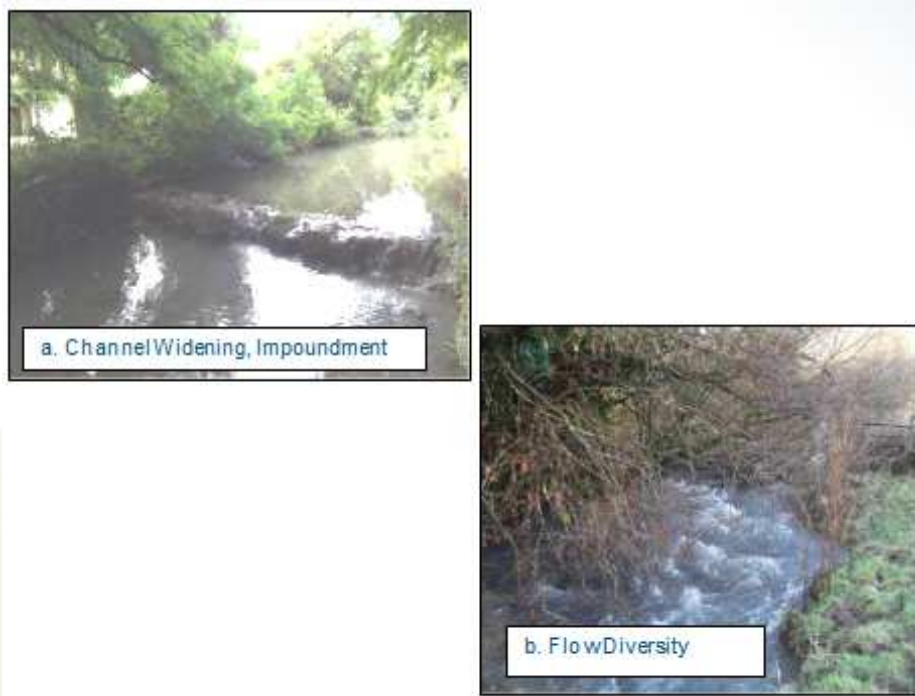
Figure 2.9 Key Environmental Features - Pennsylvania and Castle Combe

- 2.4.19 Emergent vegetation is present throughout the reach with a dominance of reed species, particularly within areas of glide habitat. Sedges, rushes, and water mint were also noted, whilst water-starwort was recorded in areas with clean gravels and good light penetration. A variety of deciduous tree species are present in a semi-continuous habit throughout the reach which provides shading and areas of open water. Bank vegetation is varied due to the diversity of land management along the river. There is little bank vegetation in areas of pastoral agriculture where livestock graze vegetation down to the water's edge.

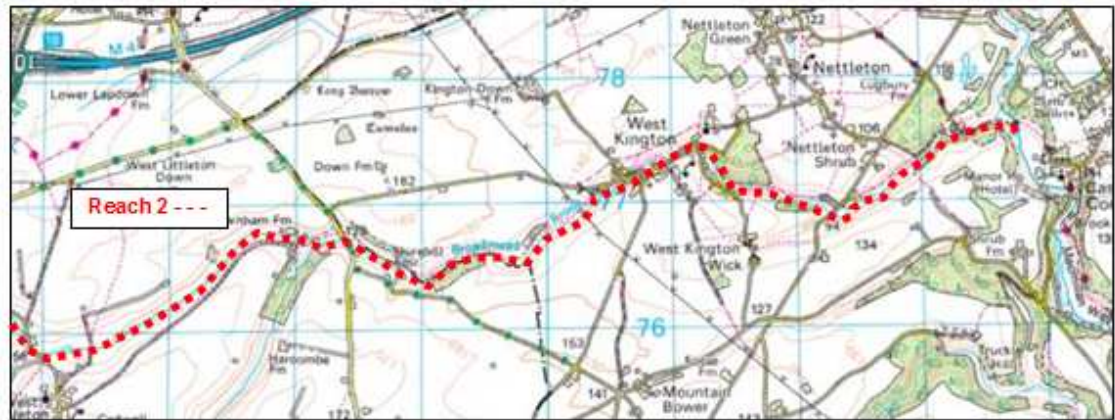
Figure 2.10 Location Plan of Reach 2

- 2.4.21 A broad crested weir of approximately 2.3m in height and 5m in width is located downstream of Nettleton Mill, near Castle Combe. The weir is only likely to be passable to migratory fish at high flows only. The reach also contains several other minor in-channel barriers, with large woody debris being the most common type of barrier to fish passage.
- 2.4.22 A location overview plan of Reach 2 is provided in **Figure 2.10**.

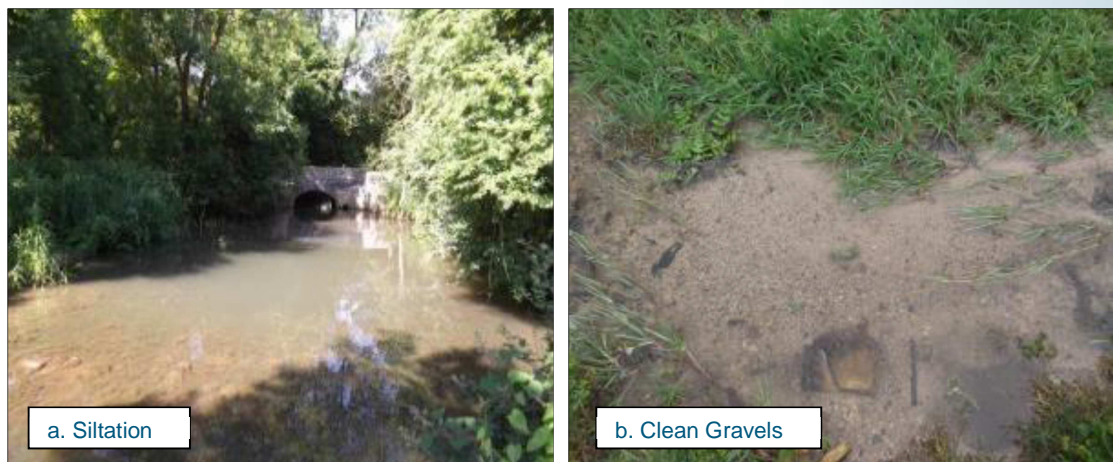
Figure 2.11 Key Environmental Features of By Brook and Upper Tributaries

- 2.4.23 Reach 3: Overall the reach between Castle Combe and Ford exhibits a substantial proportion of hydromorphological alteration due to historic milling and flood defence. Downstream of the confluence with the Broadmead Brook, the river is situated within a straight heavily modified channel and exhibits predominant glide flows. As the river flows past Brook House it enters a steep sided valley where the gradient of the river increases and thus the river starts to exhibit more varied flows. The channel in places has been enlarged and realigned and banks heavily modified, most noticeably in Castle Combe and near the weirs which are present throughout the majority of the reach. The banks in the reach are relatively unstable due to a combination of high energy flows from channel gradient, in-channel structures and livestock poaching, with considerable evidence of sedimentation occurring within the river (see **Figure 2.11a**).

- 2.4.24 Reach 3a: This tributary (North Wraxhall to Ford) is dominated by run conditions and swifter flows than the reaches on the main By Brook channel. Sediment transport is the dominant process, with the substrate displaying significant sections of clean gravels and other coarse sediment (see **Figure 2.11b**). Land use is characterised by deciduous woodland with some low intensity grazing in North Wraxhall and on the right-hand bank at the downstream section of the reach.

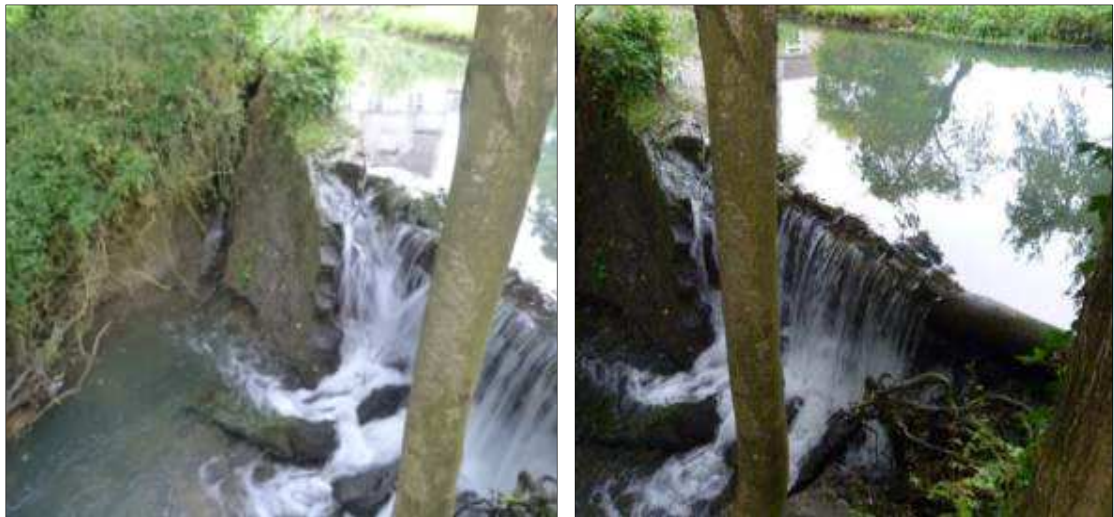
Figure 2.14 Ford Mill Weir

- 2.4.29 Ford Mill Weir is a privately owned structure upstream of Ford Mill and is in a very poor state. The weir is constructed of masonry and its right abutment has partially collapsed. Whilst it has been temporarily shored up by sandbags, there is leakage behind the structure and in time this leakage will result in further outflanking of the structure. This deterioration process will be exacerbated in the winter when river levels and flows are higher. The condition of this structure is poor and in danger of collapse (see **Figure 2.14**). Overall there is limited access to the weir which is constrained by trees.

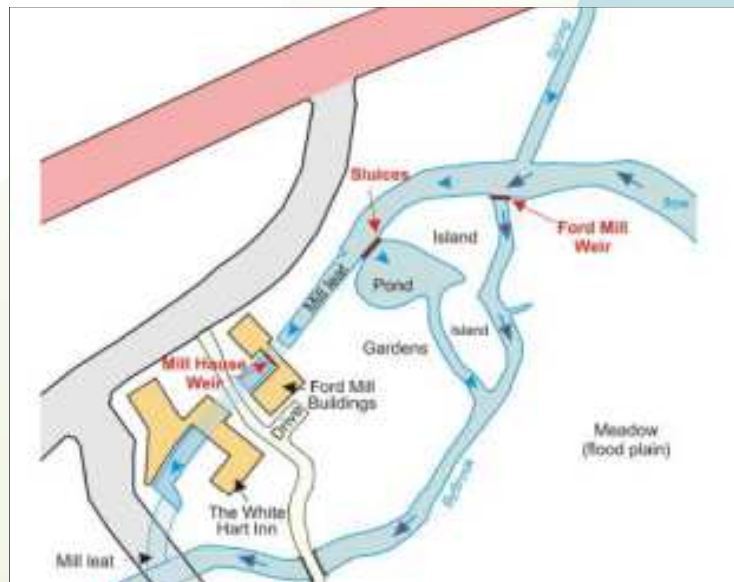
- 2.4.30 Within this reach of the By Brook, flows have been impounded in response to the complex historic milling system and the majority of flow is diverted down the main channel of the By Brook and not through the mill leat. However, the mill leat discharges back into the By Brook beneath the road bridge immediately downstream of the White Hart Inn (see inset flow diagram).

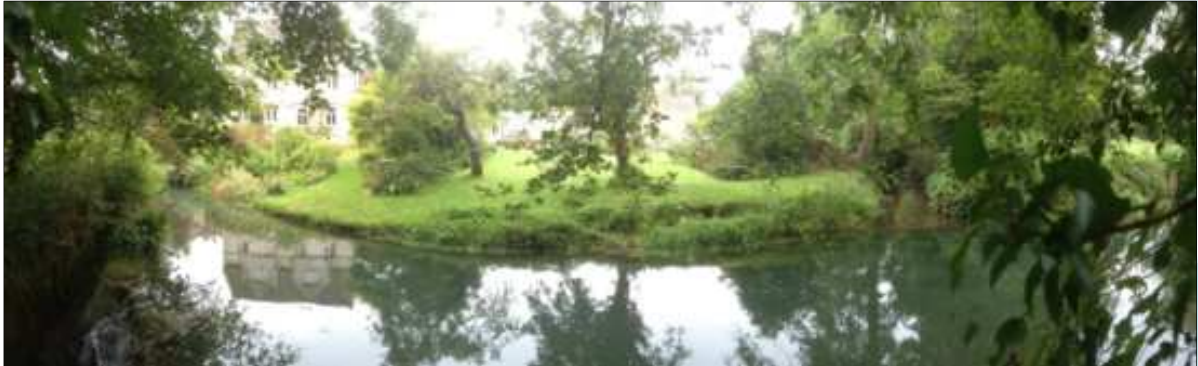
Figure 2.15 **Glide Habitat of Ford Mill Weir**

- 2.4.31 The impoundment of flows or ponding of water has reduced the overall sediment carrying capacity (velocity) of the watercourse as evident by sediment accumulation on the bed upstream of Ford Mill Weir.

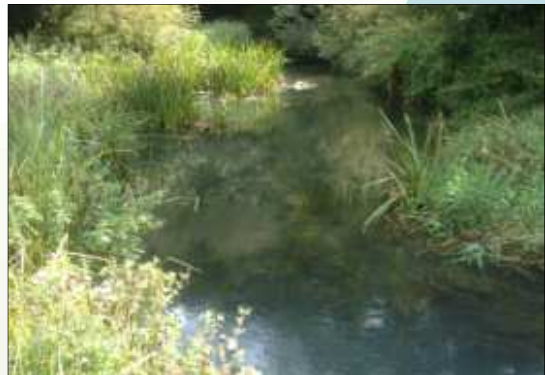
- 2.4.35 The reach of the By Brook between Ford Mill Weir and Weir D/S Ford is generally characterised by a slow flowing meandering glide habitat with good submerged aquatic and marginal vegetation such as Brook water-crowfoot (*Ranunculus penicillatus*) and common reed (*Phragmites australis*) (see insert photo). Evidence of bank instability was observed along this reach potentially in response to changes in water levels causing some sections of bank to collapse thus providing a source of sediment to the system.

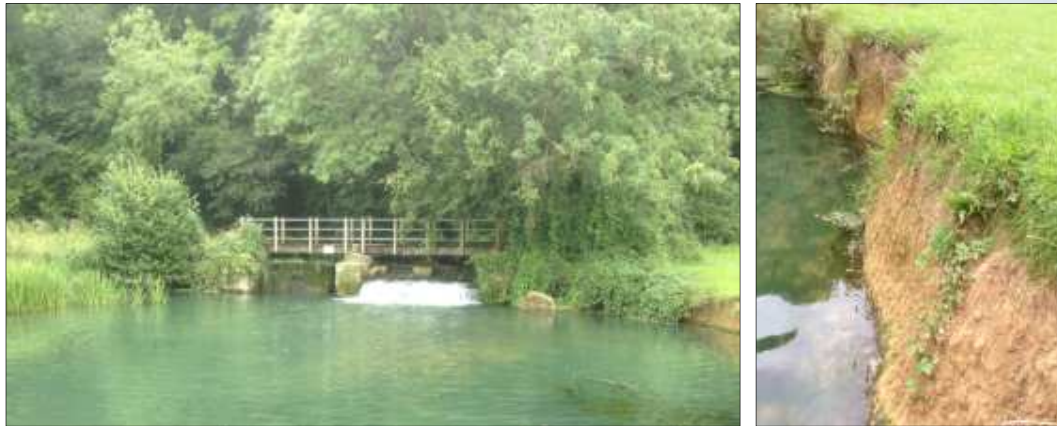
Figure 2.16 Weir D/S Ford

- 2.4.37 Directly upstream of the weir flows are impounded (up to 461m, EA, 2015), while downstream of the weir there is a large scour pool (30m wide) with evidence of bank erosion further contributing to fine sediments into the By Brook (see **Figure 2.16**). Flows are also impounded between Weir D/S Ford and Sluice D/S Ford.

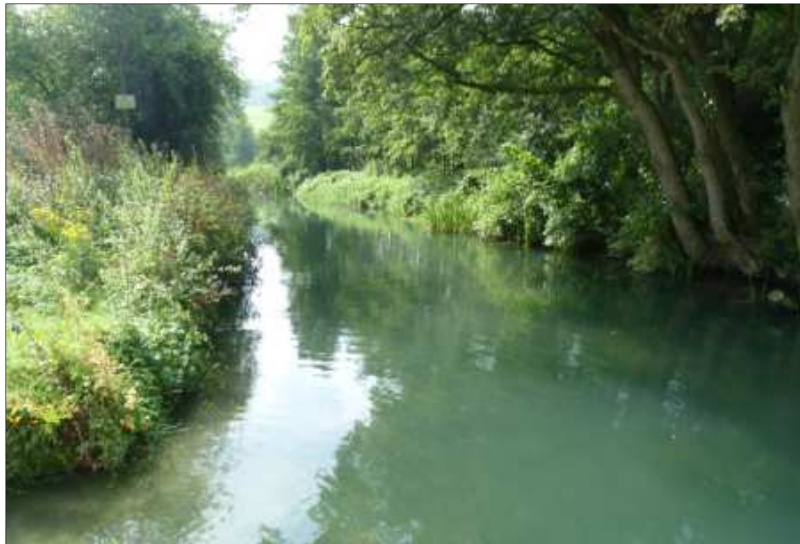
Figure 2.18 Upstream of Slaughterford Gate – Flow Impoundment

2.4.39 Further downstream of Sluice D/S Ford past the small pool-riffle systems, the habitat of the By Brook is characterised by a slow flowing straight glide habitat with good submerged aquatic and marginal vegetation such as common reed (*Phragmites australis*). However, the glide habitat up to 10m wide appears to be in response to channel modifications (e.g. over widening, dredging) and flow impoundment associated with Slaughterford Gate. Flow impoundment upstream of the structure is estimated to be more than 800m (EA, 2015) (see **Figure 2.18**) and appears to have contributed to the settlement of fines on the bed of the By Brook.

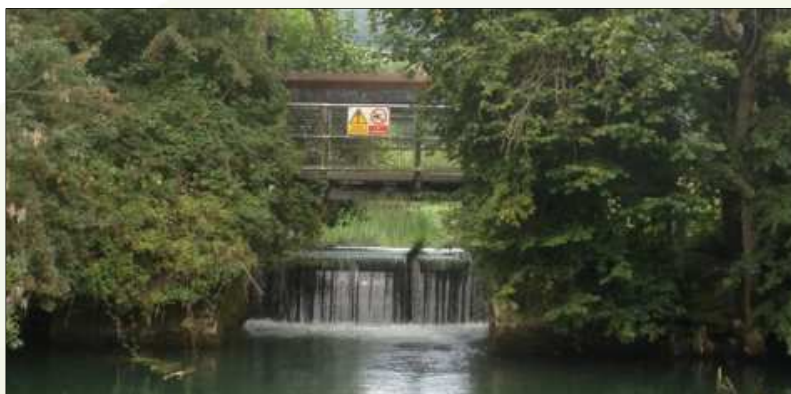
Figure 2.19 Slaughterford Gate Sluice

2.4.40 Slaughterford Gate which is approximately 900m downstream of Sluice D/S Ford (see **Figure 2.19**), is a steel weir structure currently owned by the Environment Agency (see **Table 2.1**), which was originally constructed to provide a reservoir for the historic rag mill, which formed part of the next structure downstream (Rag Mill Weir). Water level control has been non-operational since an electrically-driven automatic sluice control mechanism became jammed several years ago. Downstream of the structure is a large scour hole (20m wide) with eroded banks.

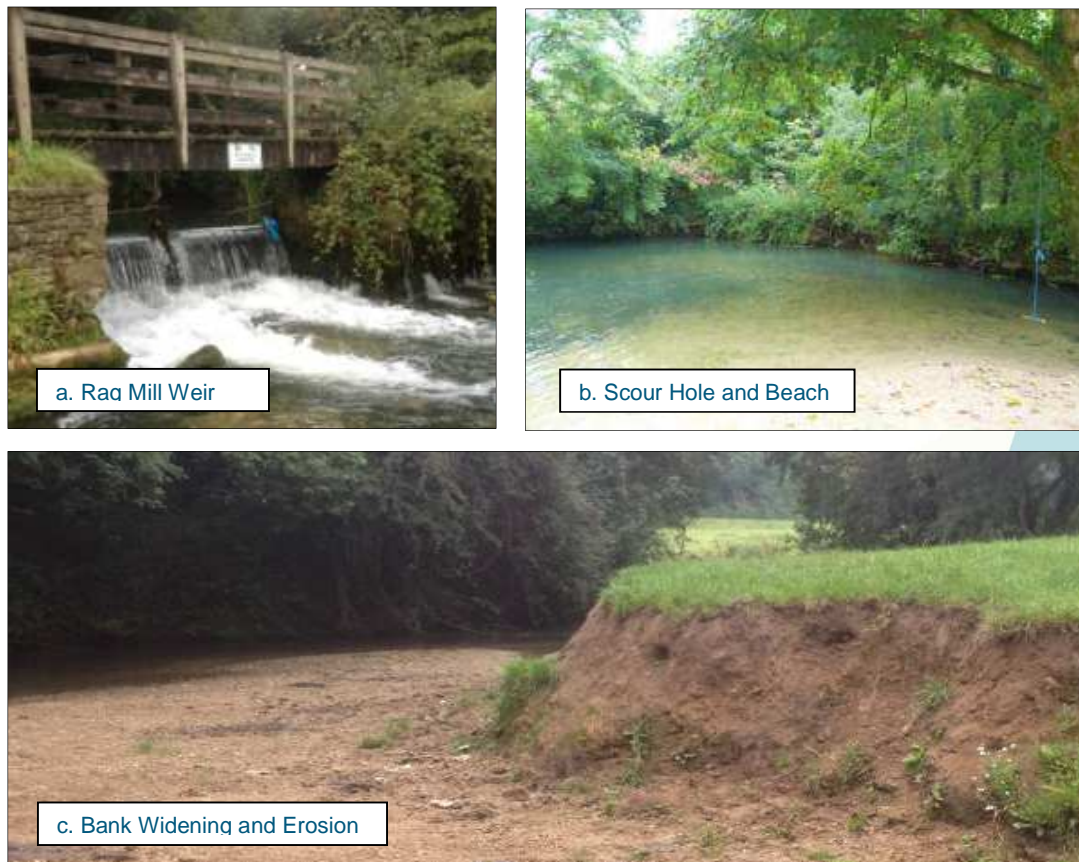
Figure 2.20 Rag Mill Weir

- 2.4.41 Directly downstream (160m) of Slaughterford Gate is Rag Mill Weir (see **Figure 2.20**). The weir, which includes a public foot-bridge across the By Brook, comprises a stepped concrete weir with removable boards and is currently in a poor condition with water seeping through the structure. It is unclear if it can actually be repaired to a suitable standard; and a significant proportion (an estimated 60% on the day of walkover) of flows is directed through the structure, instead of over the weir.

- 2.4.42 A large scour hole (12m wide) exists below the weir which has in part undercut and eroded the existing channel bank exposing coarse material and informally developed a recreational freshwater beach for local community (see **Figure 2.20**). Flows upstream of Rag Mill are impounded up to 107m (EA, 2015).

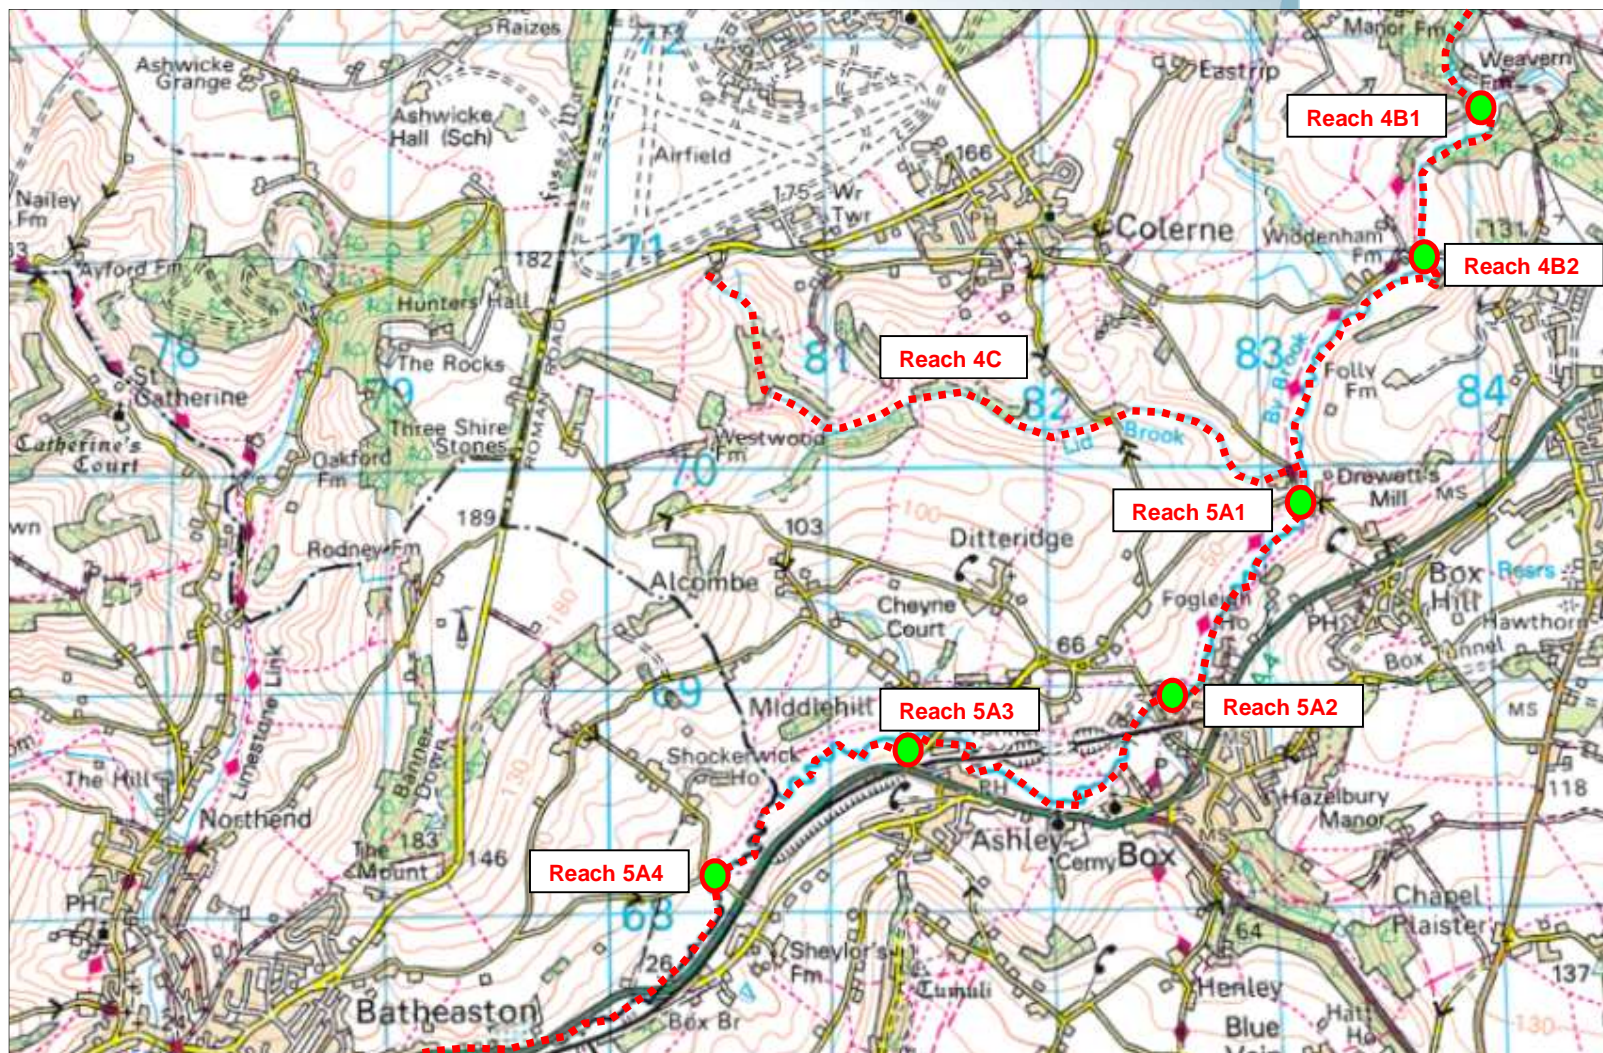
Figure 2.21 Location Plan of Reach 4B, 4C and Reach 5

- 2.4.43 An overview of the channel geomorphology (fluvial processes), modifications and structures associated with the By Brook between Weavert Mill Weir and Shockerwick is provided below.
- 2.4.44 A location overview plan of Reach 4B, 4C and Reach 5 is provided in **Figure 2.21**.

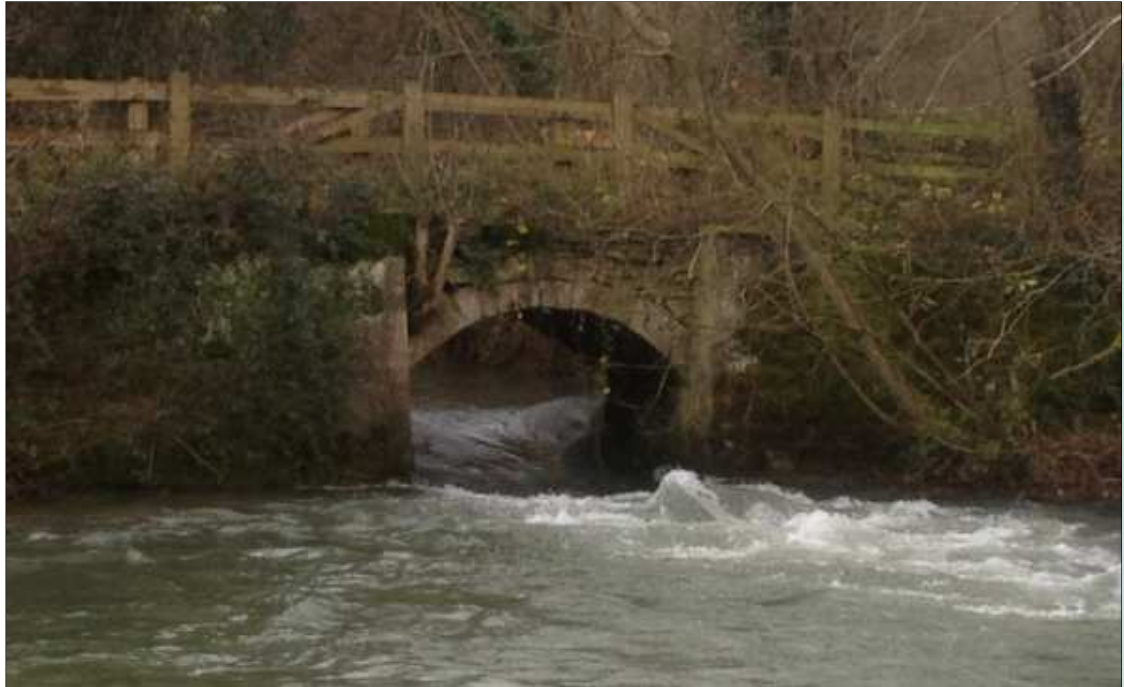
Figure 2.22 Weavern Mill Weir

- 2.4.45 Weavern Mill Weir which is approximately 2km downstream of Rag Mill Weir, is a concrete fixed weir (foot-bridge) structure which is currently in a poor condition and hidden by dense woodland and serves no current use as a water level control structure along the By Brook (see **Figure 2.22**). The weir does present a barrier to fish passage in particular during low flows.

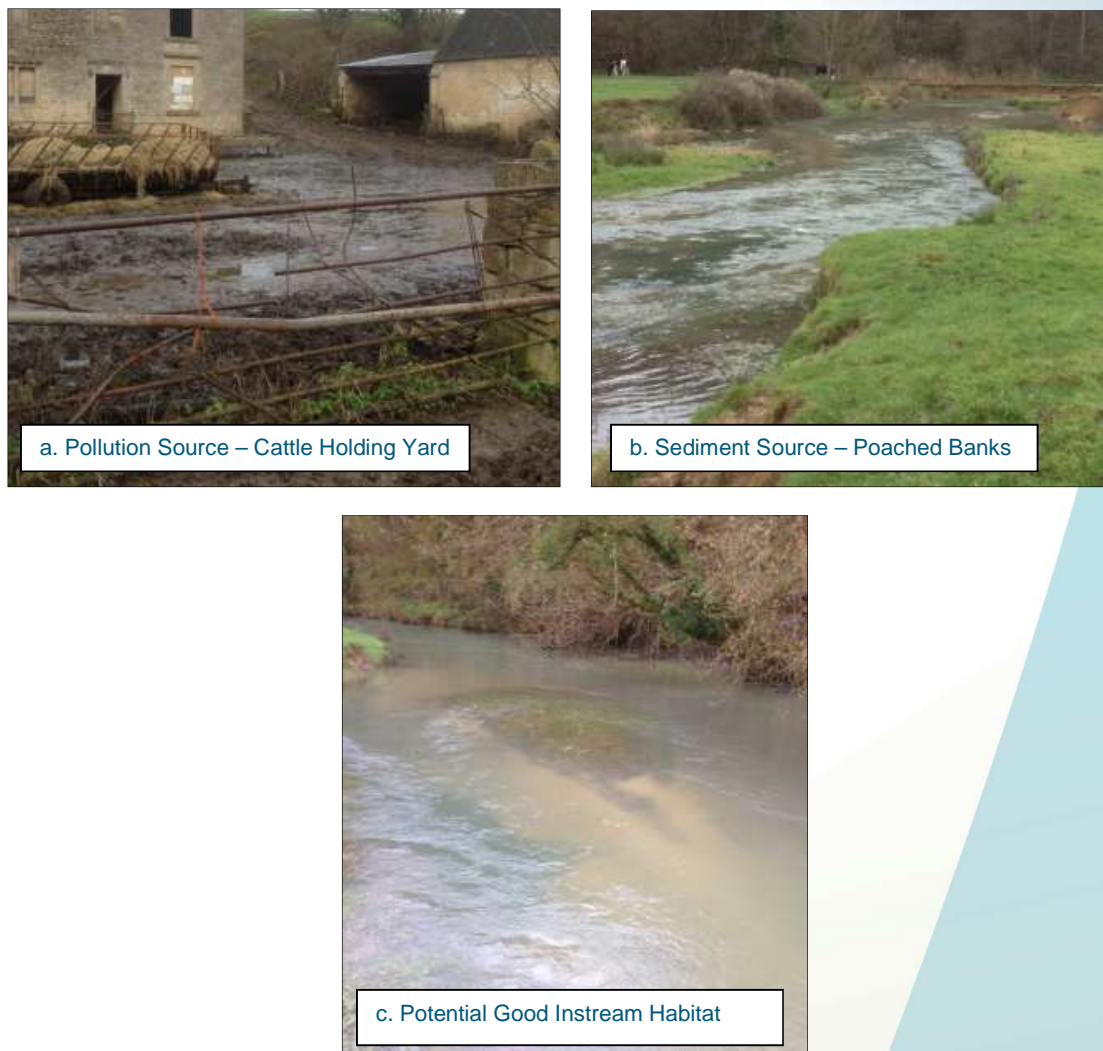
Figure 2.23 Key Environmental Features of Weavern Mill Weir Site

- 2.4.47 A scour pool (22m wide) is present directly downstream of Weavern Mill Weir and the channel in places is relatively wide and shallow which allows for cattle to cross the channel during low flows and poach the banks (see **Figure 2.23b**). However, further downstream the channel of the By Brook comprises sections which provide a good flow and geomorphological diversity, comprising of run and slow flowing glide habitat, although the impacts of the upstream sources of sediment are clearly visible on the bed of the channel (see **Figure 2.23c**).

- 2.4.46 Upstream of the weir, the section of channel varies from relatively diverse flow and geomorphic complexity with good sections of gravel bed including the side branch of the main channel to silt dominated substrates in response to channel banks being significantly poached by cattle and a poorly managed cattle holding area with no hard standing (see **Figure 2.23a**). A scour pool is evident directly downstream of a small weir which is directly upstream (150m) of Weavern Mill Weir in which flows between the two weirs reduce in velocities and silts settle out and along with washed in silts from the cattle holding area provide an environment in which the bed is covered in fine sediments.

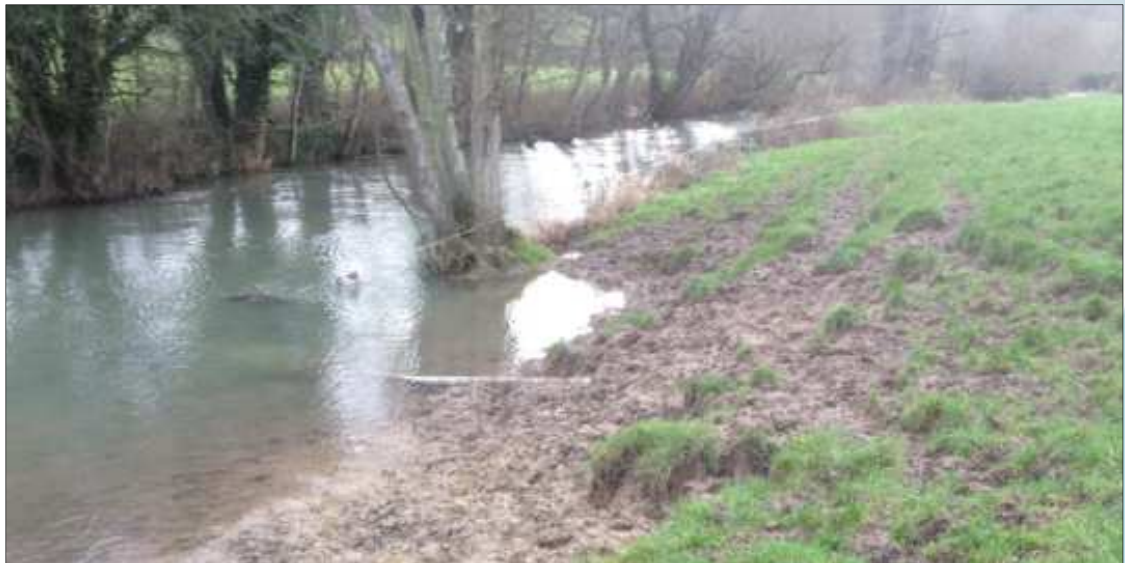
Figure 2.24 Cattle Poaching Upstream of Widdenham Mill Weir

- 2.4.49 Further downstream of Weavern Mill Weir towards Widdenham Mill Weir, the overall channel is in relatively poor condition in response to channel banks being poached by cattle with large amounts of sediment being washed into the By Brook (see **Figure 2.24**). This was clearly evident during the walkover survey in which the water quality was quite turbid in response to the transport of fine sediments which had been washed into the channel after a rainfall event. Good sections of gravel bed were noted, although the majority the channel bed was dominated by silt deposition. There is evidence directly upstream Widdenham Mill Weir that management has been taking place in response to the local angling club undertaking vegetation improvement works.

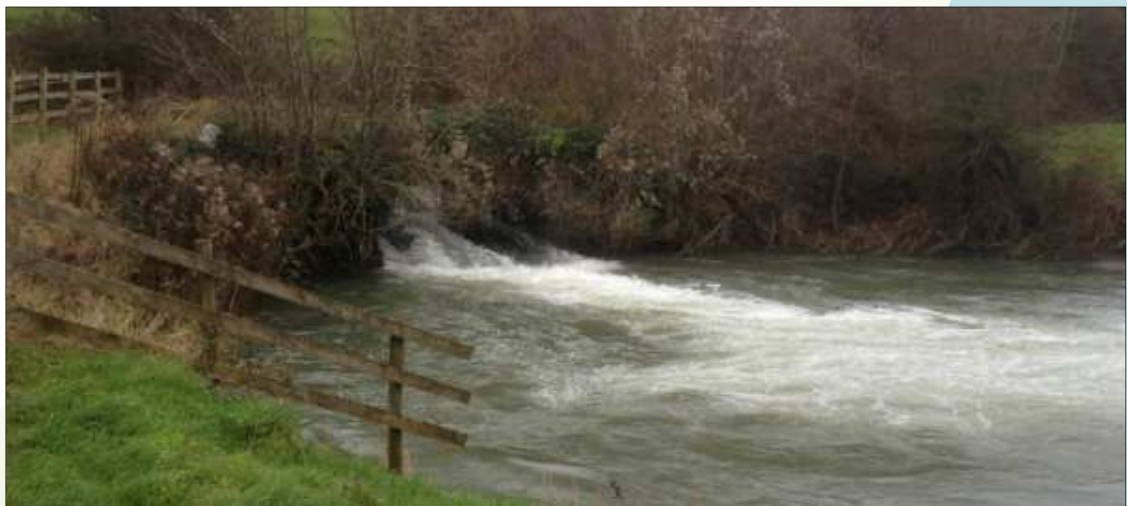
Figure 2.25 Widdenham Mill Weir

- 2.4.51 Downstream of the weir a large scour pool (25m wide) has been formed which has also caused the channel banks to erode and slump in response to fluvial processes (see **Figure 2.26a**), while up to a distance of 574m low flows are impounded upstream of Widdenham Mill Weir (EA, 2015).

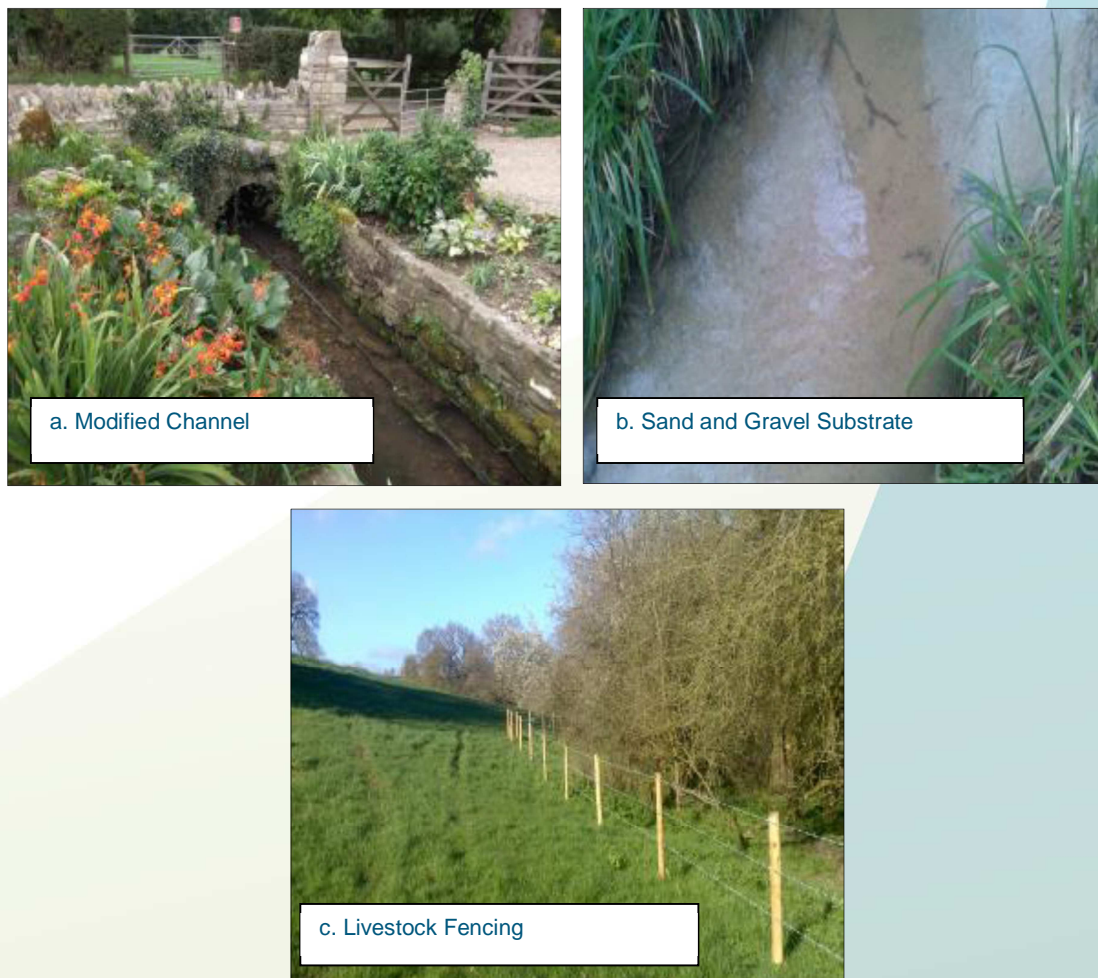
Figure 2.27 Key Environmental Features of Lid Brook

- 2.4.54 Very little riparian vegetation exists along this reach. This is largely due to livestock access to the river and the excessive poaching which has caused damage to bankside structure and vegetation. However, with livestock fencing that has been erected in the past year it is hoped that a good diversity of riparian vegetation begins to establish along this reach (see **Figure 2.27c**).

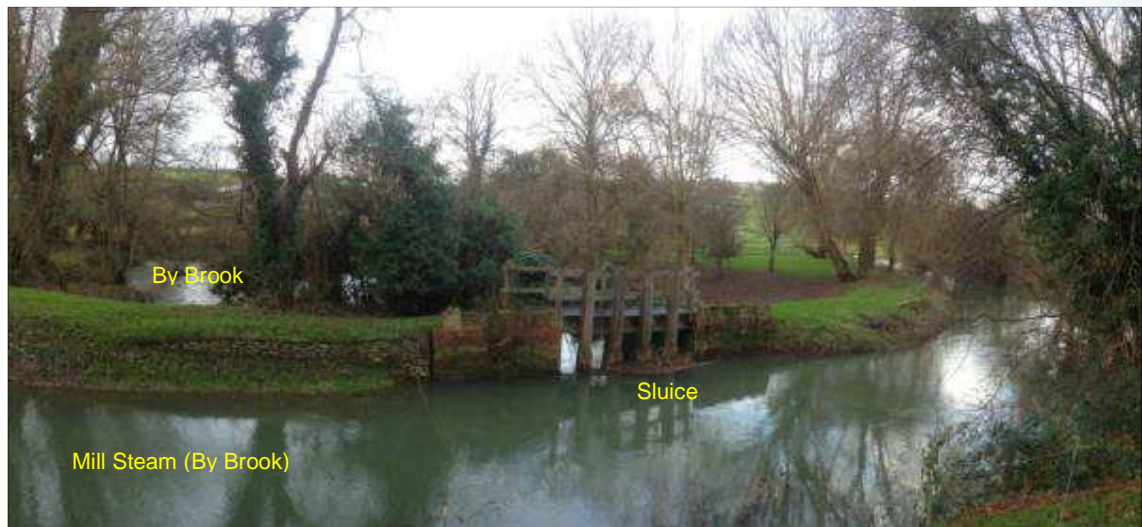
Figure 2.28 Drewitts Mill Sluice

- 2.4.55 Drewitts Mill consists of a water control structure in the form of a wooded board sluice which controls water levels along the mill stream (By Brook) (see **Figure 2.28**). The sluice is located approximately 1.2km downstream of Widdenham Mill Weir.

- 2.4.56 It was noted in the Bart report (see **Appendix A**) that the sluice is not a barrier to fish passage when no boards are in place. However, during the time of the walkover survey the sluice was completely blocked with large wooded debris which would not have been passable to fish (see **Figure 2.29**).

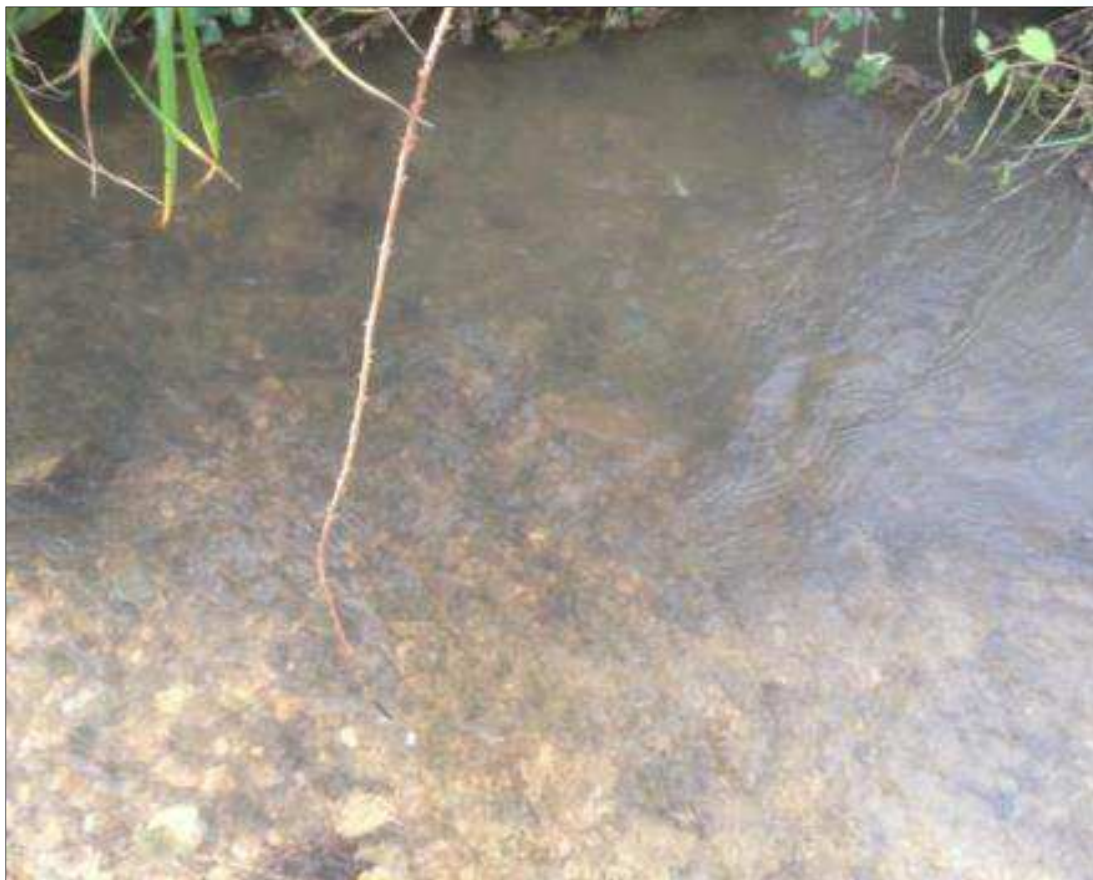
Figure 2.30 Lid Brook Gravels

2.4.57 Upstream of the sluice, flows are impounded to approximately 300m. Poached banks and floodplain were noted during the walkover survey, although there are good sections of gravel bed and instream diversity in form of large wooded debris past the extent of the flow impoundment, in which the dominant flow habitat is a combination of glides, runs and riffles. Directly downstream of the sluice there is a large scour pool (18m wide). Clean gravel beds were noted along the Lid Brook during the walkover which provides a good source of coarse sediments to the By Brook (see **Figure 2.30**).

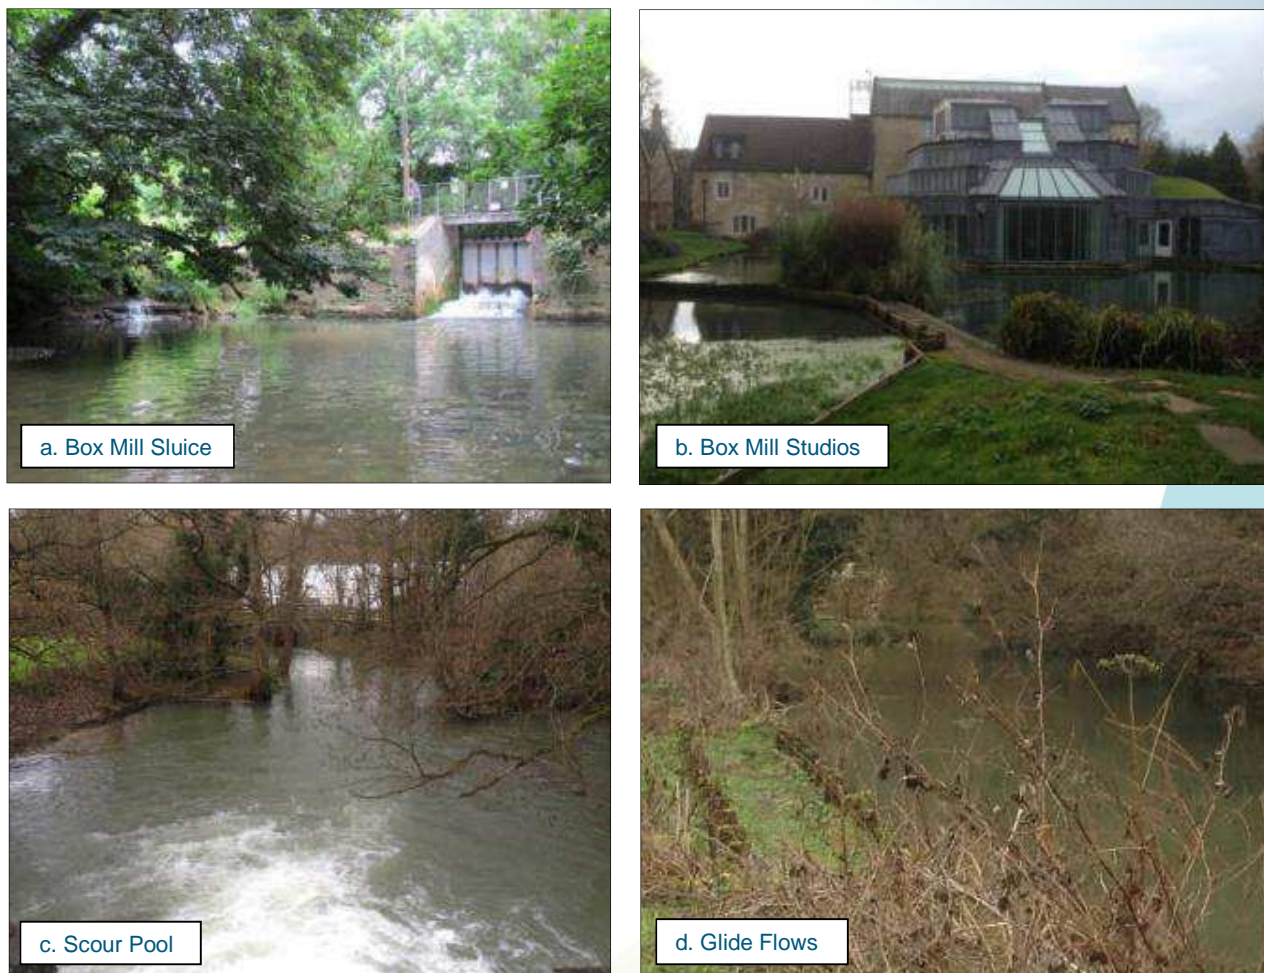
Figure 2.31 Box Mill Sluice and Key Environmental Features

2.4.58 Box Mill is located approximately 1km downstream of Drewitts Mill and comprises of four steel sluices which maintain the hydrostatic head over 2.8m, making this structure the largest fish migration barrier along the By Brook (see **Figure 2.31a**). Although historically used as a water control structure to keep water levels maintained along the mill leat for milling purposes, the sluice now maintains water levels for aesthetic reasons associated with Box Mill Studios owned by Peter Gabriel (see **Figure 2.31b**).

2.4.60 Upstream of the sluice there are slow flowing glide sections which are the dominant flow habitat (see **Figure 2.30d**). The section upstream of the sluice is a known white-clawed crayfish habitat and generally the habitat is in good condition in regards to flow and geomorphological diversity with minimal anthropogenic impacts evident during the walkover survey.

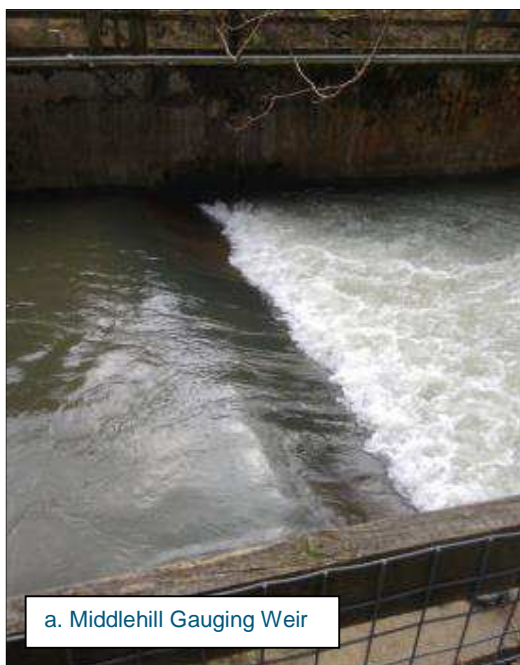
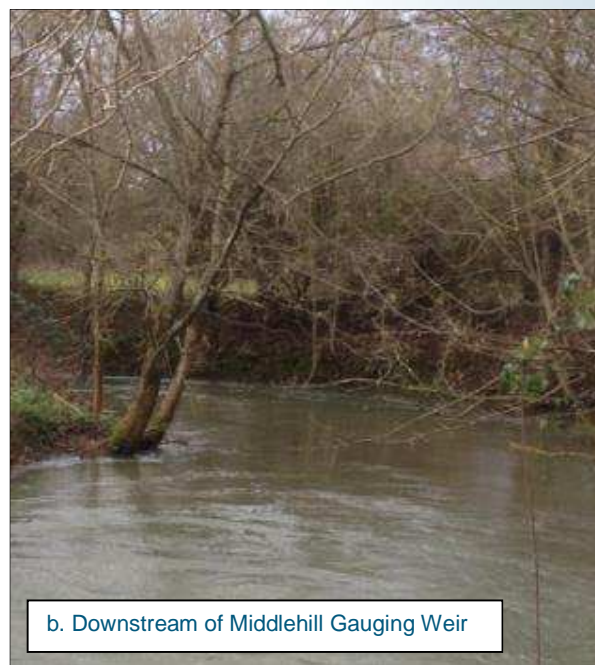
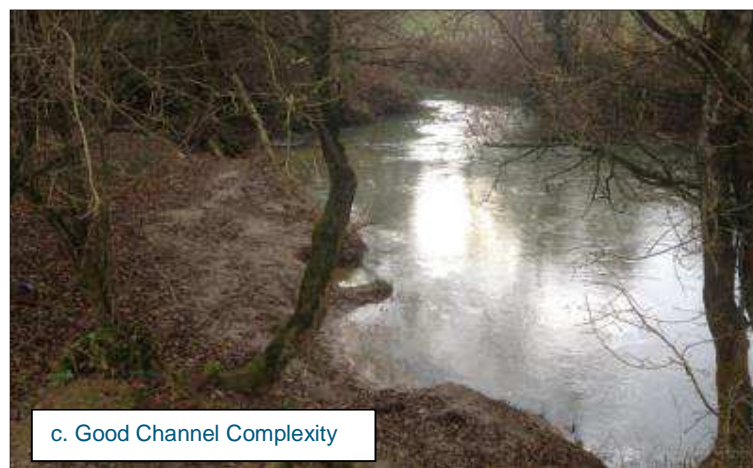
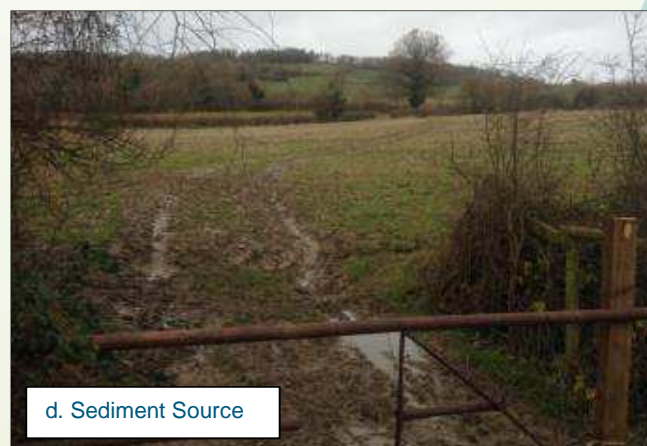
Figure 2.32 Middlehill Gauging Weir and Key Environmental Features

2.4.62 The weir does appear to present a barrier to fish passage in particular during low flows. Flows upstream of the structure are impounded for a distance of 53m during low flow conditions.
