Feasibility Restoration Report for By Brook, North East Bath

Status: Final

Date: May 2015

Project name: By Brook Restoration Project

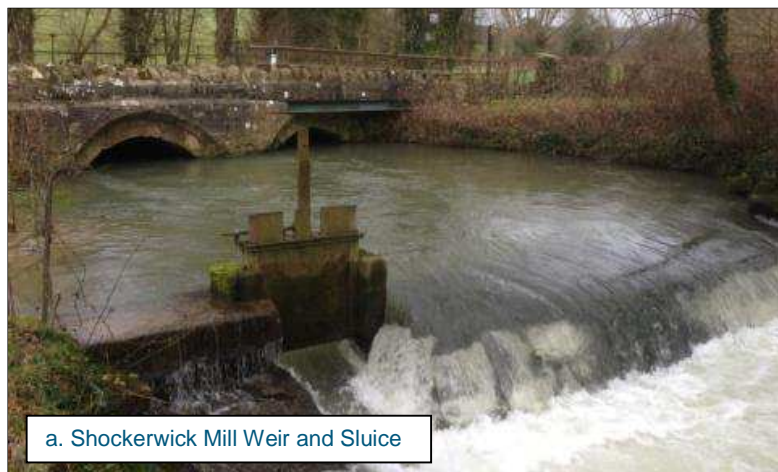
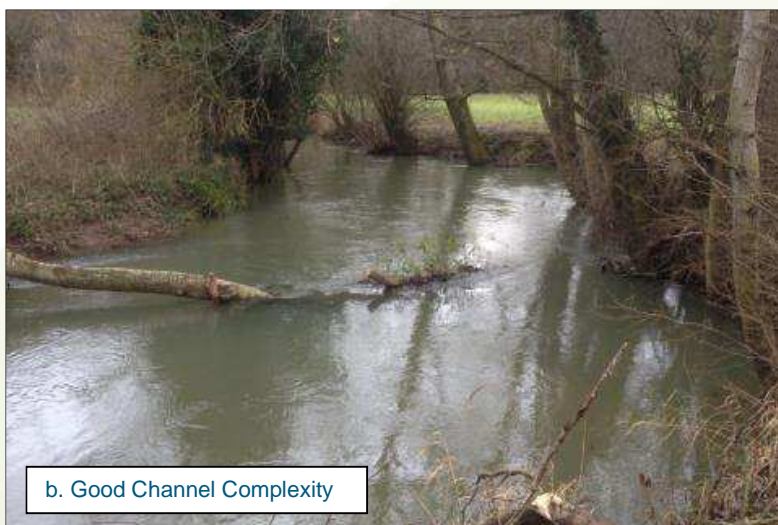
Figure 2.33 Shockerwick Mill Weir and Key Environmental Features

- 2.4.63 Shockerwick Mill Weir is located approximately 1.1km downstream of Middlehill Gauging Weir and comprises of a fixed crest weir with a steel sluice (see **Figure 2.33a**). The weir does appear to present a barrier to fish passage in particular during low flows. The current operational purpose and regime of the sluice component of the weir is unknown although there is evidence that it is operated. Flows upstream of the structure are impounded for distance of 672m during low flow conditions (EA, 2015).

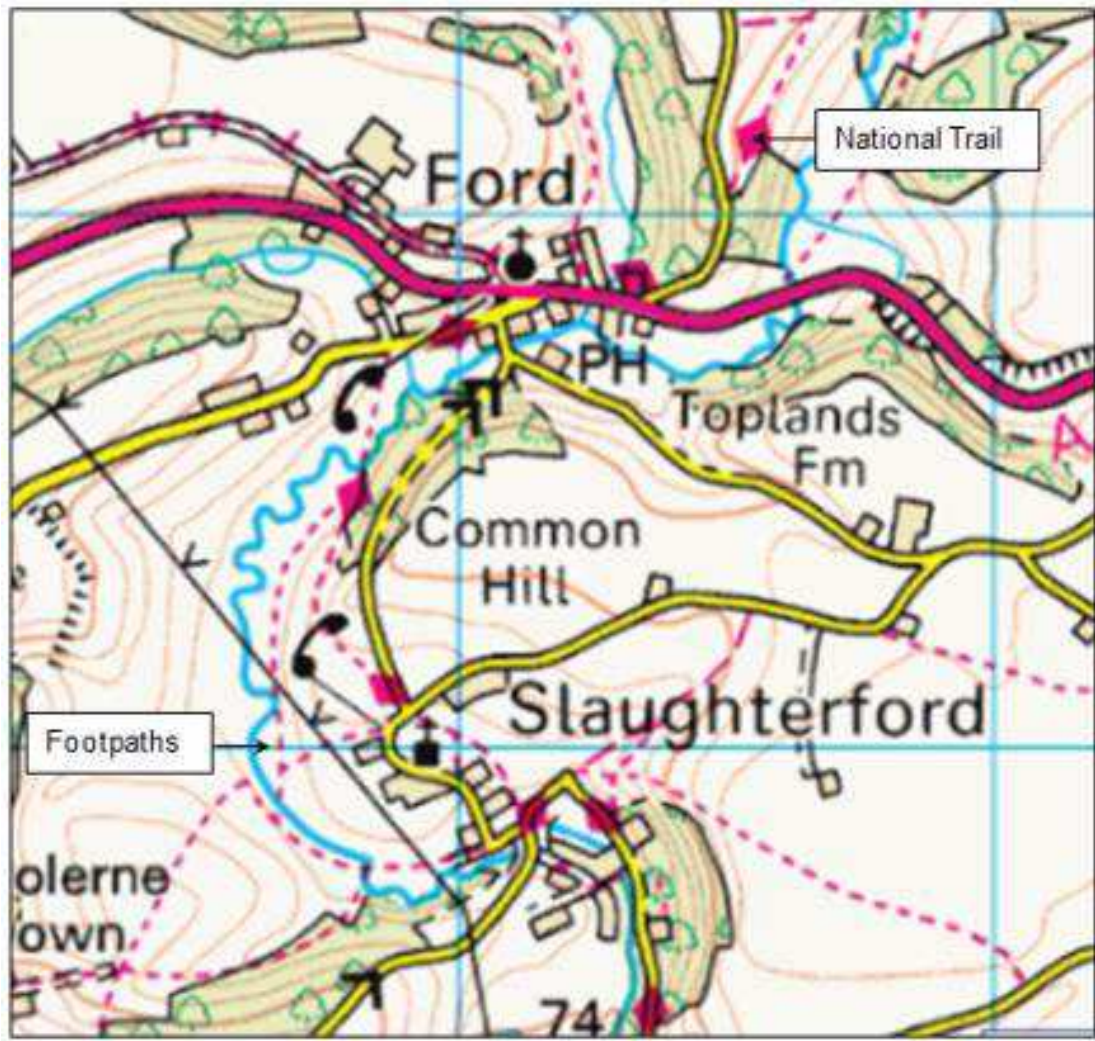
Figure 2.37 Public Access Between Ford and Slaughterford

and Slaughterford (see **Figure 2.37**) where there is the highest density of structures, increases the visual prominence of any restoration work undertaken and would potentially increase the cost of some options, as additional foot-bridges would potentially have to be constructed across restoration the works (BART, 2013).

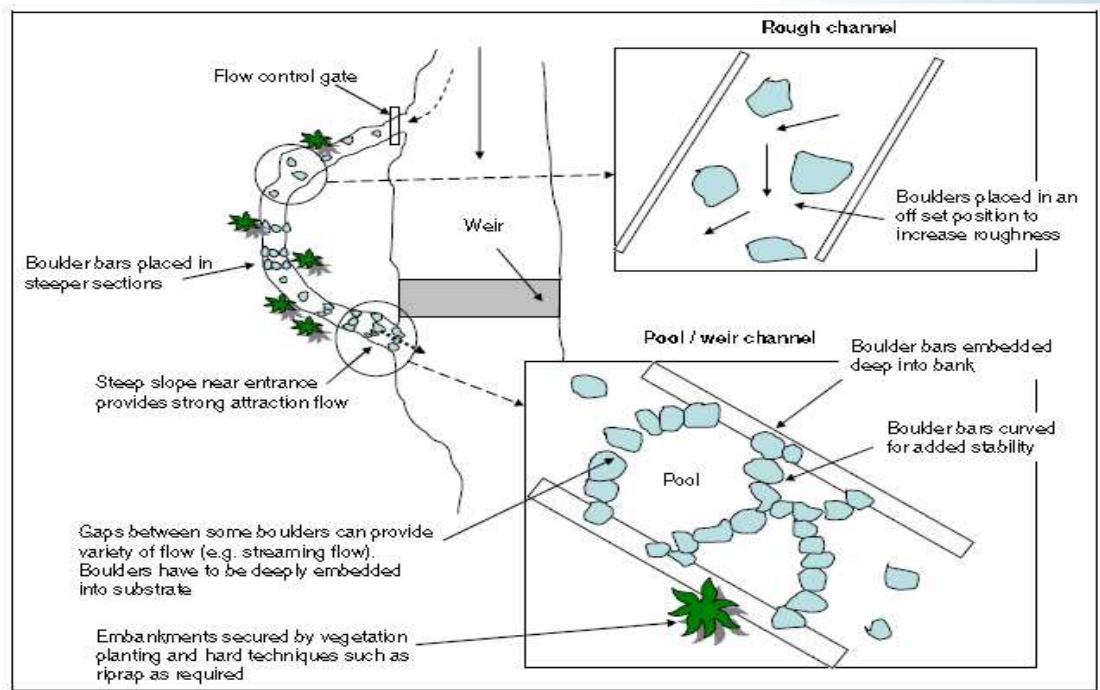
Figure 4.5 Schematic Diagram Illustrating a Bypass Channel Construction Arrangement

Note: This schematic does not relate directly to Reach 4A2 (Weir D/S Ford) and is merely used to illustrate bypass channel design.

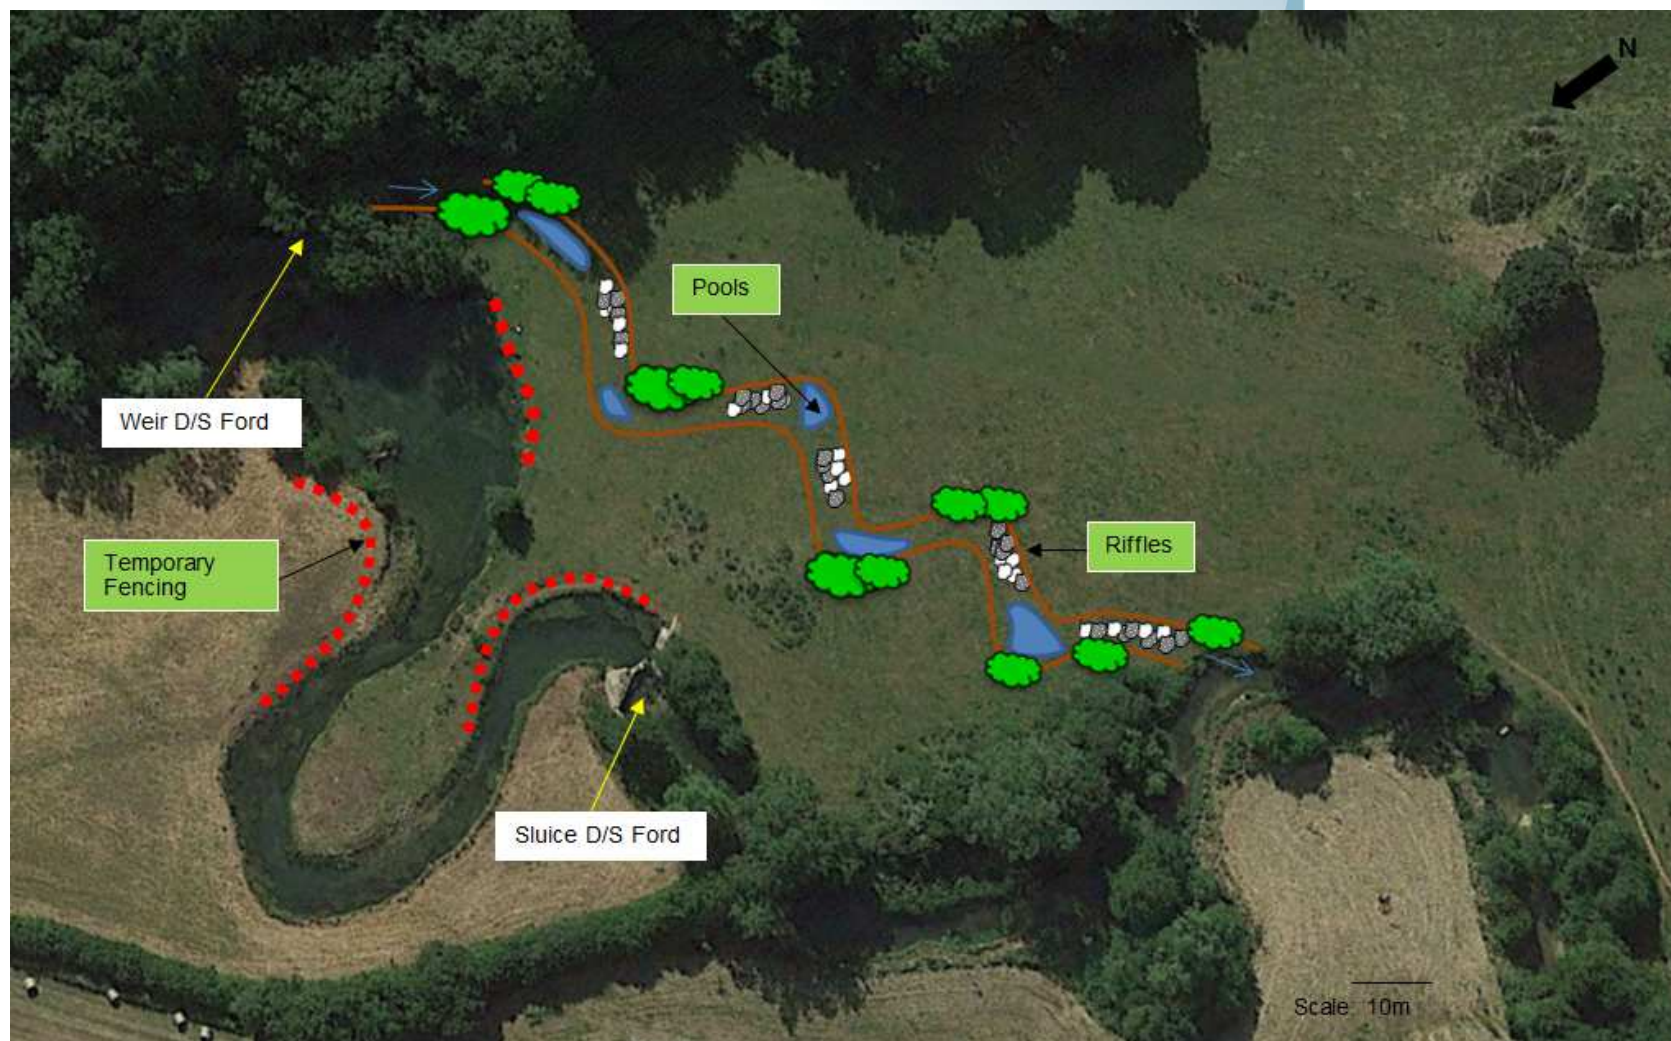
Figure 4.6 Concept (Outline Design) Layout of the Natural Bypass Channel for Reach 4A2 (Weir D/S Ford)

- 4.5.11 In addition, temporary fencing could be incorporated around the banks downstream of Weir D/S Ford to reduce fine sediment input into the main channel of the By Brook from cattle poaching (see **Figure 4.8** – transported fine sediments after a flood event). The fencing should be set back from the banks to allow for continued fluvial process and natural development of the meander bends, although soft bank protection works may be required along the left bank directly downstream of the weir to reduce the expansion of the scour hole.

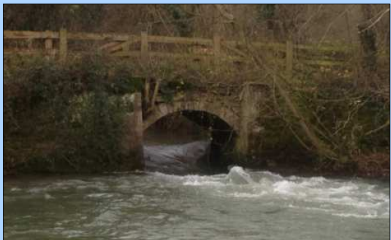
<ul style="list-style-type: none"> In-channel structures: Concrete fixed weir (crest of 20m), which is currently in a poor condition and hidden by dense woodland. The weir incorporates a foot-bridge / access track used by landowners. Silt covered spawning beds. Bank erosion due to livestock poaching. 	<ul style="list-style-type: none"> Structural removal. Natural re-alignment of the channel bed and to allow for fish passage. Technical fish pass: Larinier or pool and traverse style fish pass installed on either the right or left hand bank adjacent to the weir (see Appendix A for more details). 	<ul style="list-style-type: none"> Provision to provide a viable fish passage solution would not be constrained by site access, as a gravel track to Weavern Farm is located adjacent to the weir. Removing the structure would require a replacement foot-bridge or public access across the By Brook. At the time of the walkover undertaken by RHDHV, the weir did appear passable at high flows, although velocities were high in response to flows being funnelled through the structure. As such the natural re-alignment of the channel bed via re-profiling through the structure may provide a viable fish passage solution. The banks are relatively steep along the right hand bank (facing downstream) adjacent the weir, and as such the option of a pool and traverse appears the less likely option regarding the technical fish passes, with the Larinier the favoured option. No U/S impoundment. 	<ul style="list-style-type: none"> There is potential for a natural bypass channel upstream of the weir structure along the left hand outer floodplain either as a stand-alone bypass or connected with the existing watercourse networks. Although the management of the cattle holding area (see Figure 2.23a) would need to be addressed as the bypass channel would most likely get impacted upon by the nutrient / sediment run-off of the cattle yard. BART to work with farmers on livestock fencing (or natural vegetated buffer strips) and land management to reduce sediment and nutrient input into the river. This option appears to be the first stage of restoration which should be implemented along this reach prior to the development of fish passage solutions. Bank re-profiling.

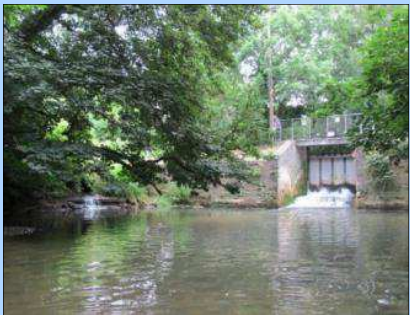
<ul style="list-style-type: none"> In-channel structures: Four steel sluices which maintain the hydrostatic head over 2.8m, making this structure the largest fish migration barrier along the By Brook. Agricultural run-off. Steeply eroded banks. 	<ul style="list-style-type: none"> Two-stage Larinier Super-Active fish pass with elver pipe (see Appendix A for more details). Natural bypass channel using an existing back-channel (see Appendix A for more details). 	<ul style="list-style-type: none"> The construction of the Larinier fish pass does appear feasible, although access to undertake the works would require access tracks down from Drewitts Mill. The construction of the bypass channel also appears feasible, although this would need to take into consideration another in-channel structure upstream of Box Mill sluice. There is no impoundment associated with this structure (see Table 2.3). 	<ul style="list-style-type: none"> It's unlikely that structural removal will be accepted by the landowner who requires water levels to be maintained for ornamental ponds. Another natural bypass channel could be constructed using the existing drainage features along the right hand outer floodplain (facing downstream) which would start approximately 300m upstream of the sluice and re-enter the By Brook directly downstream of the sluice (scour hole). This would bypass both in-channel structures while using the existing drainage network. BART to work with farmers on livestock fencing (or natural vegetated buffer strips) and land management to reduce sediment and nutrient input into the river. Bank re-profiling.
