## Enhancing fish spawning and nursery habitat on the upper Bristol Avon

In 2012, the Wild Trout Trust (WTT) had undertaken a site visit on behalf of the Somersfords Fishing Association (SFA) covering a stretch of the river between Kingsmead Mill and Roaring Hatches, reporting on existing habitat with recommendations for improvements.

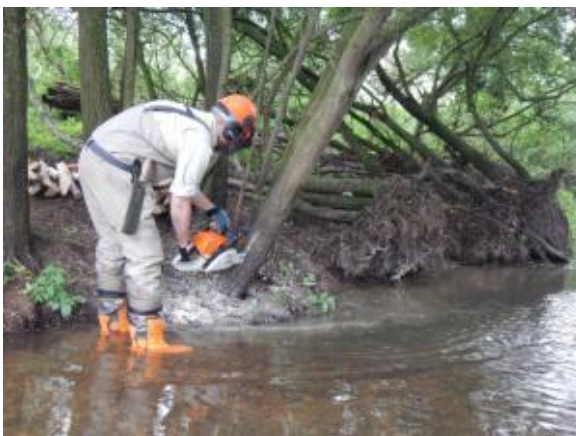
*Mike Blackmore from the Wild Trout Trust 'hinging' a willow as a core element of a live willow deflector (Image © Mark Everard)*

The basic structure of the flow deflector was achieved by ‘hinging’ willows into the river edge by cutting halfway through the trunk near ground level, the trees falling downstream still connected to their roots and thus remaining alive. These were secured using chestnut posts to ensure that the structure will remain in place during spate flows, packed with additional live willow off-cuts, and pinned down by wiring live willow cross-members to the posts which were then rammed further into the stream bed to compact the mass. This accelerated the flows of water over the gravel bed on the outer edge, creating additional habitat within and downstream of the structure in which both fry and mature fish could find refuge from strong currents and predators.

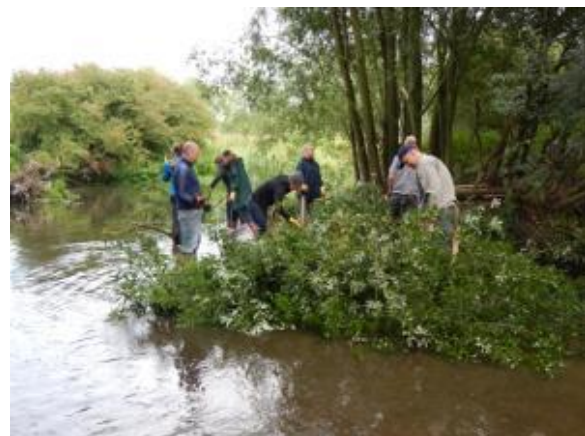
*Swapping spreadsheets for wellies, some of the Environment Agency's SEP team hard at work building the willow deflector (Image © Mark Everard)*

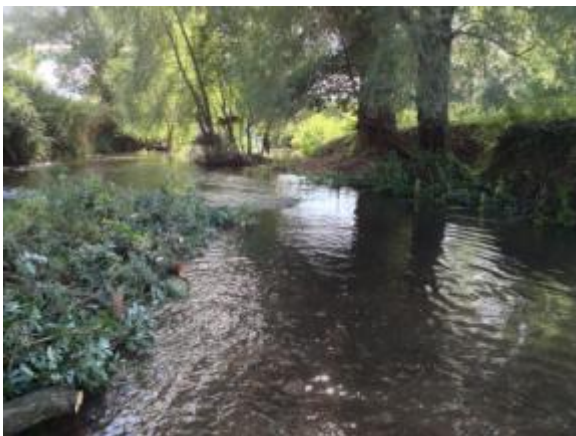
Completed job: deflector on the left, scouring logs on the riffle, and faggots against the right bank (Image © Mike Blackmore)

The gravel scouring structures comprised a pair of logs set as an upstream ‘V’, each log pinned with steel rods into the gravel bed in the fast and shallow water to promote scour. The purpose of this is to open up the gravel, driving out the excessive silt that had accumulated in its interstices and maintaining it in a condition suitable for the spawning needs of trout, grayling and other gravel-spawning fishes (such as dace and chub) in the reach of river.

To prevent erosion on the face of the opposite bank, as well as to provide refuge and feeding habitat, long shoots of ash and willow were packed down by faggots (wired bundles) of willow off-cuts, topping with faggots of hawthorn to deter the attentions of cattle, wired to posts that were then rammed home into the river bed for security.
