Chew Smart Rivers Overview Report

Nov 2020

Document reference BART – 18110 - REP- 1.0

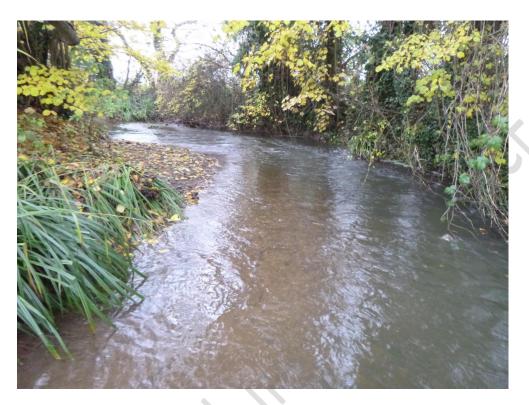
Macro-invertebrate site 1: At Shrowle

Site 1 had a good diversity of macro-invertebrate taxa present in both 2019 and 2020 samples. The BMWP scores were good and very good for 2019 and 2020 respectively and ASPT scores were high; both indices, therefore, suggest good water quality in this location.

The macro-invertebrate assemblages present at the site indicate that there is a good variety of available habitat types and that water quality in this location is able to support a good diversity of macro-invertebrates. The notes recorded at the time of sampling would support these findings as there was a range of different habitat and flow types available at the site including riffle, run, pool and slack flow types, an unvegetated point bar and a variety of different substrate types. A small amount of in stream macrophytes (Apium nodiflorum) were recorded during each of the surveys. These features provide natural habitat variation for macro-invertebrates to live within.

All of the pressure ratings scores were good or high for Site 1 with the exception of nutrients which did not have a score. The pressure ratings and biological indices suggest that in this location the river is fairly natural with only minor pressures from flow and siltation impacting on the ecology here. The lack of pressures in this location is likely to be because the site is the most upstream sites of all the Smart Rivers sites, it is closest to the source of the river and is located upstream of Chew Valley Reservoir.

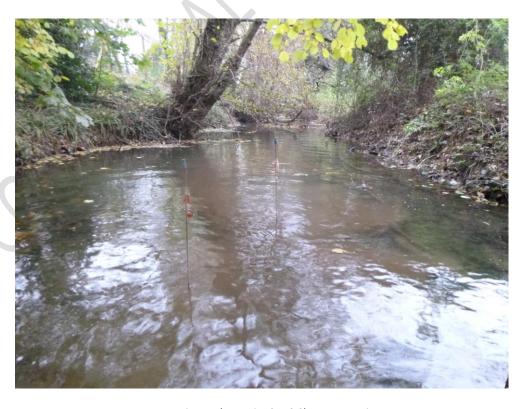
Macro-invertebrate site 2: DS Chew Reservoir

Site 2 had a very limited range of macro-invertebrate taxa present in both 2019 and 2020 samples. The BMWP scores were both moderate for 2019 and 2020, although the 2020 score was right on the border with the poor category. ASPT scores were the lowest recorded at all the Chew sites; both indices, therefore, suggest macro-invertebrates assemblages are severely restricted in this location.

The macro-invertebrate assemblages present at the site indicate that there is a poor variety of available habitat and that the habitat and water quality conditions at the site are not able to support a good diversity of macro-invertebrates. The notes recorded at the time of sampling would support these findings as although there was a range of different flow types available at the site including pool, run and slack flow types, the site was mainly a very slow run habitat with very sluggish, ponded flow and high levels of silt – 65% and 70% recorded in 2019 and 2020 respectively. The site was also very heavily shaded. These features provide very poor habitat variation for macro-invertebrates to live within.

All of the pressure ratings scores were moderate or worse at Site 2 with the exception of nutrients which was "unimpacted" / "slightly impacted" in 2020. The pressure ratings suggest that this site is severely impacted by pesticides, siltation, flow and organics. The pressure ratings and the biological indices together suggest that in this location the river is severely impacted, resulting in a very restricted macro-invertebrate community. The location of Chew Valley Reservoir upstream of the site and the compensation flow concrete weir immediately upstream are likely to be contributing significantly to the pressures on the river Chew at Site 2.

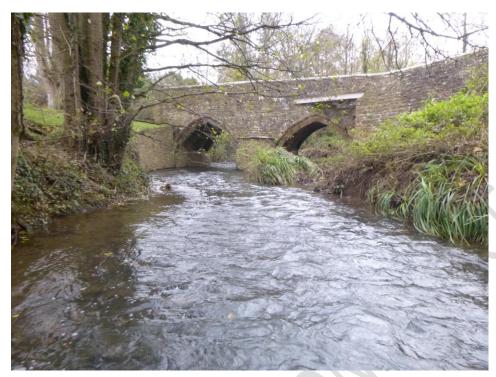
Macro-invertebrate site 3: 20m DS Bridge at Stanton Drew

Site 3 had a good diversity of macro-invertebrate taxa present in both 2019 and 2020 samples. The BMWP scores were good and very good for 2019 and 2020 respectively and ASPT scores were high; both indices, therefore, suggest good water quality in this location.

The macro-invertebrate assemblages present at the site indicate that there is a good variety of available habitat types and that water quality in this location is able to support a good diversity of macro-invertebrates. The notes recorded at the time of sample would support these findings as there was a range of different habitat and flow types available at the site including run and slack flow types, the water was moving quickly through the main channel and was slow / slack at the edges and there were a variety of different substrate types. A small amount of in stream macrophytes (two sprigs of sparganium emersum) and filamentous algae (cladophora agg.) were recorded in the 2020 survey and mosses (fontinalis antipyretica) were recorded in both surveys. These features provide natural habitat variation for macro-invertebrates to live within.

The pressure ratings for pesticides and siltation at Site 3 for both 2019 and 2020 were moderate and in the "moderately impacted" categories – with 2019 results for both pressures on the border with good / "slightly impacted". Nutrients were good, on the border of "unimpacted" / "slightly impacted" in 2020 (with no score in 2019). Flow and organics were both good or high with "unimpacted" in 2019 and "slightly impacted" in 2020. The pressure ratings suggest that the ecology of this site is most impacted by pesticides and siltation with only minor pressure from nutrients, flow and organics.

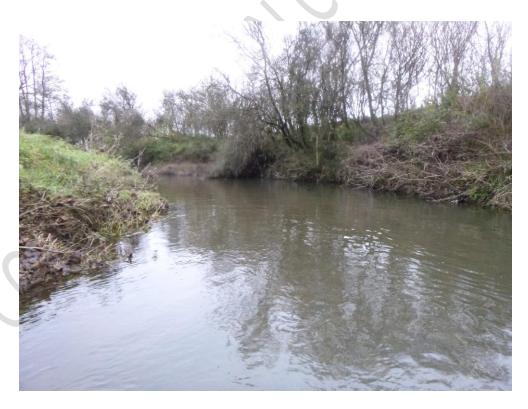
Macro-invertebrate site 4: At Parsonage Farm

Site 4 had a good diversity of macro-invertebrate taxa present in both 2019 and 2020 samples. The BMWP scores were very good for both 2019 and 2020 respectively (although both scores were at the lower end of this category) and ASPT scores were high; both indices, therefore, suggest good water quality in this location.

The macro-invertebrate assemblages present at the site indicate that there is a good variety of available habitat types and that water quality in this location is able to support a good diversity of macro-invertebrates. The notes recorded at the time of sample would support these findings as there was a range of different habitat and flow types available at the site including run and pool flow types and a variety of different substrate types. A small amount of in stream macrophytes (*ranunculus sp.*) and filamentous algae (*cladophora agg.*) were recorded. These features provide natural habitat variation for macro-invertebrates to live within. Slow flows were, however, also recorded at the site and overlaying silt was present on the substrate. These features could be impacting on the in-stream ecology.

The pressure ratings for pesticides at Site 4 were moderate / good in 2019 and good / high in 2020. Siltation results for both 2019 and 2020 were in the "moderately impacted" category. Nutrients were on the border of "slightly impacted"/ "moderately impacted" in 2020 (with no score in 2019). Flow and organics were both good with "slightly impacted" ratings in both years. The pressure ratings suggest that the ecology of this site is most impacted by pesticides, siltation and nutrients with only minor pressure from flow and organics.

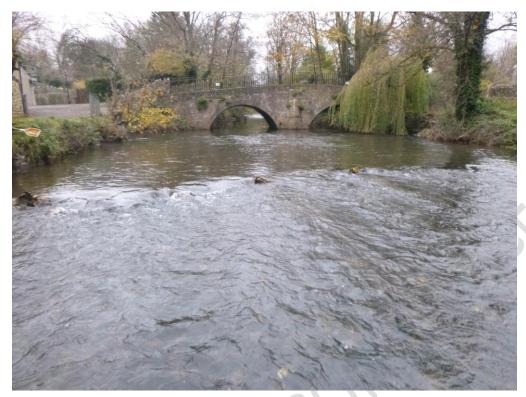
Macro-invertebrate site 5: At Dapps Bridge

Site 5 had a good diversity of macro-invertebrate taxa present in the 2019 samples and a limited range of macro-invertebrate taxa present in the 2020 samples. The BMWP scores were good for 2019 and moderate for 2020 with a drop of 28 between the years. ASPT scores were the lowest recorded of all the Chew sites with the exception of the heavily impacted Site 2 DS of Chew Reservoir. Both indices, therefore, suggest macro-invertebrate assemblages are restricted in this location.

The macro-invertebrate assemblages present at the site indicate that the habitat and water quality conditions at the site in 2020 are not able to support a good diversity of macro-invertebrates. The notes recorded at the time of sample would support these findings as the only flow type recorded was run flow and although there were a range of different substrate types available at the site, the flow was backed up slightly behind a kiddies dam at the time of survey which was restricting the natural flow. These conditions, therefore, provide limited habitat variation at Site 5 for macro-invertebrates to live within.

Pesticides and siltation pressure ratings were moderate or worse at Site 5. The nutrient rating was high / "unimpacted". Flow and organics ratings were good — "slightly impacted" in both years with the exception of 2019 flow which was moderate and on the "slightly impacted / moderately impacted" border. The pressure ratings suggest that the ecology of the site is at least moderately impacted by pesticides and more severely impacted by siltation. Flow and organics are shown to slightly impact on the site whilst nutrients do not have an impact. The Dapps Bridge site is located towards the downstream end of the river Chew approximately 500m US of the large weir in Keynsham Park. The weir can be seen to have a detrimental impact on the river Chew by backing up the water for a large distance and causing slow flows and sediment build up. It is likely that although the river returns to a more natural state at the Dapps Bridge site, the weir may still be having a detrimental impact on the watercourse here. It is also possible that the kiddies dam/s that are regularly built at the Dapps Bridge site may be effecting the flow here and causing sediment to build up.

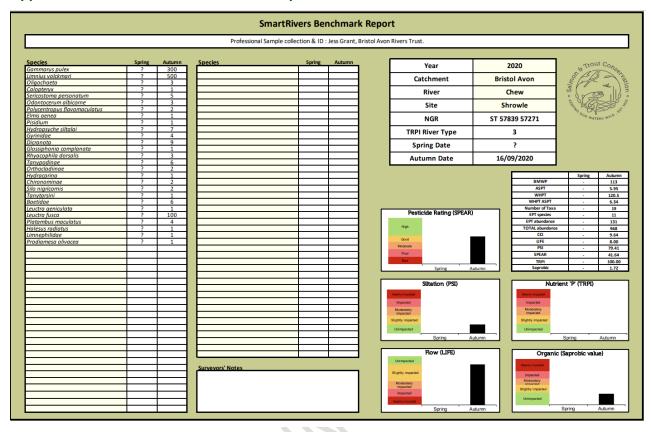
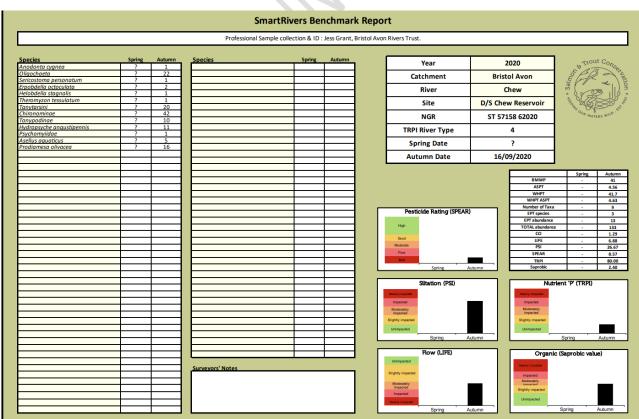
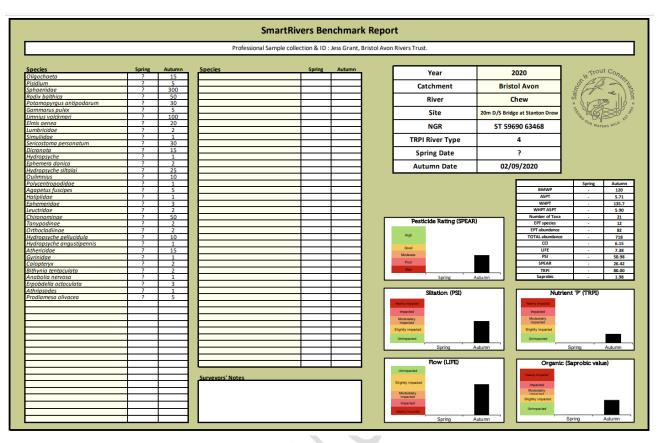
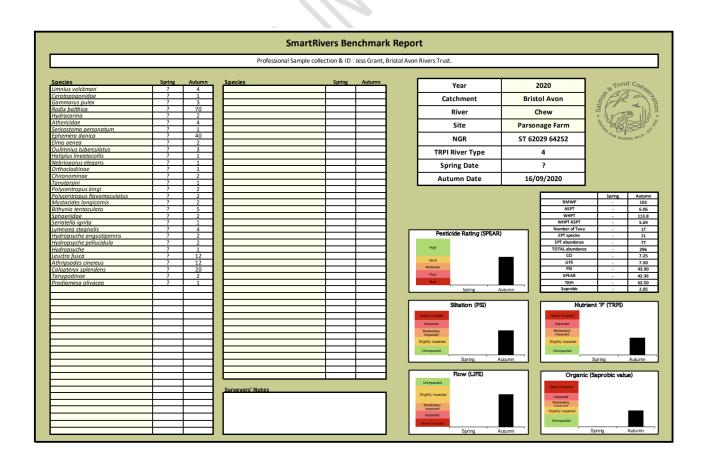
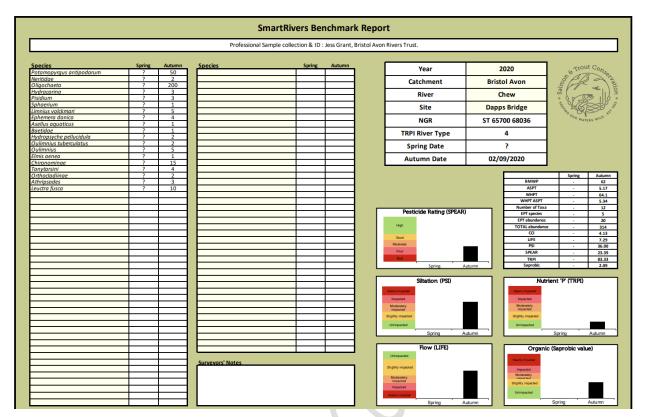
Appendix 2 - Smart Rivers Bench Mark Reports

A Smart Rivers bench mark report was produced for each of the macro-invertebrate samples collected. The bench mark reports for Autumn 2020 are included as Appendix 2. Sections 3.2 and 3.3 below display data from the bench mark reports in table format to allow comparisons between the sites and years to be made.

Table 4 below shows the pressure ratings calculated for the 2019 survey and the 2020 survey, included in graph format in the bench mark reports as Appendix 2.
