Cam Brook and Midford Brook Riverfly Monitoring Summary Report

October 2024

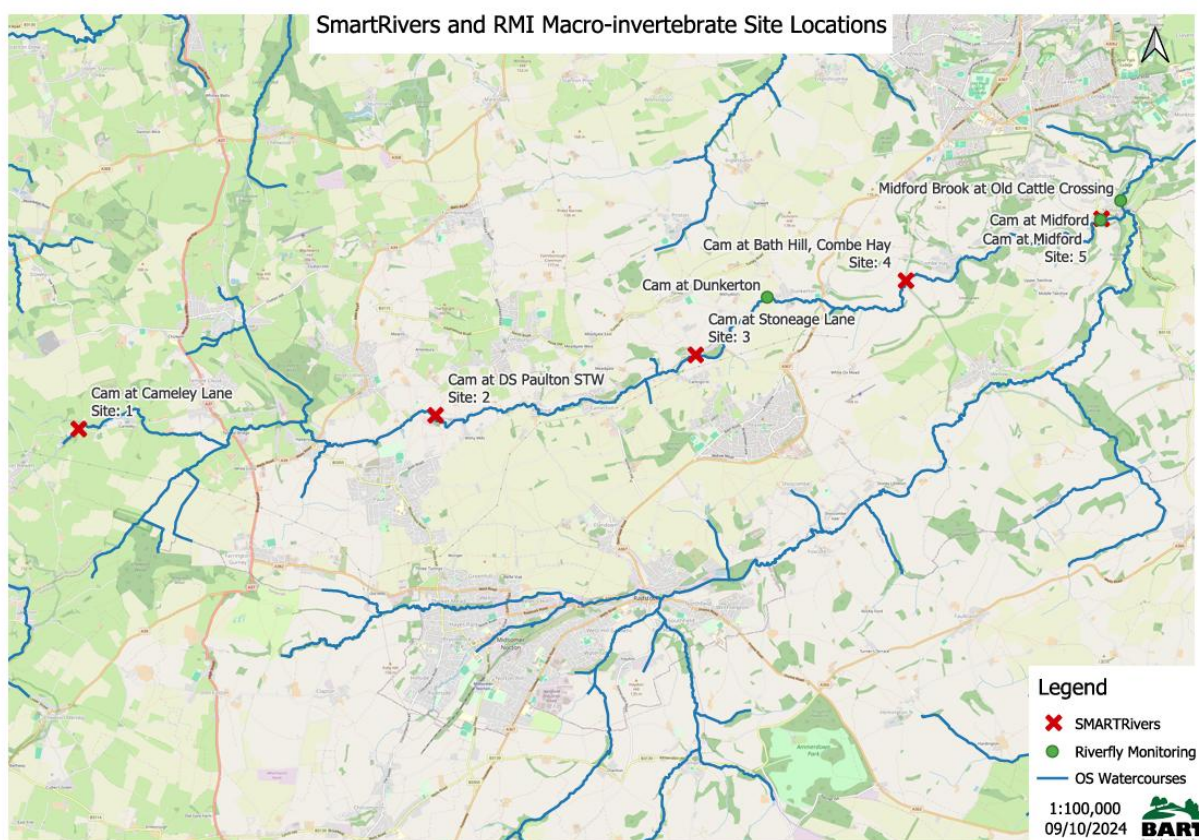
Figure 1 – Map of SmartRivers and RMI sites on the Cam and Midford brooks

Figure 1 below shows the locations of the SmartRivers and RMI sites on the Cam and Midford brooks.

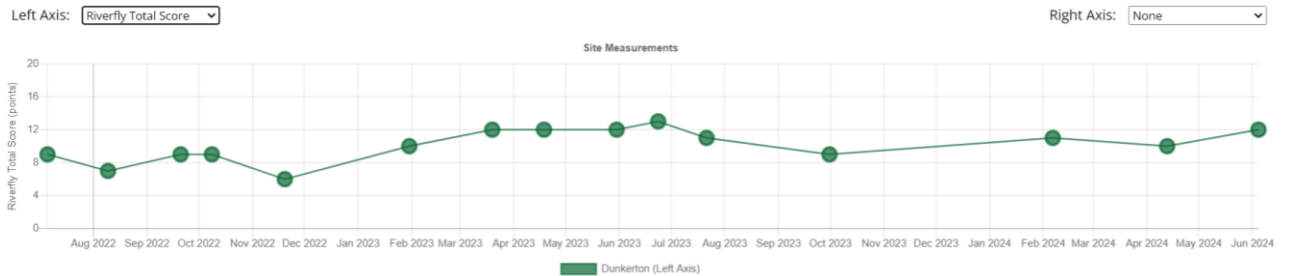
Figure 4 Cam at Dunkerton

Figures 4 to 6 below show the RMI total riverfly scores over time for each of the RMI sites on the Cam and Midford Brooks. The graphs are taken from BART’s Riverhub (<https://riverhub.co.uk/>). It should be noted that the trigger level set by the Environment Agency for each site is 7.

Riverfly total scores at the Cam at Dunkerton site ranged between 6 and 13. The vast majority of samples scored between 9 and 12 with no clear trend over time (the site was monitored regularly between July 2022 and present day). Two samples fell below the trigger level of 7 (6 scored in August 2022 and a 5 scored in November 2022). These low samples could have been the result of the drought conditions of Summer 2022, known to have had an impact on macro-invertebrate abundances throughout the catchment. . These results were reported to the Environment Agency to inform their drought investigations.

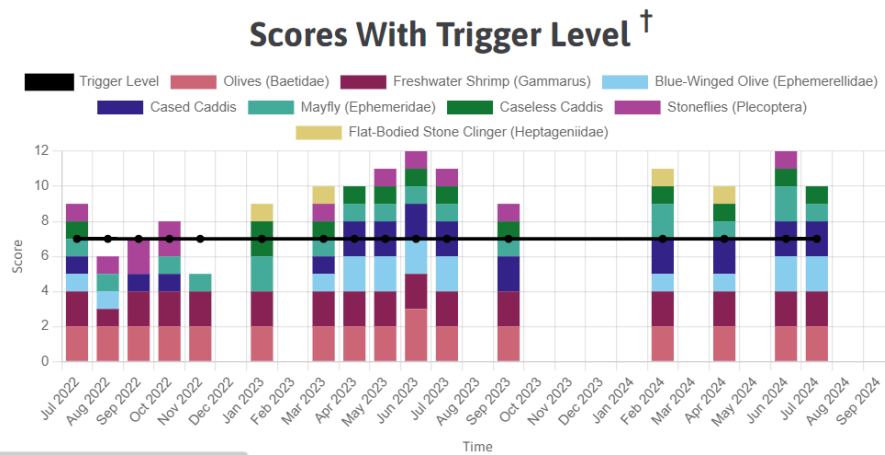
Figure 7 Cam at Dunkerton scores and taxon distribution

All of the eight RMI groups have been recorded at the Dunkerton site. Shrimps and Olives were the most abundant in the samples. Flat bodied mayflies were the least abundant – recorded in four of the samples – as shown in figure 7.

The RMI data suggests conditions at the site are able to support a good diversity of Riverfly groups. The low scores in 2022 suggests that the ecology at the site is vulnerable to low flow conditions.

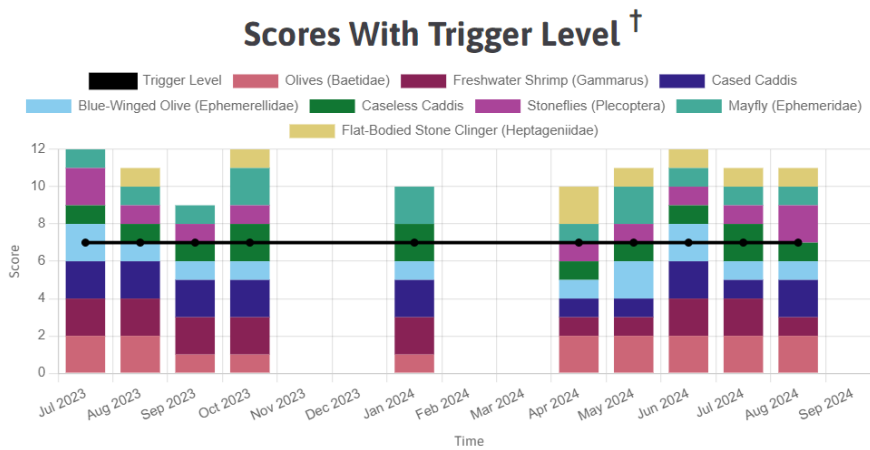
Figure 8 Cam at Midford scores and taxon distribution

Riverfly total scores at the Cam at Midford site ranged between 10 and 12 (the site was monitored ten times between July 2023 and present day).

All of the eight RMI groups have been recorded at seven out of the ten samples taken at the Midford site. Flat bodied mayflies are missing from three of the samples. The gaps in data in Winter of 23/24 are likely to be the result of high flow conditions in the catchment at this time. The RMI data suggests conditions at the site are able to support a good diversity of Riverfly groups.

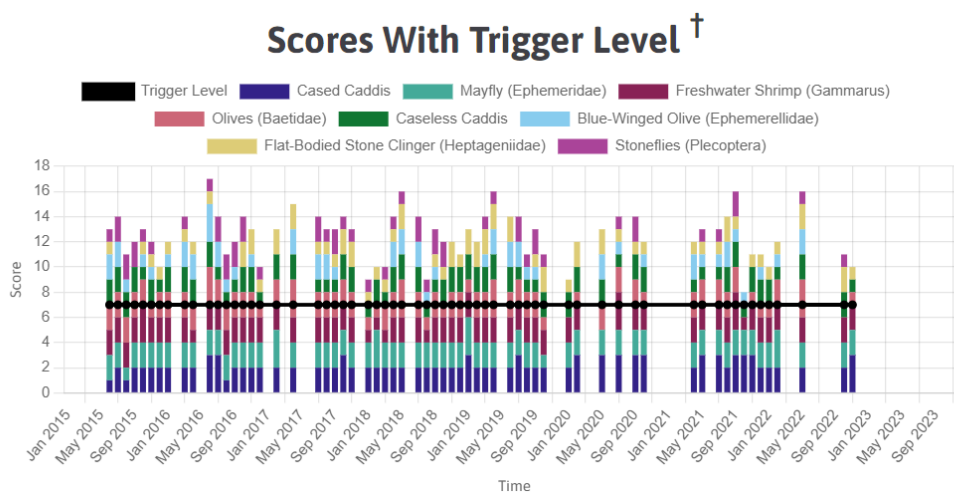
Figure 9 Midford Brook at Old Cattle Crossing scores and taxon distribution

Riverfly total scores at the Midford Brook site at Old Cattle Crossing ranged between 9 and 18 with the highest scores generally recorded in the summer and the lowest scores in the winter. The vast majority of samples scored between 12 and 15 with no clear trend over time (the site was monitored regularly between 2015 and 2022). No samples fell below the trigger level of 7.

All of the eight RMI groups have been recorded at the Midford Brook site with Cased Caddisflies being the most abundant of the eight RMI groups. Stoneflies were the least abundant of the RMI groups. The RMI data suggests conditions at the site are able to support a good diversity of Riverfly groups.

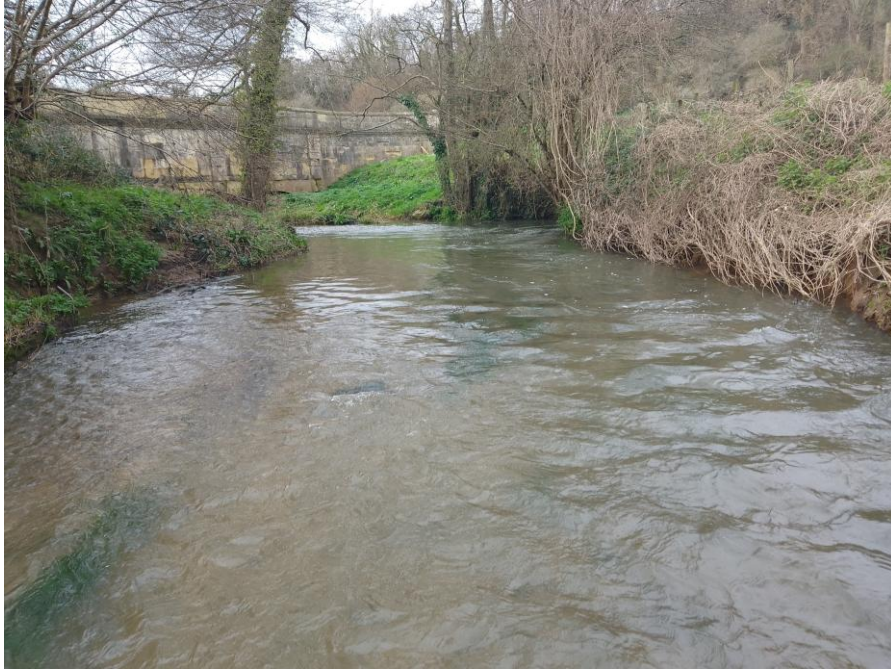
Site 1: Cam at Midford

The Midford site Spring results should be discounted due to the high flows impacting reliability. The Autumn sample scored unimpacted or slightly impacted for all the pressures, again supporting the comment that conditions are good at this site.

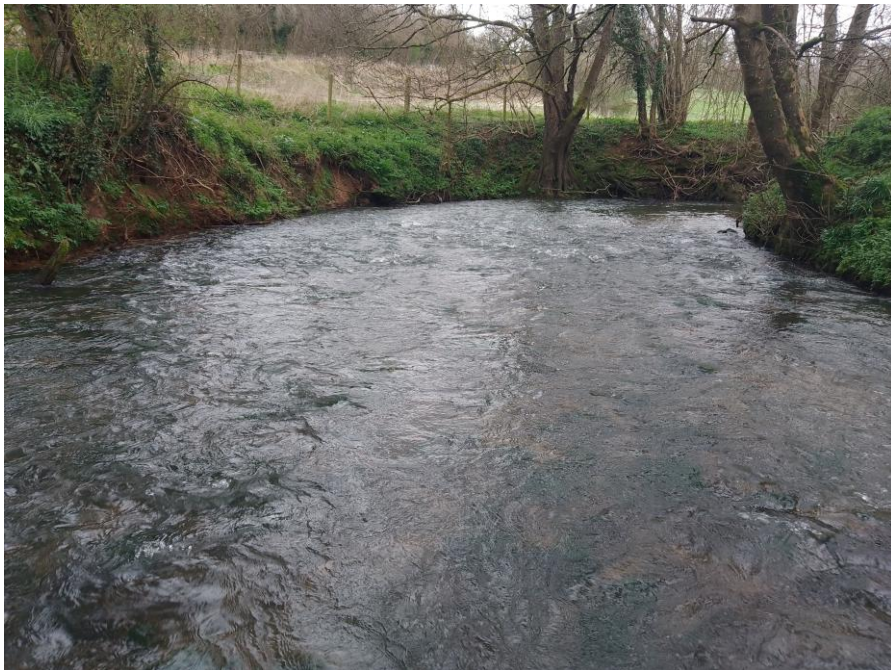
Site 2: Cam at Bath Hill, Combe Hay

The Cam at Bath Hill, Combe Hay scored slightly impacted or unimpacted for all pressures apart from the Autumn scores for siltation and pesticides which both scored impacted. This suggests that there are seasonal pressures on this section of watercourse, possibly as a result of run off from the agricultural land uses upstream. Walkover surveys undertaken by BART in 2021 identified large, sloped, bare arable fields with small buffer zones immediately upstream of Bath Hill. Following rain fall events these fields are likely to result in significant diffuse run off entering the brook.

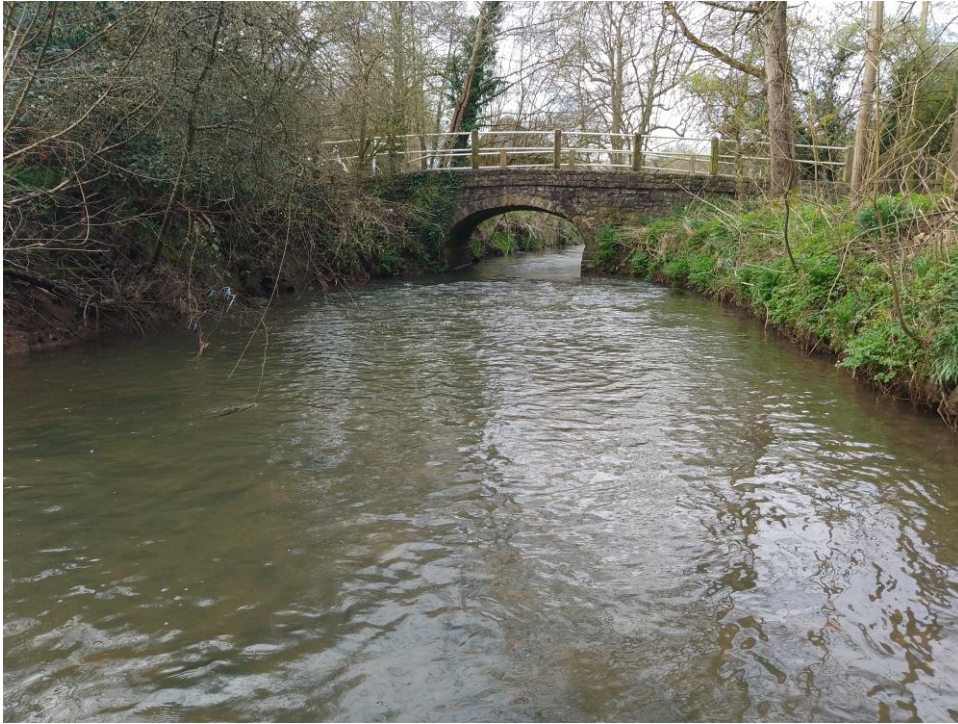
Site 3: Cam at Stoneage Lane

It should be noted that low diversity can affect the calculation of the more sensitive SmartRivers metrics - TRPI (phosphorus) and PSI (sediment). This could account for the no rating for Nutrient “P” at the Stoneage Lane site – this site had the lowest diversity of macro-invertebrates of all five sites.

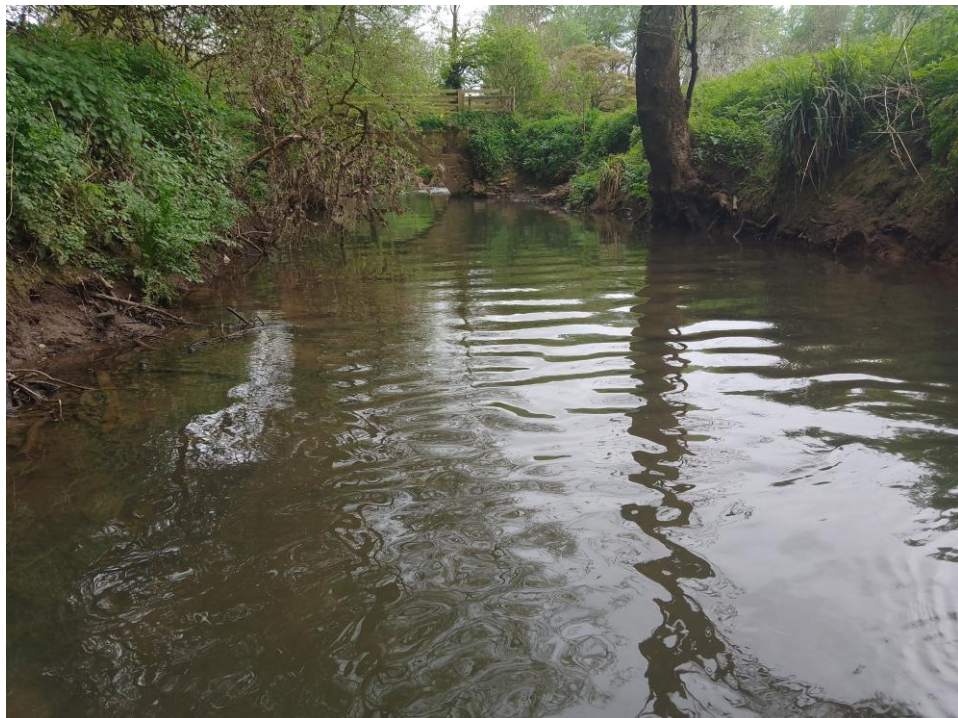
Site 4: Cam at DS Paulton STW

The DS Paulton STW site scored moderately impacted or impacted for all pressures apart from flow (slightly impacted in Spring) and nutrients (slightly impacted in Autumn). This suggests that the macro-invertebrates at the DS Paulton STW site are restricted due to all the pressures recorded. The very high saprobic scores – 2.46 and 2.34 at this site suggests considerable water quality issues are present here.

Experts at WildFish state that SmartRivers saprobic scores above 2 should be flagged as problematic. Following this investigation BART will feedback this information to Wessex Water. High levels of overlaying silt were recorded at the time of sampling at the DS Paulton STW site – 100% of the site had a thick covering of silt. Excessive sediment caused by anthropogenic factors is detrimental to the water quality and ecology of a watercourse, including fish and invertebrates. Impacts on macro-invertebrates include the clogging of gills and the destruction of suitable habitats. River restoration works to improve the habitat in this location, pinch the channel, increase flow diversity and reduce overlaying silt is recommended.
