Little Avon Catchment Riverfly Monitoring Summary Report

March 2025

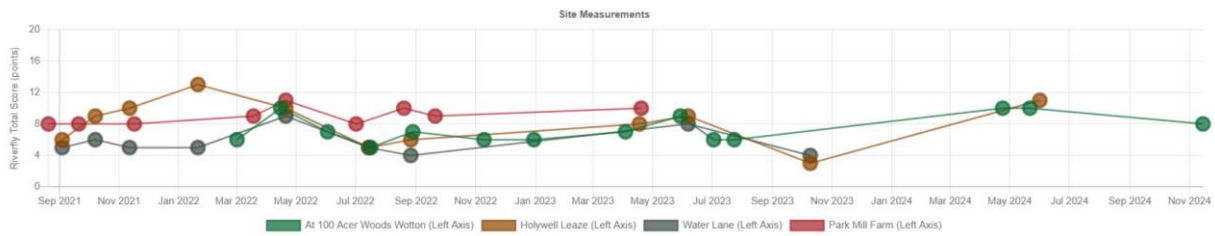
Figure 5 Riverfly Total Scores for the Dyer's Brook RMI Sites

Scores fell below trigger level on one occasion – at Holywell Leaze in October 2023. The Water Lane site scored 4 in August 2022 and October 2023. The August 2022 site could have been the result of drought conditions in the catchment putting extra pressure on the macro-invertebrate communities. The Holywell Leaze site scored 3 in October 2023 with only 50 shrimps and one blue winged olive present. There was no obvious signs of pollution present at the time of survey. Scores were also low in summer 2022 with scores of 5 and 6; these low scores could have been the result of drought conditions in the catchment.

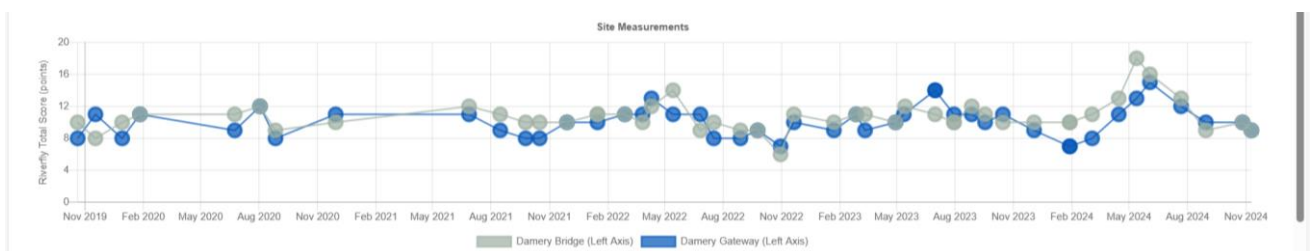
Figure 8 Riverfly Total Scores for the Little Avon next two sites – moving downstream – Damery Bridge and Damery Gateway

The drought conditions of Summer 2022 affected many of the rivers in the catchment and the RMI data from sites such as those on the Little Avon river helped to inform the Environment Agency’s drought investigations. **Little Avon sites showing clear drought impacts include Damery Bridge, Damery Gateway and Cascades.**

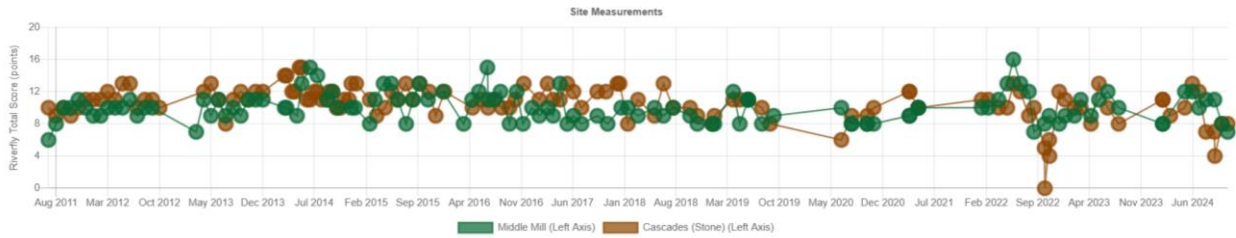
Figure 10 Riverfly Total Scores for the Little Avon next two sites – Middle Mill and Cascades

The site with the most trigger level breaches is the Little Avon at Cascades site – towards the bottom of the watercourse near Stone. This has breached its trigger level on 5 occasions – including the drought period of autumn 2022. **Further investigation is recommended into the potential water quality issues affecting this site.**

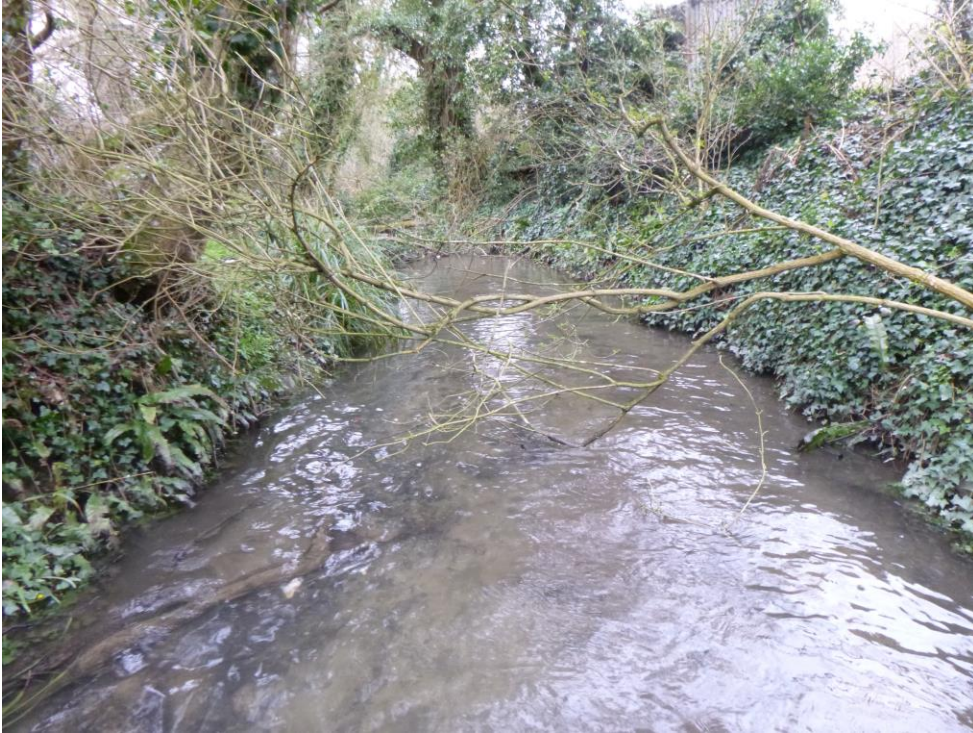
The notes recorded at the time of survey showed that the habitat conditions at Site 4 had changed considerably in the Spring 2021 sample as the result of a natural in stream blockage caused by some large woody debris falling in the watercourse. This had caused the water to back up behind the blockage, replacing the shallow, fast flowing riffle / run habitat recorded in autumn 2020 with a slow, slack / run habitat with a thick silt substrate. The reduction in the number of macro-invertebrates found and the subsequent drops in Number of scoring taxa and BMWP scores between autumn and spring and the increase in sediment, and potentially nutrient pressure in the spring SmartRivers results reflects this change in habitat conditions. The SmartRivers pressure on the site from pesticides was present in both seasons and the change in habitat conditions did not, therefore, have an impact on this.

Little Avon Tribs Macro-invertebrate site 4: Dyers Brook DS Wotton-Under-Edge

This site is located downstream of Wotton-Under-Edge. It is recommended that a water quality monitoring project is carried out on the Dyers brook to assess the conditions and the potential impact of water quality on the ecology of the brook, focusing particularly on the stretch downstream of Wotton-Under-Edge.

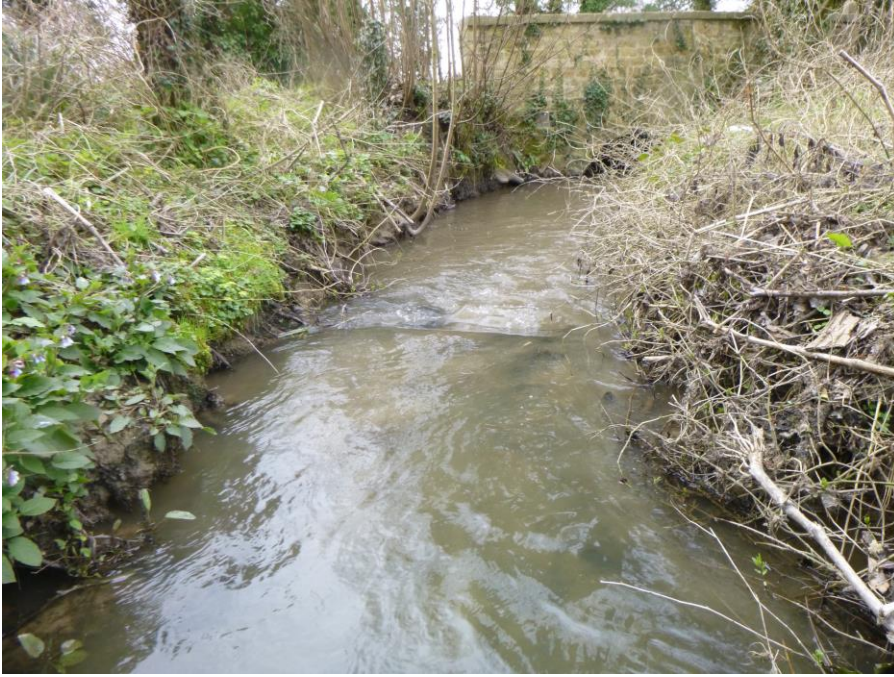
The notes recorded at the time of sampling indicate that there is very poor habitat available at this site and the water was also deep (average 60cm depth) and slow flowing. Very high silt levels were recorded in both samples (90% of the substrate type and a thick layer on all the channel substrate). The poor habitat conditions at this site and presence of large quantities of silt are likely to be restricting the macro-invertebrate assemblages at Site 6. Further investigation is recommended into the reasons for the slow, backed up, heavily silted channel in this location. If undertaking measures upstream and downstream to improve the continuity of flow in this section is not possible then in stream river restoration works to increase the habitat features available, such as installing large woody debris within the channel, should be considered.

Little Avon Tribes Macro-invertebrate site 6: Doverte Brook DS Nibley STW

The site is immediately downstream of Nibley sewage treatment works and further investigation into the water quality of the brook in this location is recommended. Additional macro-invertebrate monitoring is also recommended above the sewage treatment works to allow comparison between macro-invertebrate assemblages.

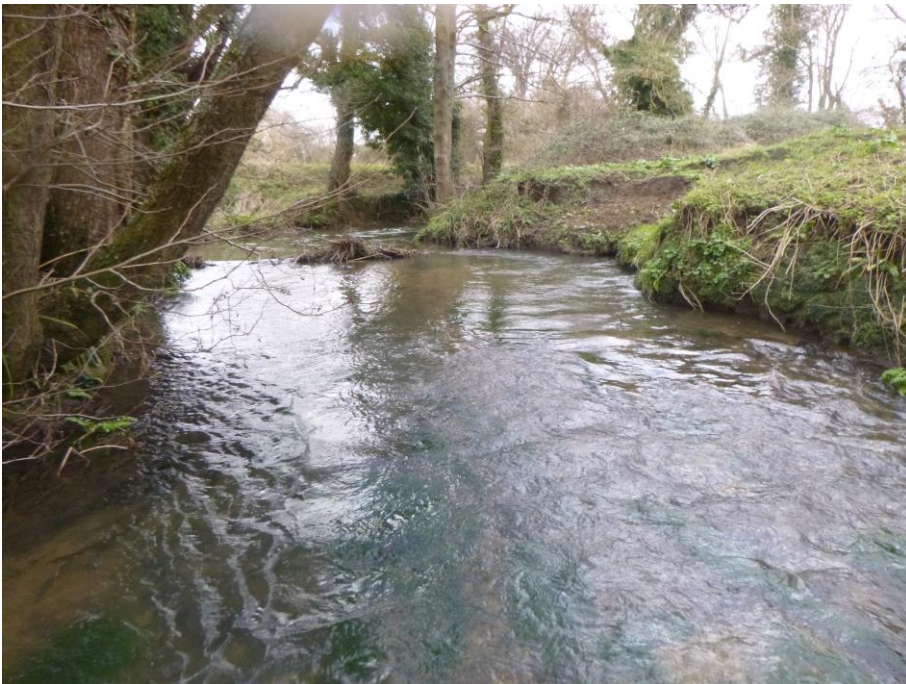
Site 7 had an excellent diversity of macro-invertebrate taxa present in both spring and autumn samples. The BMWP scores were excellent in both samples, well within the “High – unimpacted” water quality category at 120 and 121. The Number of Scoring Taxa were also high with 21 scoring taxa present in both seasons. ASPT scores were close to 6 (5.71 and 5.76), and amongst the highest found at the Little Avon sites.

Little Avon Macro-invertebrate site 7: Ozleworth Brook at Lower Barnes Bridge

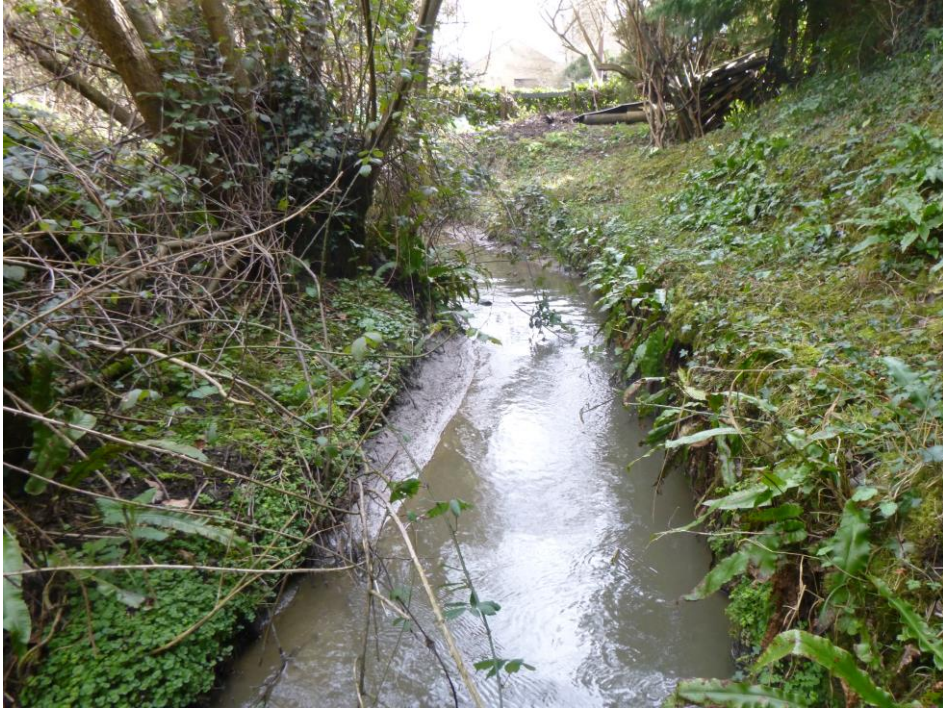
The site with the most restricted macro-invertebrate assemblages was the Dovere Brook at Mill End. The biological indices at this site were very low indicating poor water quality and habitat in this location. The notes recorded at the time of sampling show that there was very restricted habitat at the site with thick silt / mud recorded in both seasons. The flow was a very slow run flow with 100% silt cover present, steep banks and no macrophytes. The turbidity was moderate / high and there was an odour

present. These features provide very poor habitat variation for macro-invertebrates to live within and are likely to be restricting the macro-invertebrate assemblages in this location.

The macro-invertebrate assemblages recorded at Site 8 were poor. The SmartRivers pressure ratings found extremely high chemical stress at this site and the organics ratings suggested considerable water quality issues. The sediment and phosphorus metrics could not be used as there were so few taxa present. It is extremely likely that the polluting inputs entering the Doverte brook upstream of the macro-invertebrate site, as reported by BART to the Environment Agency, are responsible for the very poor macro-invertebrate assemblages recorded at the site.

Little Avon Macro-invertebrate site 8: Dovere Brook at Mill End

Due to the severity of these findings BART reported the issues to the Environment Agency for further investigation and the Environment Management Team have led an investigation into this problem site. BART staff re-visited the site in January 2022 and found that these issues were still impacting the watercourse. Further issues were also recorded during this visit including a slurry heap leaching down the hill and into the river and tree removal adjacent to the watercourse and these findings were also reported to the Environment Agency alongside the SmartRivers findings for further investigation.

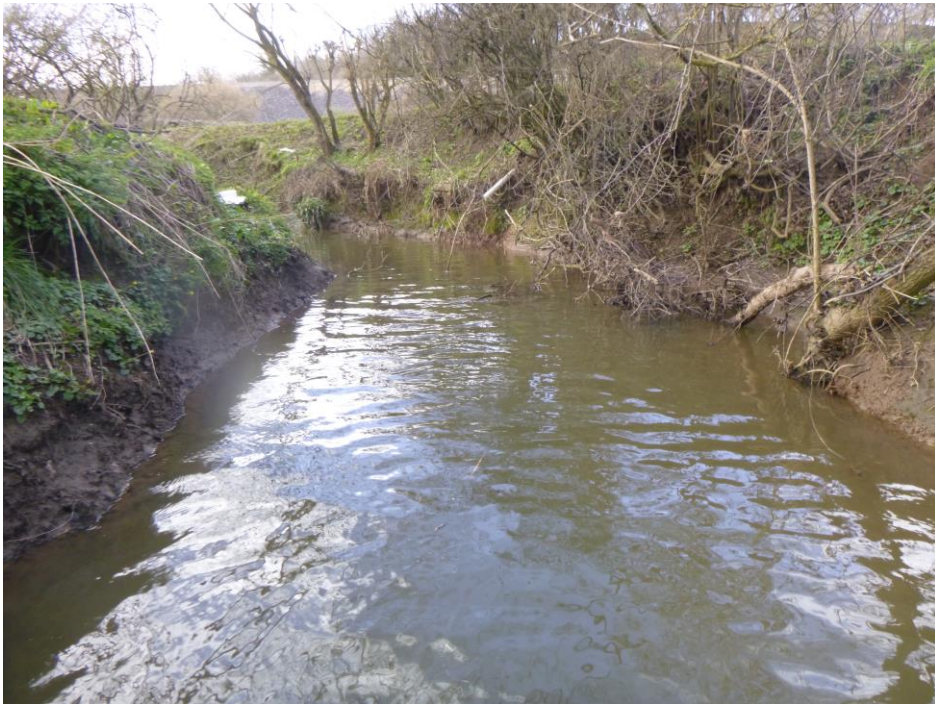
It should be noted that the catchment suffered from drought conditions in summer 2022 and the impact of the summer low flows could have had a detrimental effect on the macro-invertebrate assemblages recorded in this late September sample. The low flows could have exacerbated the impact of the pressures contributing to the very high chemical, phosphorus, sediment and flow stress exhibited by the macro-invertebrate communities in autumn.

The conditions at the site are also likely to have contributed towards stresses on the macro-invertebrate communities. The steep banks were recorded as collapsing in places – this would add sediment to the river at the macro-invertebrate site location. Severe poaching and a very muddy track were recorded immediately upstream of the site causing significant sediment input into the river here. Other impacts on the stretch upstream of Site 9 recorded during BART's walkovers include culverting of the river under the railway track- potentially impacting the flow at the site and Wickwar Sewage Pumping Station which is located downstream of Wickwar – potentially contributing towards the concerning chemical and phosphorus stresses and the high saprobic score in autumn (suggesting considerable water quality issues).

Little Avon Macro-invertebrate site 9: Little Avon DS Wickwar

- BART farm visits / landowner engagement along the stretches of riverbank that are heavily poached – including the Little Avon DS Wickwar site;
- Further investigation into the causes of trigger level breaches at the Little Avon at Cascades RMI site;

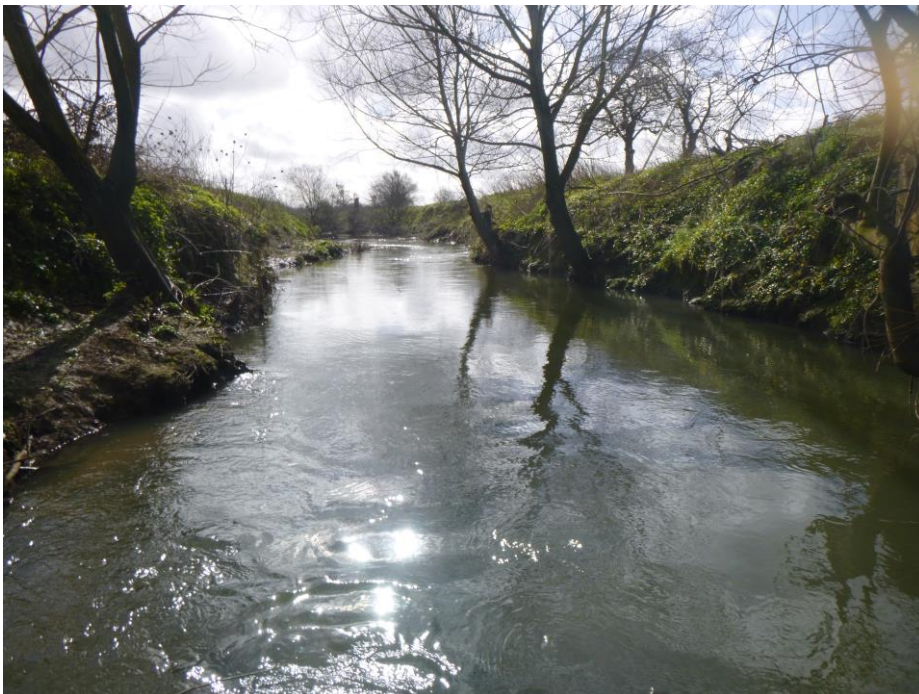
Although the biological indices scores were higher in autumn than spring at this site, the SmartRivers pressures ratings are poorer in autumn compared to spring suggesting considerable water quality pressures on the macro-invertebrate communities, particularly in autumn. The SmartRivers pressure ratings scores found concerning phosphorus and sediment stress exhibited by the macro-invertebrates in autumn at this site. This correlates with the silty conditions and higher levels of algae recorded at the time of the autumn survey. Some flow and chemical stress were indicated in both seasons with impacts slightly more evident in autumn.

Other impacts on the stretch upstream of Site 11 recorded during BART's walkovers include incised channel with bank erosion and bare maize fields with no buffer zone – all these features are likely to be causing sediment to enter the river. Site conditions recorded during the survey suggested that sediment levels were higher during the autumn sample, again potentially the result of the recent low flows. The average river depth recorded during the autumn sample was lower (20cm) than during the spring sample (40cm).

Little Avon Macro-invertebrate site 11: Little Avon at Matford Bridge
