South Bristol Rivers Macro-invertebrate Monitoring Summary Report

June 2025

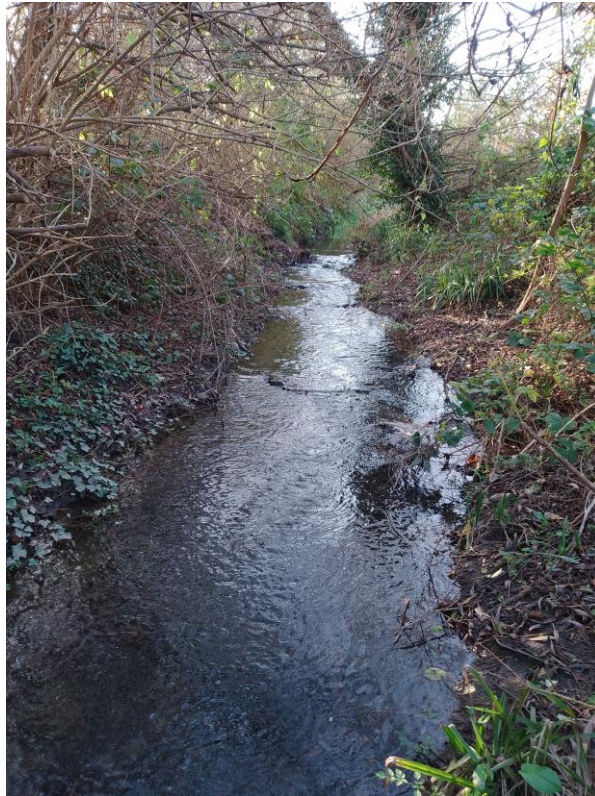
The Malago Brook sample site was located on a stretch of the brook where BART had previously undertaken restoration works. Berms were seen to be pinching the channel nicely at the survey site with good riffle and run flow recorded in this location. Thick overlaying silt was, however, was also recorded at the site. The macro-invertebrate assemblages found were more limited in the spring sample than in the autumn sample (11 scoring taxa and 15 scoring taxa respectively) and the BMWP water quality score was also much lower in spring (50 compared with 77). As well as a low diversity of taxa in spring, the taxa were also present in very low numbers. For example, of the 11 taxa only three had abundances over four - shrimps (*Gammarus pulex*) and two caseless caddis fly families (*Agapetus fuscipes* and *Hydropsyche siltalai*).

The SmartRivers pressure scores showed that four of the five pressures were having a concerning impact on the macro-invertebrates in this location. The pressure of least concern at this site was organics. Although restoration works have likely improved the habitat at this site, the macro-invertebrate communities are still restricted by the water quality issues here. **Further investigation into the water quality issues on the Malago Brook is recommended – this should involve a desk top study looking at current data as well as targeted water quality monitoring and a wet weather survey if necessary.**

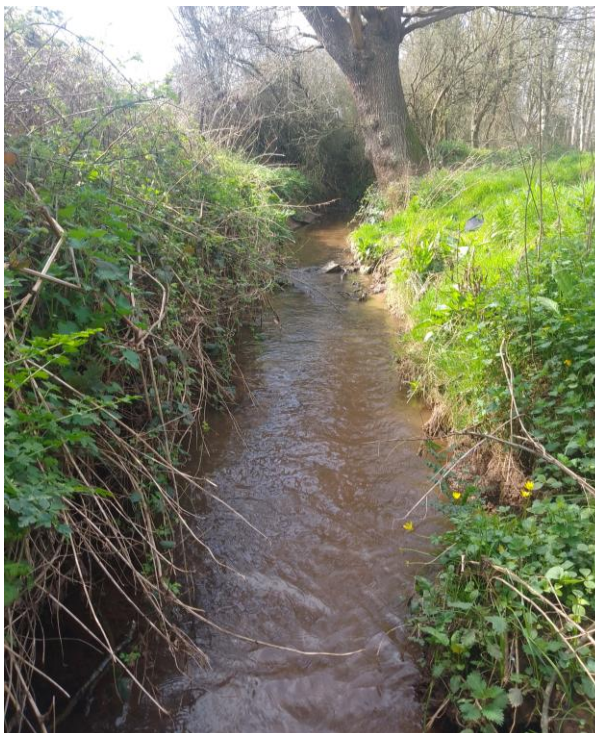
The Ashton Brook site had very poor habitat conditions recorded on the survey form. The substrate was recorded as 80% silt, the banks were very steep and the flow was recorded as a very slow (nearly slack) run. As with the Malago Brook site the macro-invertebrate assemblages found in the Ashton Brook were fairly limited and most taxa were present in low numbers. For example in the autumn sample, although 15 scoring taxa were recorded, only three had abundances over ten – shrimps, worms (Oligochaeta) and leeches (*glossiphonia complanata*). In spring, out of the 12 scoring taxa only shrimps, non biting midge larvae (*prodiamesinae*) and fly larvae (*eloeophila sp*) had abundances over ten. With the exception of shrimps which score 5 (midway) on the BMWP water quality scale, these taxa are all pollution tolerant.

The SmartRivers pressure scores show that chemicals are the pressure of most concern at this site. Siltation was also flagged as an issue of concern in the autumn sample – the heavy siltation at this site would support this finding. **Further investigation into the chemical water quality issues and heavy sedimentation on the Ashton Brook is recommended – this should involve a desk top study looking at current data as well as targeted water quality monitoring and a wet weather survey if necessary.**

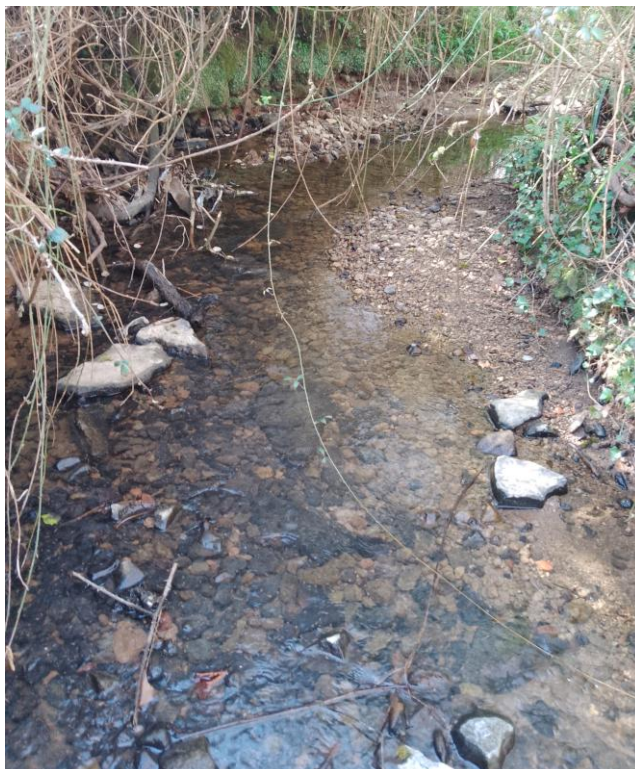
The Colliter's Brook samples had the greatest diversity of macro-invertebrates present (21 scoring taxa in autumn and 16 in spring) and the highest BMWP scores (113 and 86) compared to the other sites. These scores indicate that conditions at the Colliter's Brook site were able to support a good range of macro-invertebrates. Habitat conditions at this site were good with a good variety of substrate types (cobbles, pebbles, gravel, sand, silt and clay), a mix of flow types (riffle, run and pool) and a point bar located on the RHB pinching the channel in this location.

The SmartRivers pressure scores shown in table 1 support these findings with scores of unimpacted or slightly impacted for all pressures with the exception of chemicals in autumn which scored "impacted". There are a number of possible sources of chemicals in watercourses including point source pollution from road run off, leachate from former landfill sites and diffuse pollution from pesticides, herbicides or fungicides applied to agricultural land. **Further investigation into the water quality issues on the Colliter's Brook is recommended. This should involve a desk top study looking at current data as well as targeted water quality monitoring if necessary.**

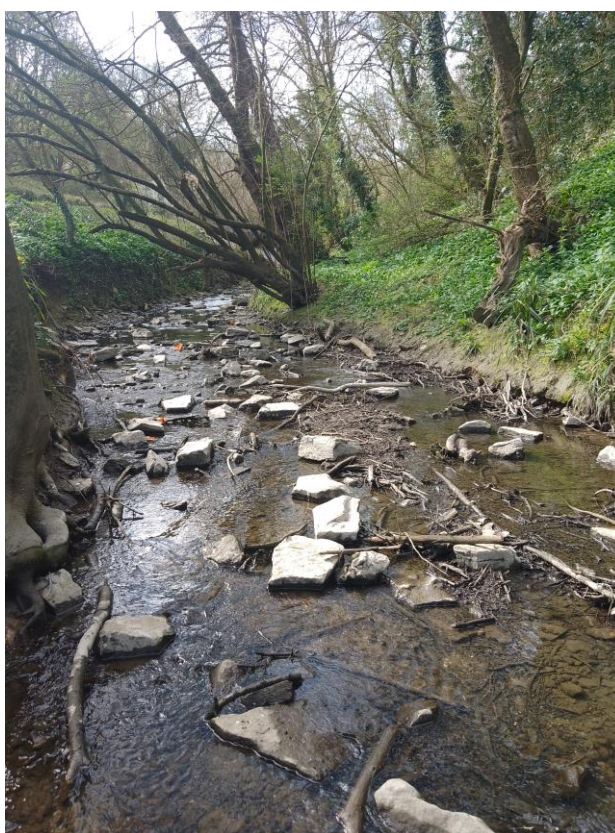
The Pigeonhouse Stream had a very restricted diversity of macro-invertebrates present in both samples. Only 13 scoring taxa were recorded in each sample and BMWP scores were low for both samples. The surveyor recorded sewage fungus present on stones and a strong smell of sewage during both spring and autumn sampling. There was a good range of substrate types (boulders, cobbles, pebbles, sand and silt) present at the site and a large riffle habitat was present, although overlaying silt was recorded on the substrate.

The SmartRivers pressure scores showed a concerning impact on the macro-invertebrates from all five pressures. Chemicals scored heavily impacted in both seasons and siltation and flow scores were both heavily impacted in autumn and impacted in spring. The Pigeonhouse Stream had the highest Saprobic values of all the sites suggesting significant organics issues here. **Further investigation into the water quality issues on the Pigeonhouse Stream is recommended – this should involve a desk top study as well as further macro-invertebrate monitoring, targeted water quality monitoring and a wet weather survey if necessary.**

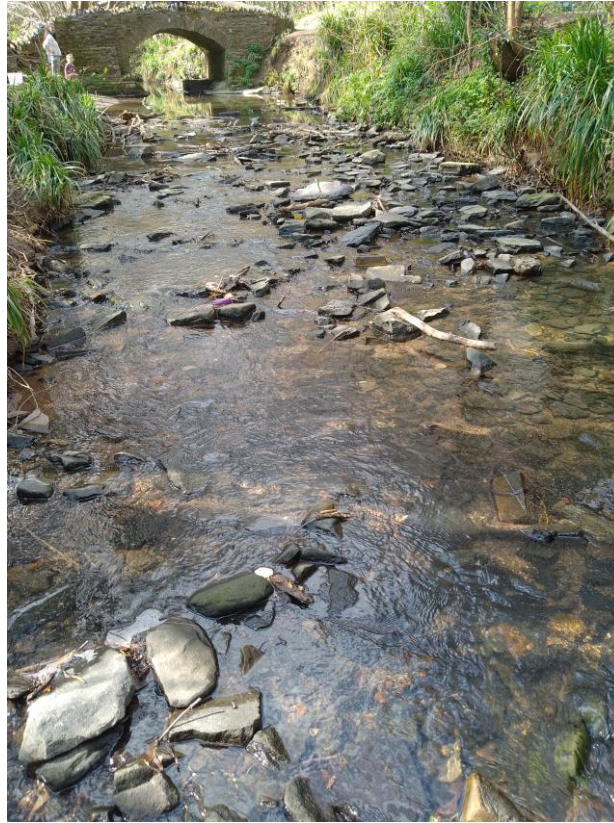
The Brislington Brook samples had the lowest diversity of macro-invertebrates present of all the sites (only 8 scoring taxa in each sample) and very low BMWP scores (27 in both samples). These scores indicate that conditions at the Brislington Brook site are not able to support a good range of macro-invertebrates. The habitat at the Brislington Brook site was good with riffle and run habitats recorded, good substrate composition and light shading present. It is, therefore, likely that significant water quality issues are impacting the Brislington Brook site and restricting the macro-invertebrate communities here.

The SmartRivers pressure scores support these findings and the heavily impacted chemical scores for both autumn 2024 and spring 2025 indicate that chemicals are the greatest pressure here. Sediment is also likely to be an issue in this location with a siltation score of moderately impacted for both

seasons. Experts at Wildfish state that at sites with WHPT NTAXA below 10 the TRPI (Phosphate) scores should be discounted (and other metrics treated with caution) as the invertebrate community is too poor to calculate scores. The WHPT NTAXA was below 10 for both of the Brislington Brook samples.

Further investigation into the water quality issues on the Brislington Brook is recommended – this should involve a desk top study as well as further macro-invertebrate monitoring, targeted water quality monitoring and a wet weather survey if necessary.
